**DERAILMENT OF TANK CARS WITH  
SUBSEQUENT FIRE AND  
EXPLOSION ON CHICAGO,  
ROCK ISLAND AND  
PACIFIC RAILROAD COMPANY**

**NEAR DES MOINES, IOWA**

**SEPTEMBER 1, 1975**

**REPORT NUMBER: NTSB-RAR-76-8**

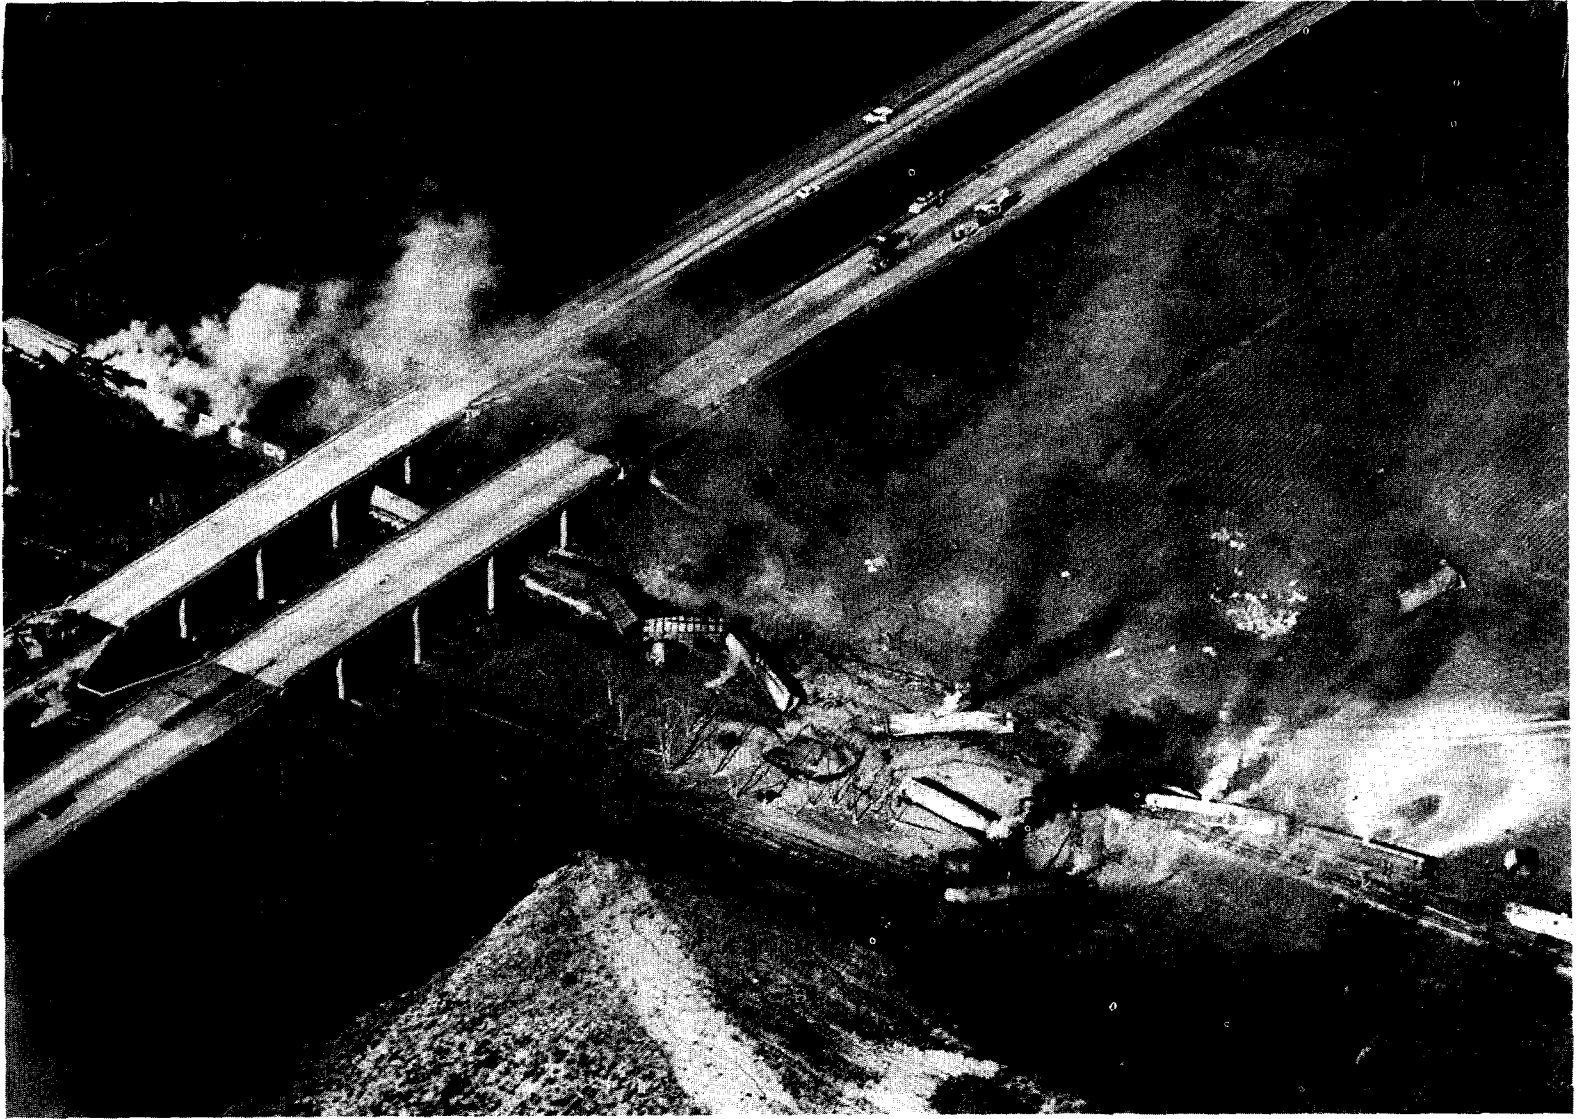
The first cars derailed at milepost (M.P.) 77.9 at a No. 10 frog of a left-hand turnout. The major fire and explosions occurred just beyond the highway bridge which carried Interstate Highways 80 and 35 over the railroad. (See Figure 1.) At M.P. 78.6, southbound trains begin to descend 2 miles of a 1-percent grade; the 2 miles extend through the 5,900-foot, 1-degree curve on which the cars derailed.

Figure 1. Aerial view of accident site.

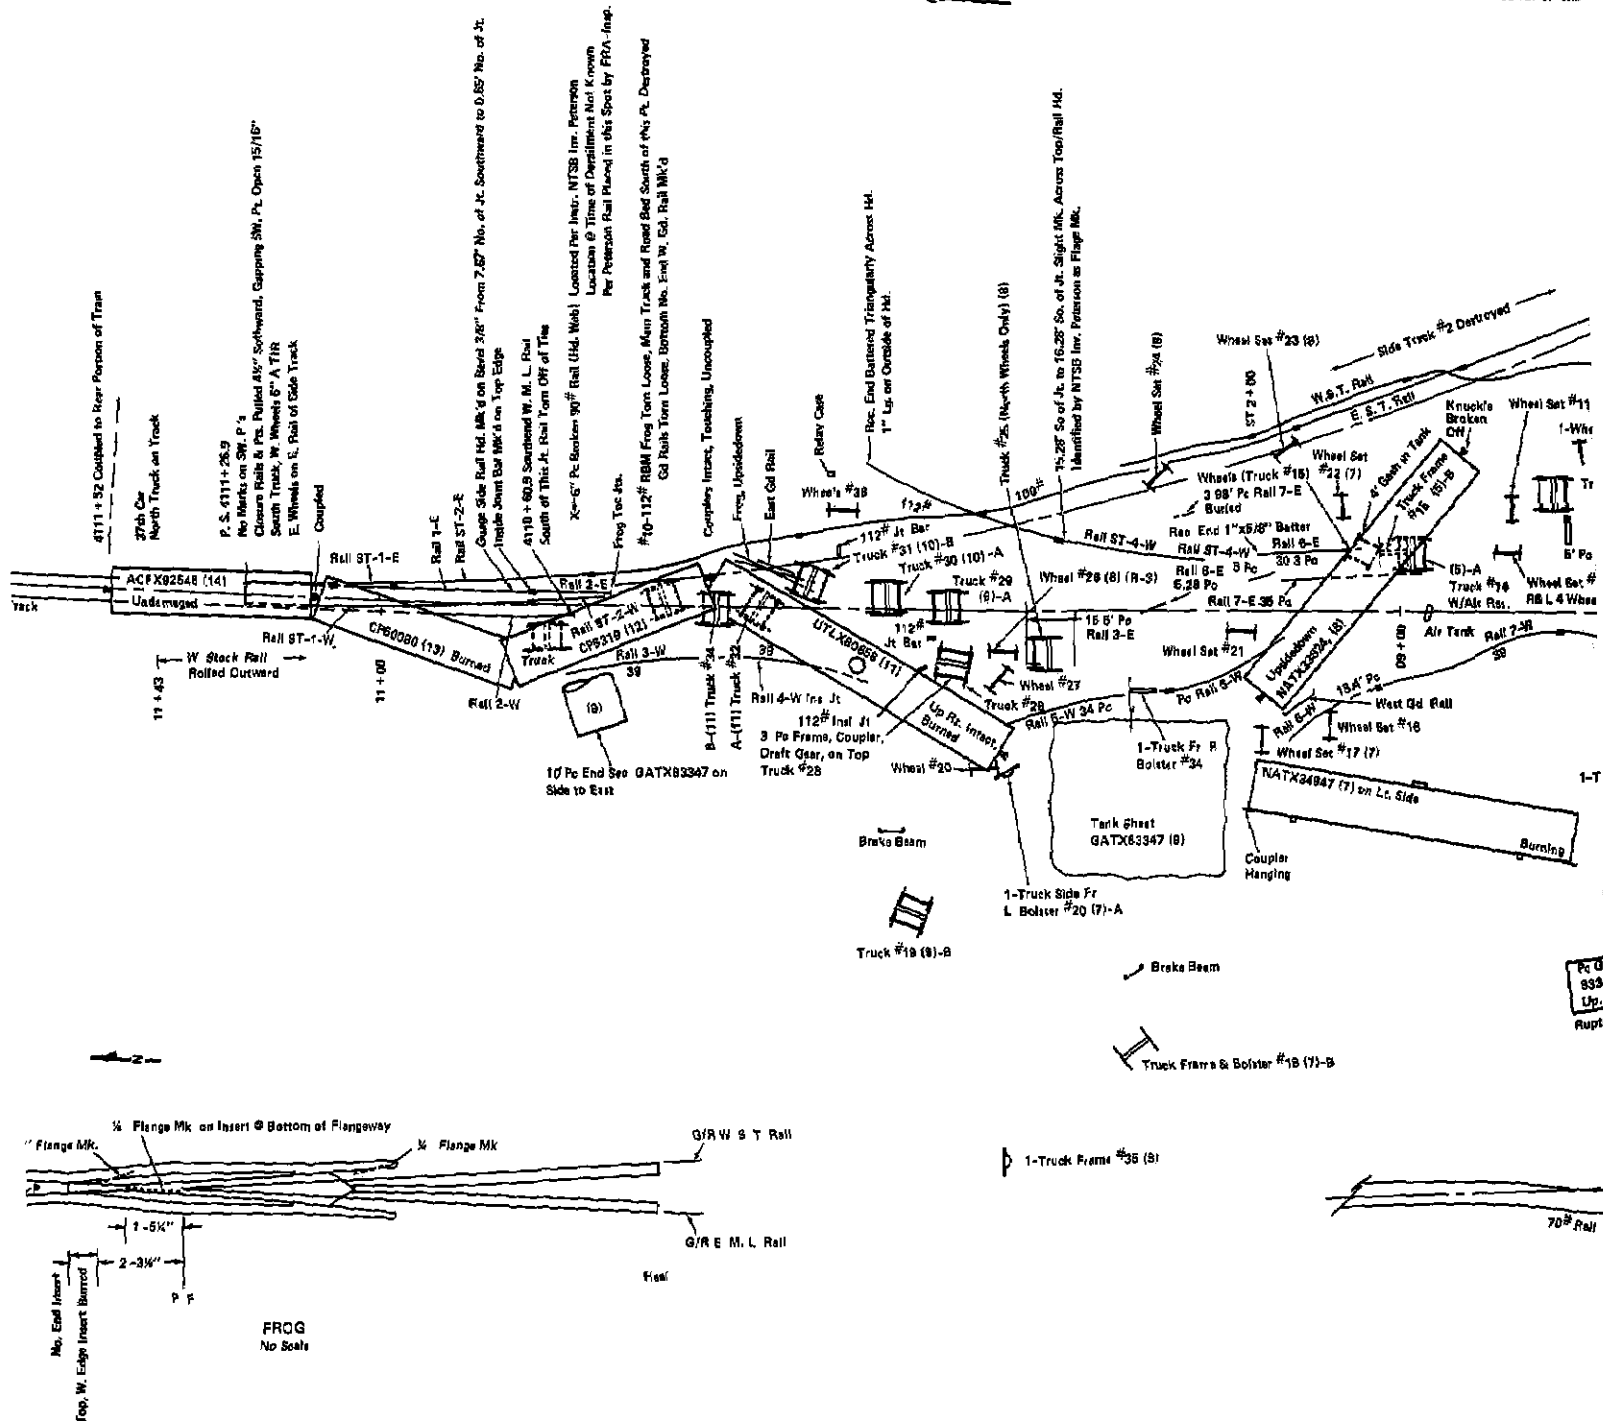
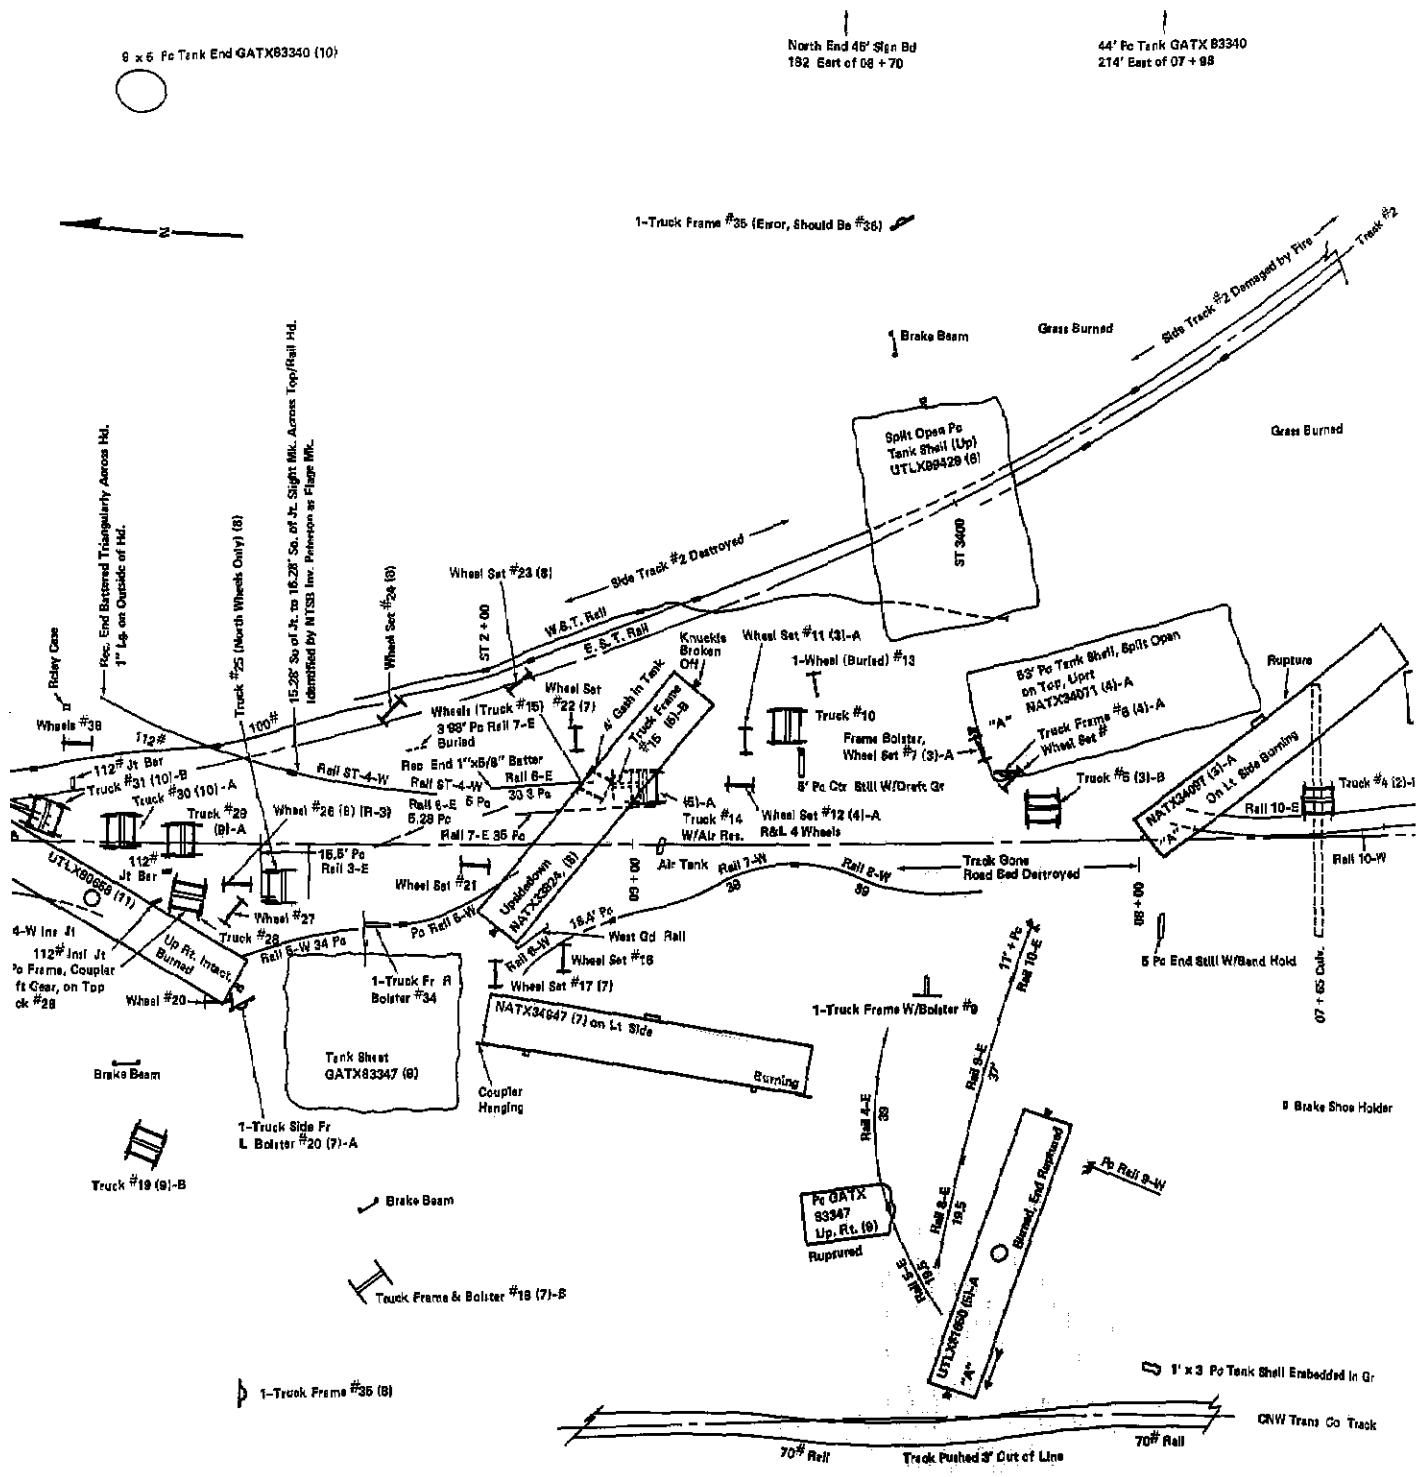
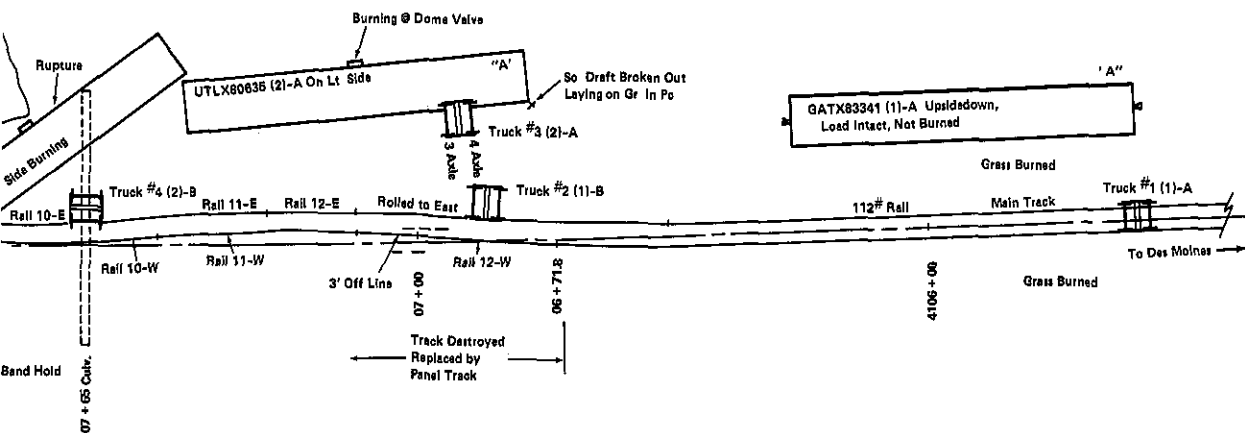
## Figure 2

The switch was relatively undamaged except where the cars derailed. The main-line guardrail was found 126 ft south of its proper location, with its receiving end battered by wheels. There were wheel marks on the rail's web, south of the heel of the switch points. These were produced by the last few cars that derailed. The frog was found south of its original location. The main-line toe of the frog had a 1 1/16-inch-wide, 3/4-inch-long, 5/8-inch-deep mark, probably made by a wheel flange. A mark was also found on the north end of the frog's toe filler block. A flange mark was found on the insert of the frog at the bottom of the flangeway. The mark on the filler block was caused by a wheel set found in the vicinity of the guardrail, 127 feet south of its original location. Wheel marks on the turnout ties and rails beyond the frog indicate that some of the wheels of the first derailed cars went east on the siding.

In many instances wheel marks were traced to the wheels; however, nothing conclusive could be assigned to them. In some instances, wheel sets could not be related to the cars from which they came. (See Figure 2.)

# PLAN OF ACCIDENT AREA AND LOCATION OF CAR COMPONENTS

The running gear of the first three cars to derail showed no evidence of mechanical deficiencies. These three cars lost their trucks and appeared to have slid while overturned on their sides. The trailing truck and bolster of the third car were dragged on the track structure before the car overturned. The fourth derailed car exploded and was found in two parts. The lead end of the car consisted of about 1/4 of the car. The head was not punctured. The remainder of the tank shell was flattened by the explosion.

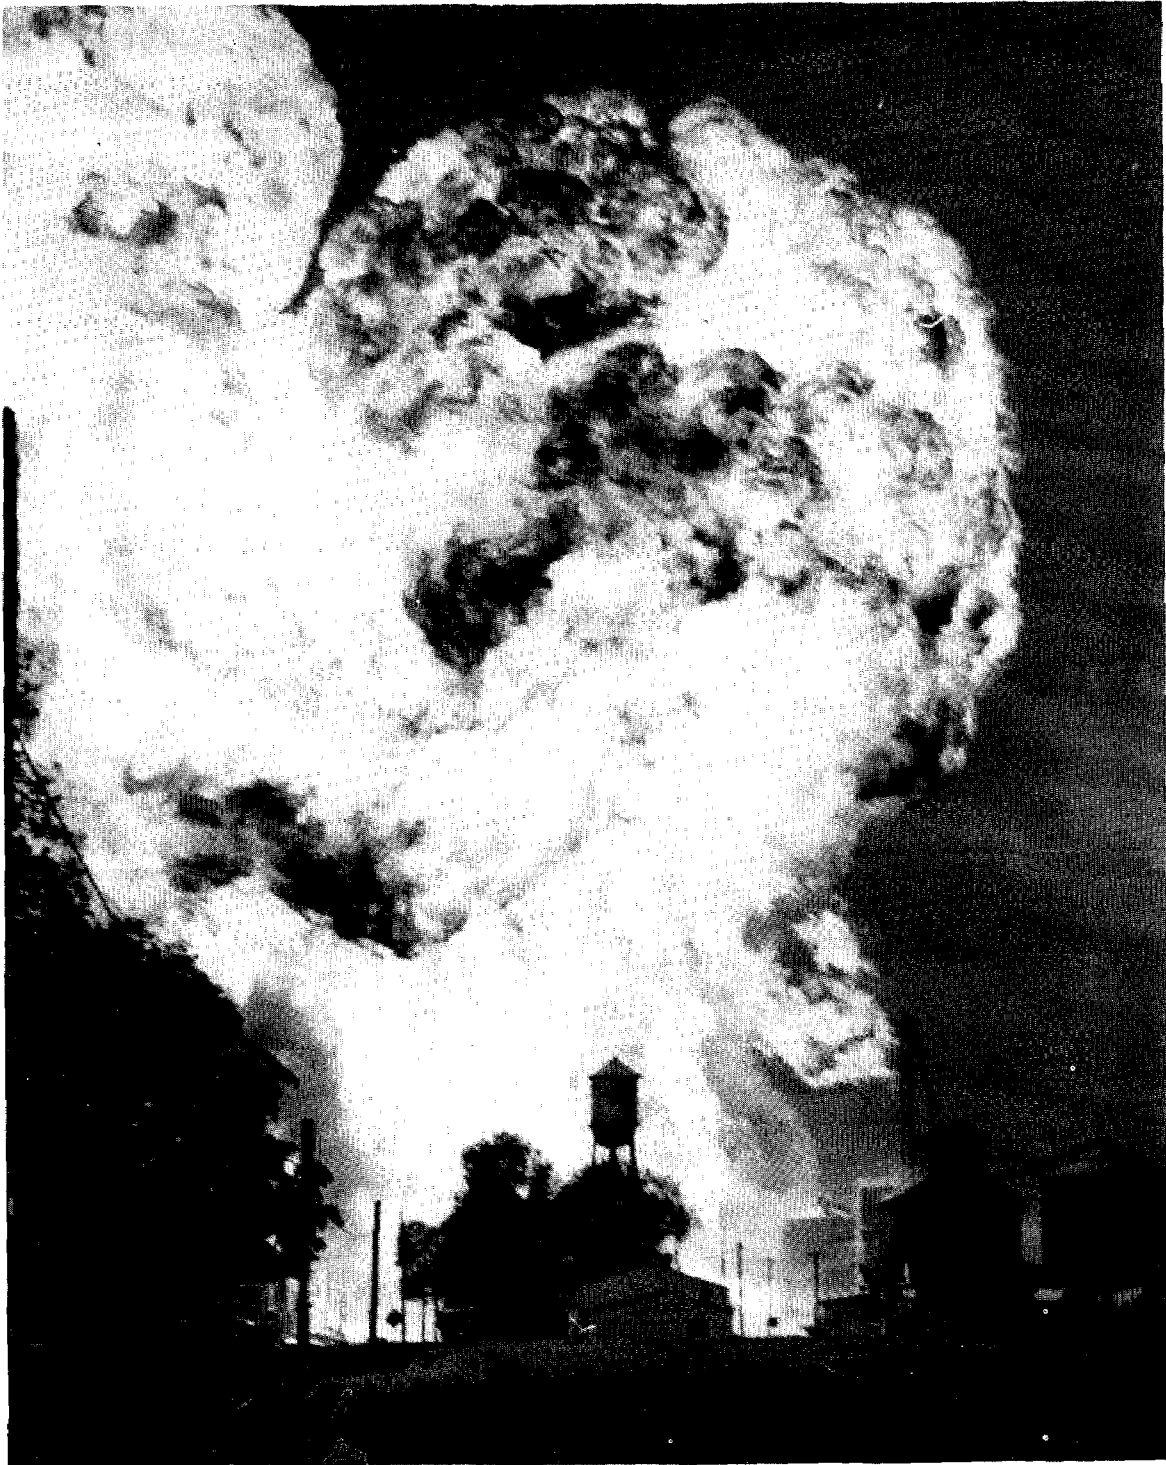
APPENDIX No. 2

The circumstances of this accident are markedly similar to those of the accident that occurred at Crescent City, Illinois, on June 21, 1970. At Crescent City, a 15-car derailment resulted in the initial release of propane from one of the nine cars containing this commodity. Fire ensued immediately thereafter, and fire departments responded to the scene and attempted to fight the fire. Subsequent explosions occurred during a period ranging from approximately 1 to 4 1/2 hours after the initial derailment. Large portions of the involved tank cars "rocketed" up to 1,700 feet from the accident site. Sixty-six firemen, reporters, and photographers were injured as the result of the subsequent explosions. A photograph of the explosion is shown in Appendix No. 2.

Explosion that occurred at Crescent City, Illinois, approximately 1 hour after initial derailment of tank cars containing propane.
