RAILROAD ACCIDENT INVESTIGATION

Report No 3848

PANHANDLE AND SANTA FE RAILWAY COMPANY

JUILLIARD, TEXAS

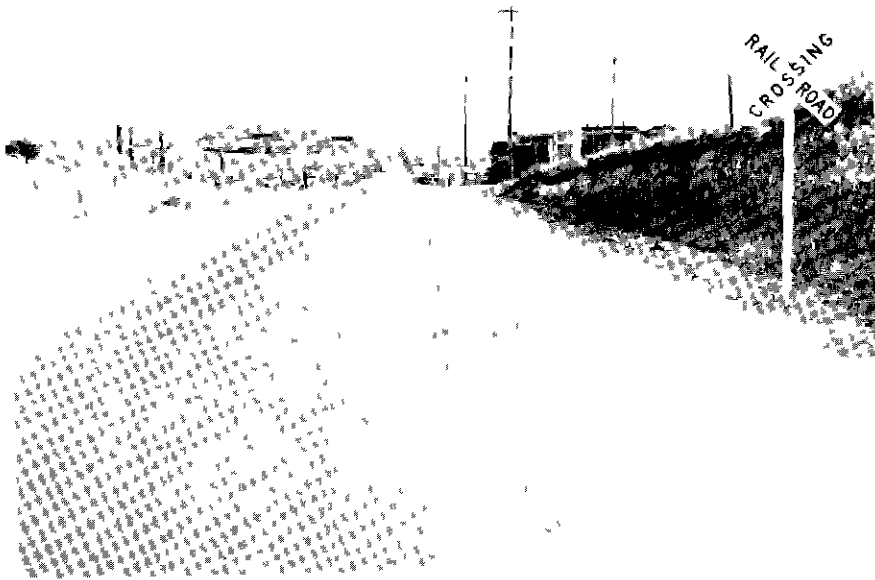
PLATE 1

Northbound motorist's view of rail-highway crossing involved Train shown is westbound Photograph was taken from a point 250 feet south of crossing

The accident occurred on the main track at a point 5.9 miles west of the station at Amarillo and 3.6 miles east of Julliard, Texas, where the railroad is crossed at grade by St. Francis Ave. (PLATE 1). From the east the track is tangent throughout a distance of 2,030 feet to the point of accident and 1,231 feet westward. The grade is 1.0 percent descending westward.

As a northbound vehicle approaches the crossing, the driver's view of a westbound train approaching the crossing is considerably obstructed by the banks of the cuts in which the highway and the tracks are laid. From a point 200 feet south of the crossing the driver of the vehicle can see a westbound train approaching throughout a distance of 200 feet east of the crossing. When a driver of a northbound vehicle stops south of the crossing, in accordance with that part of Texas state motor vehicle laws pertaining to highway stop signs at rail-highway grade crossings, he can observe a westbound train approaching the crossing throughout a distance of at least 1,000 feet east of the crossing.

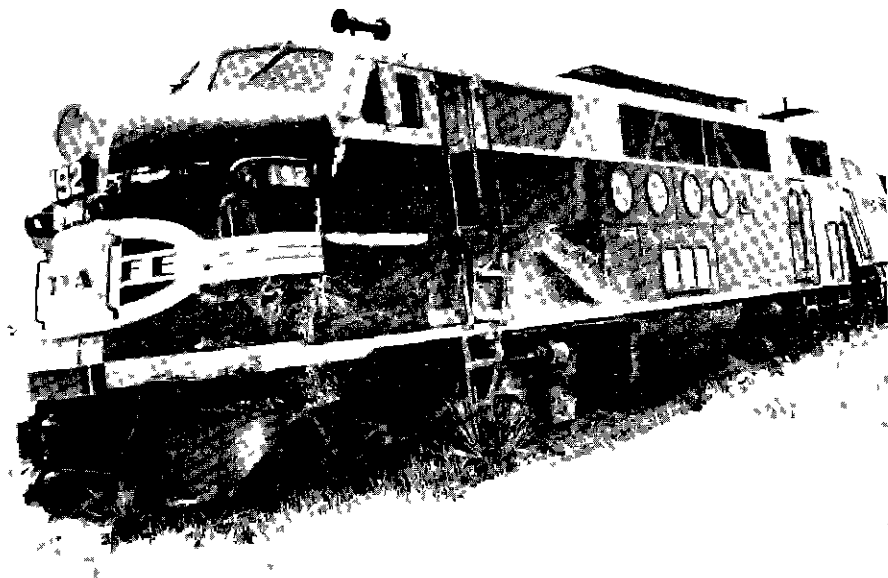
PLATE 2

The locomotive and the 1st to 16th cars, inclusive, were derailed. The locomotive stopped upright with the front end 390 feet west of the point of collision and 32 feet north of the track (PLATE 2). The derailed cars stopped in various positions on or near the track structure. The diesel-electric units were somewhat damaged, 6 cars were considerably damaged, and 8 cars were destroyed.

The motortruck stopped in the southwest angle of the intersection, about 50 feet west of the point of collision and 12 feet south of the centerline of the track. It was destroyed.
