DERAILMENT OF
PENN CENTRAL FREIGHT TRAIN B-4
AND COLLISION OF
SOUTHERN RAILWAY PASSENGER TRAIN No.6
WITH DERAILED CAR AT
ARLINGTON, VIRGINIA
APRIL 27, 1972

REPORT NUMBER : NTSB-RAR-73-2

ADOPTED: FEBRUARY 28, 1973

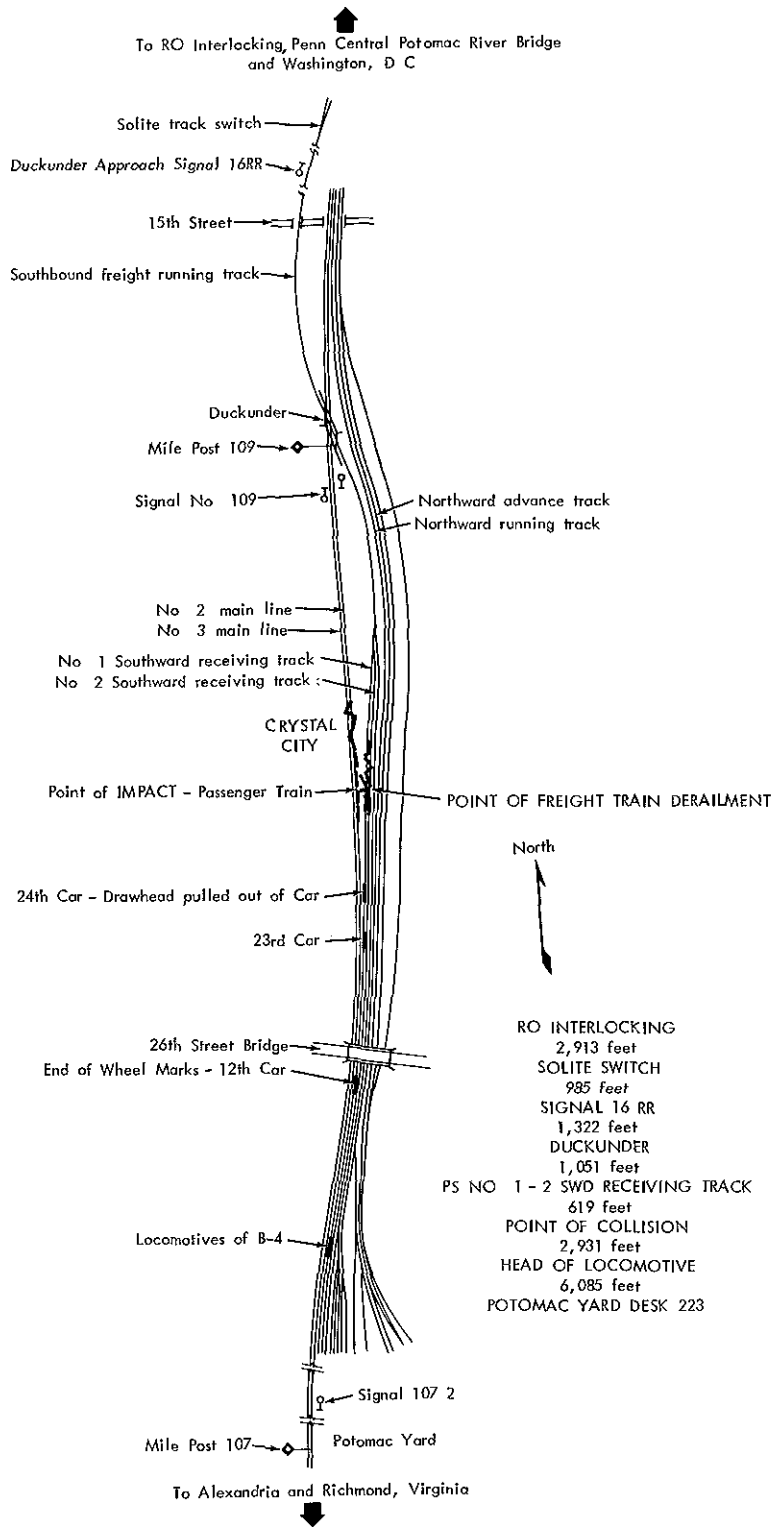
Potomac Yard extends about 4 miles south from the Potomac River. The northern end of the yard lies between the George Washington Memorial Parkway and US Route 1 in Arlington County, Va , adjacent to a complex of office and apartment buildings known as Crystal City. The southward receiving yard has 13 tracks. The No. 1 southward receiving track, the longest, is on the west side of the yard. This track originates at a switch from the southbound freight running track, at a point about 1.2 miles south of the Penn Central bridge over the Potomac River. The first derailment in this accident occurred on this track 635 feet south of the switch. (See Figure 1.)

Figure 1 Plan of accident site.

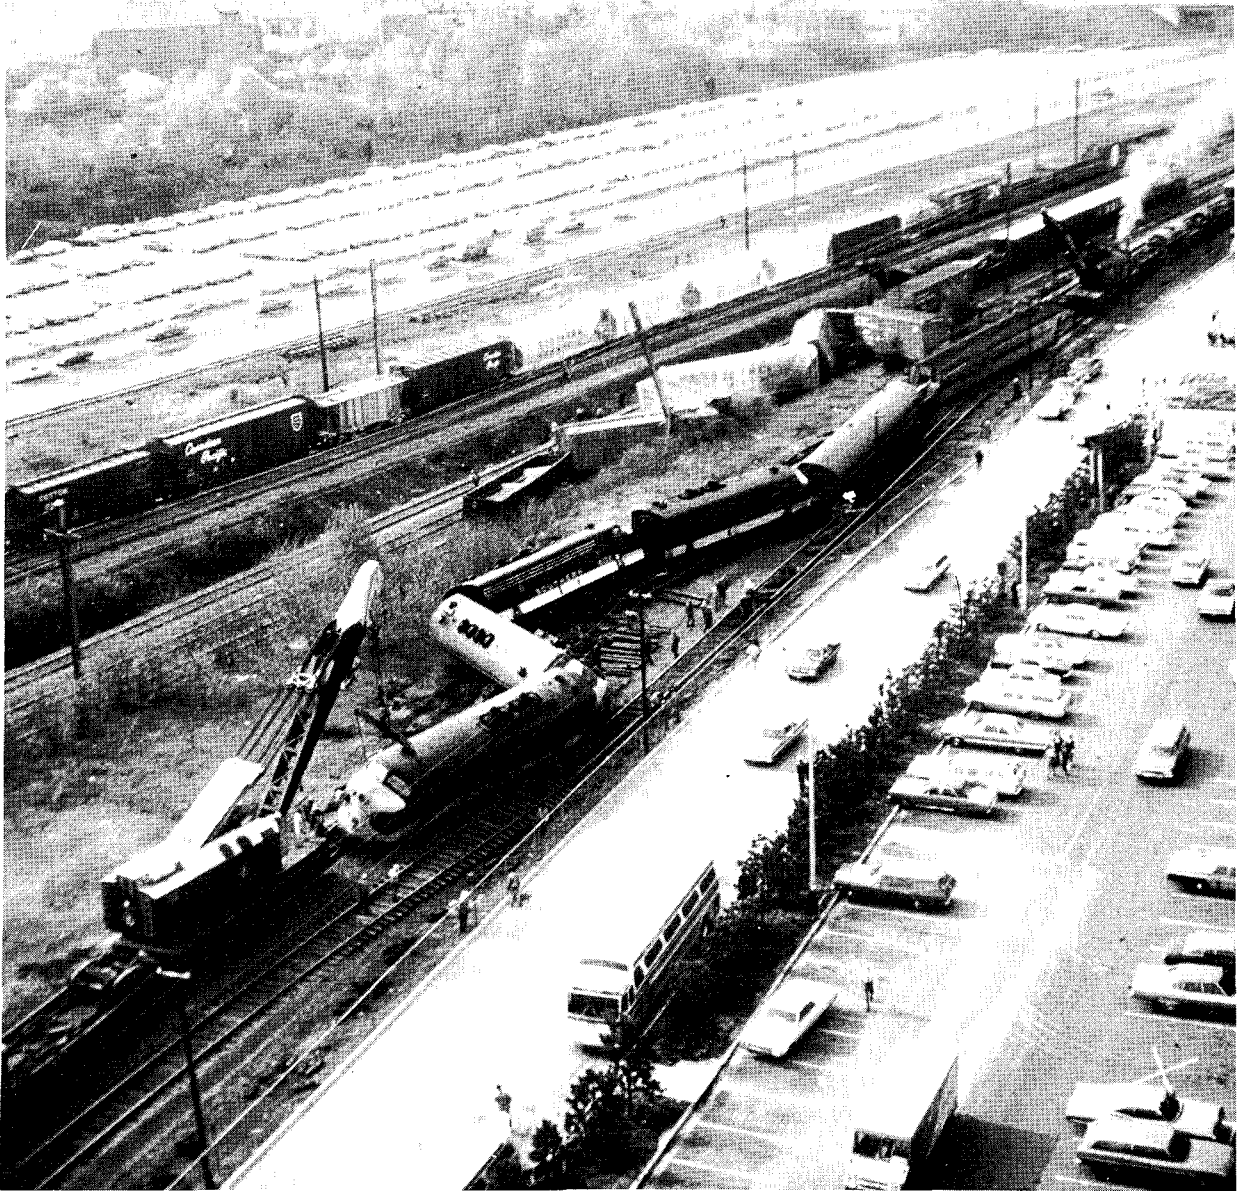
After the locomotive traveled about 1,900 feet on the No. 1 southward receiving track, the 12th car in the train (SCL 23656) derailed 635 feet south of the No. 1 southward receiving track switch. The 13th through the 28th cars remained on the rails, but the 29th through the 35th cars derailed at the same point as the

Figure 2. Overview of accident site, showing derailed freight and passenger trains.

12th car. (See Figure 2.) Locomotive power still was being applied and the coupler was pulled out of the south end of the 24th car. This separation apparently initiated an emergency brake application at about 10:17 p.m.

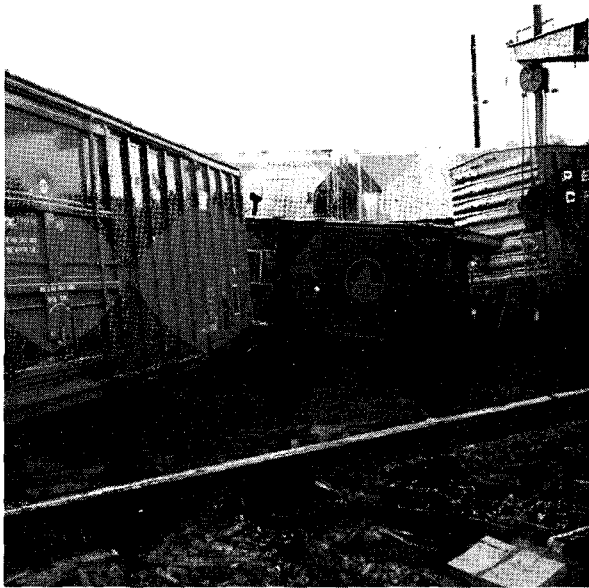
Figure 3. Derailed Penn Central boxcars in contact with B&O caboose.

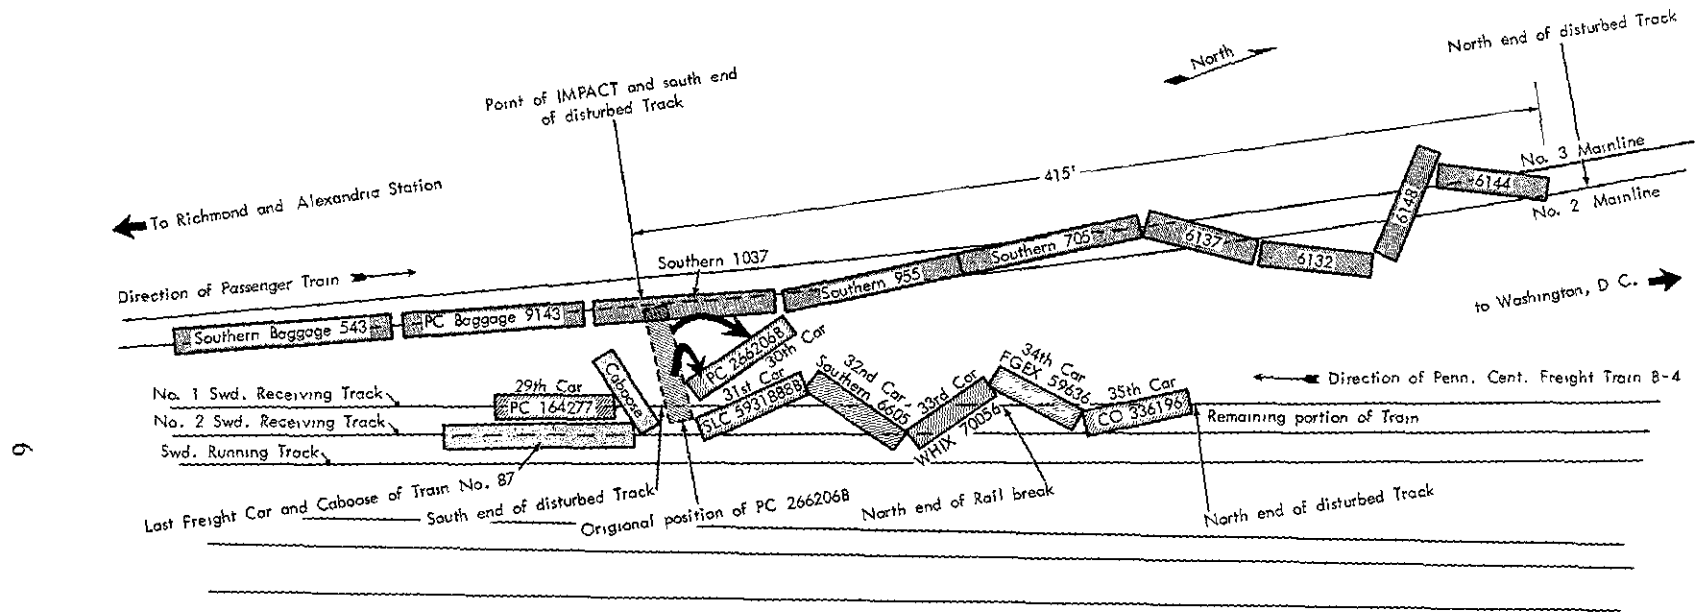
The 12th car traveled 1,349 feet with the front wheels of both trucks derailed to the east. After the emergency brake application, at least three derailed boxcars (the 29th, 30th, and 31st cars) struck the caboose of B&O train No. 87, which was standing on the No. 2 southward receiving track adjacent to the point of derailment. (See Figure 3.) Then, the 30th car veered westward and fouled the No. 2 main track. (See Figure 4.)

Figure 4. Position of derailed freight cars and passenger train.

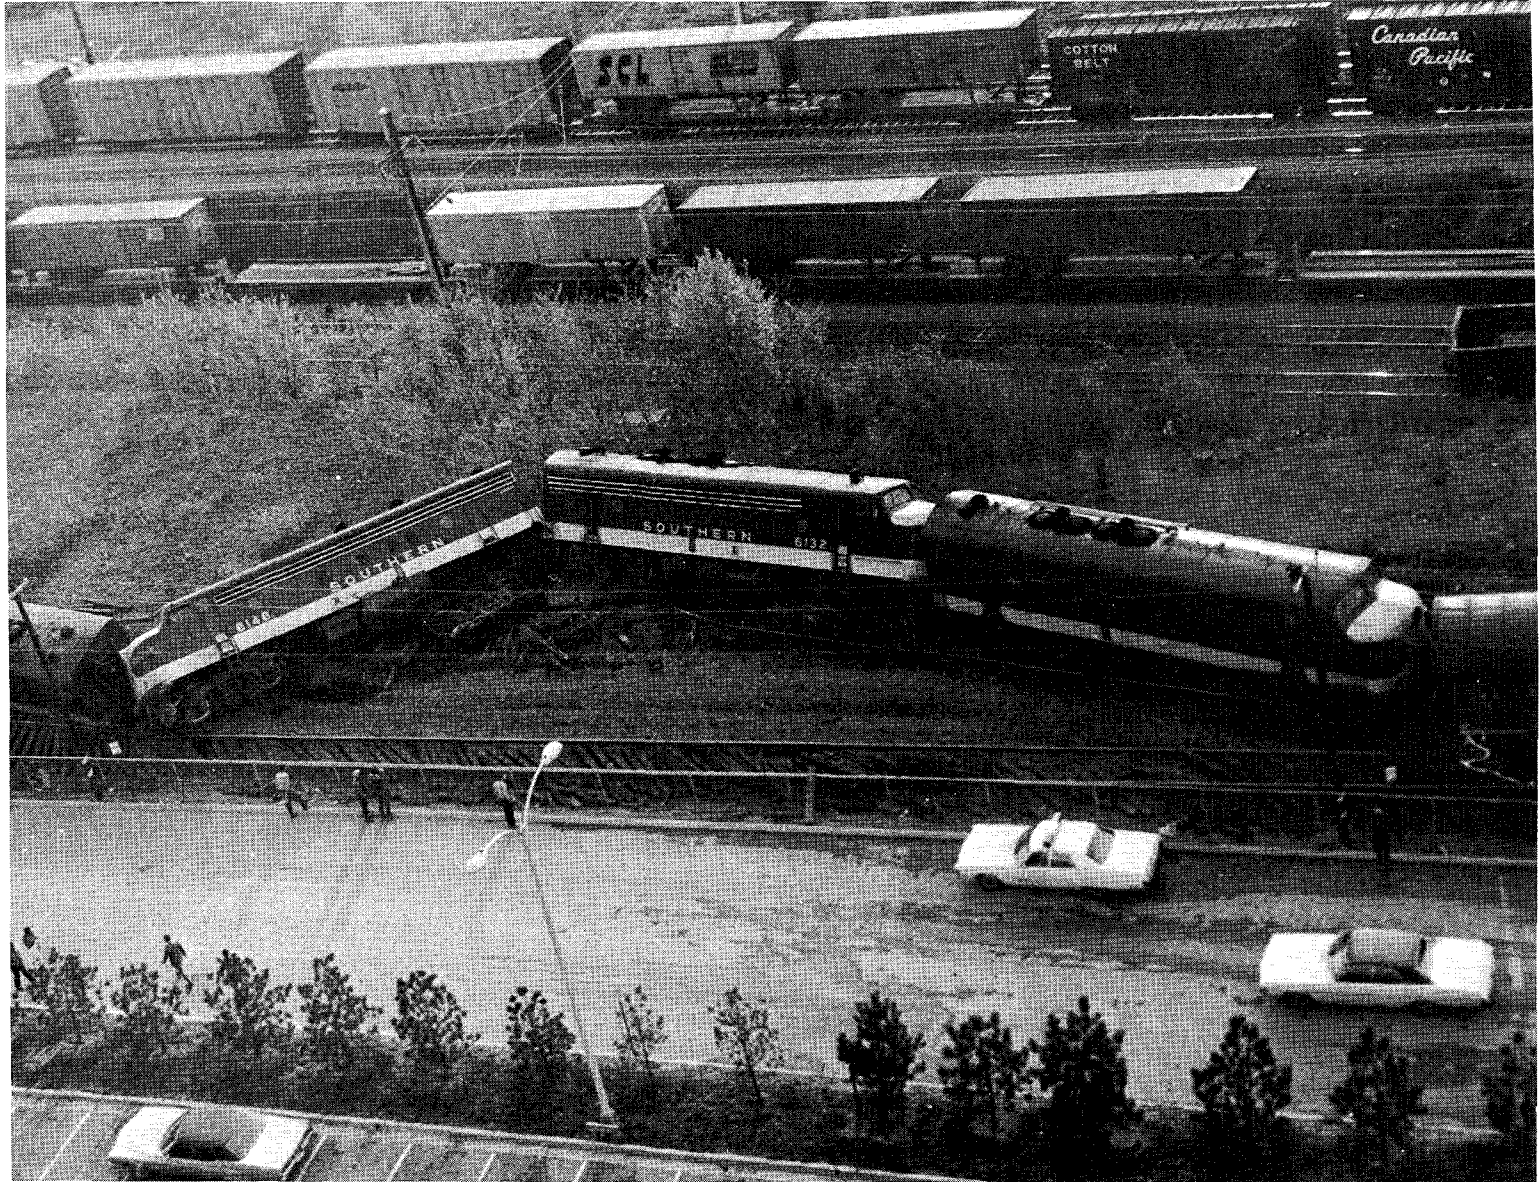
Figure 5. Derailed Southern Railway locomotives.

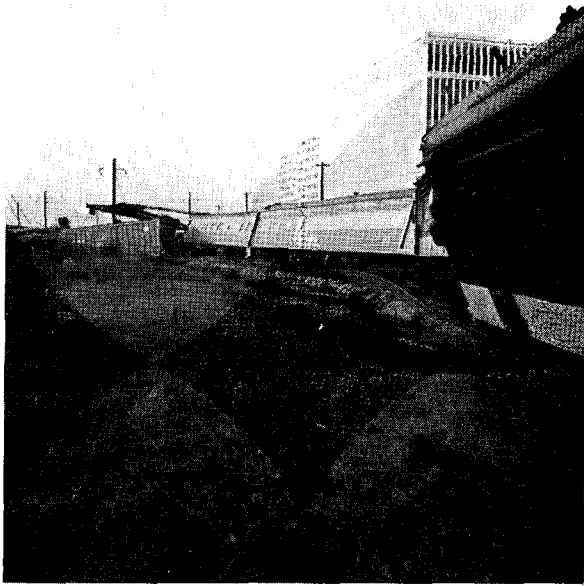
As the passenger train's locomotive rounded the curve, the engineer and fireman saw the derailed boxcar on the track about 10 car-lengths away. The engineer immediately applied the brakes and positioned himself on the floor of the locomotive cab. He estimated that the time of the collision was 10:27 p.m. The locomotive units derailed and stopped in a jack-knifed position, as shown in Figure 5. The coaches also derailed and stopped approximately in line, leaning slightly. (See Figure 6.)

Figure 6. Derailed Southern Railway coaches.

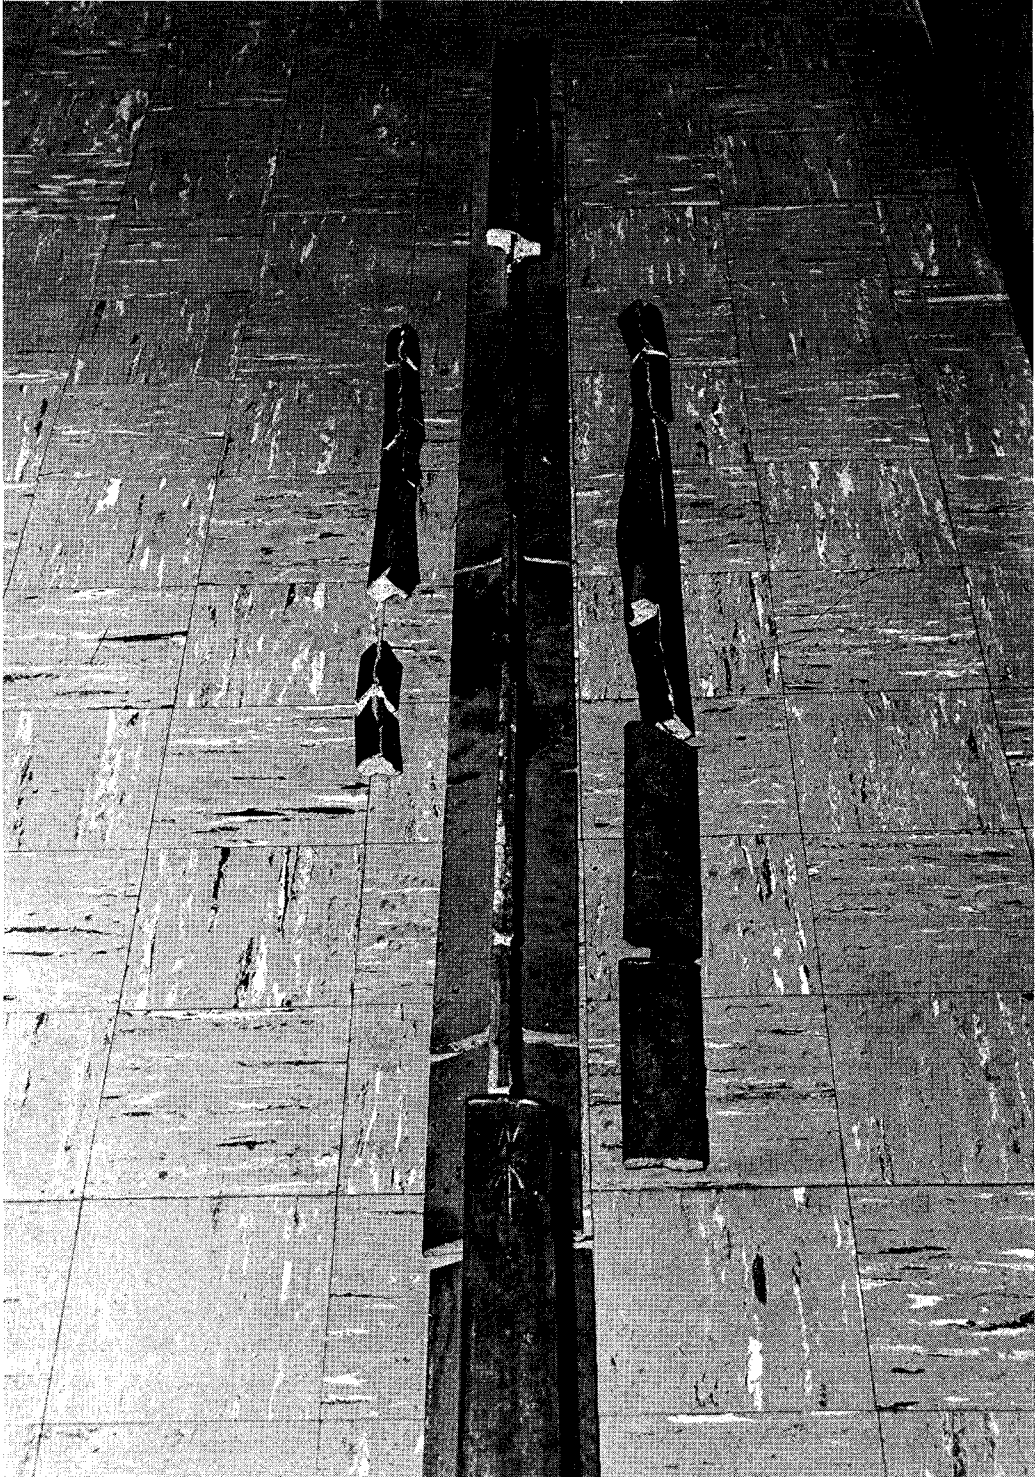
After the accident, a break was found in the east rail of the No. 1 southward receiving track 635 feet south of the north switch. Inspection revealed an internal, vertical 9-foot-2-inch-long split in the rail head. A 5-foot-3/8-inch section of the rail had broken out. (See Figure 7.) The battered ends of the pieces of this broken rail section indicated that the pieces had broken out progressively. About 75% of one of the cross-sectional breaks showed evidence of a pre-existing break. The web exposed by the break had been traversed by wheels.

Figure 7. Section of broken rail from No. 1 southward receiving track.

There are few published criteria to assist railroad managers in determining the safety of second-hand rail for yard tracks. The age of the rail, its weight, length, or wear characteristics do not disqualify its reuse. In this case, only the defect in the rail head made it unsafe for use in the No. 1 southward receiving track.

The National Transportation Safety Board determines that the probable cause of the derailment of the freight cars was a defective rail, which broke while the train was passing over it. The probable cause of the collision between the passenger train on the adjacent main track and the derailed B-4 freight car was that the crewmembers of B-4 did not flag the passenger train as they were required to do by the operating rules

1. The Federal Railroad Administration modify Federal Track Safety Standards to insure that yard tracks adjacent to main tracks are maintained and inspected in such a way as to eliminate the probability of track-related derailments (Recommendation No. R-73-5). In this connection the Safety Board reiterates and emphasizes one of the Board's recommendations in its report on the derailment of a Penn Central freight train and the collision of one of its derailed cars containing hazardous material with a passenger train at Sound View, Conn., on October 8, 1970. The recommendation urged that the:
