RAILROAD ACCIDENT INVESTIGATION

REPORT NO. 4167

PENN CENTRAL COMPANY

SEPTEMBER 23, 1968

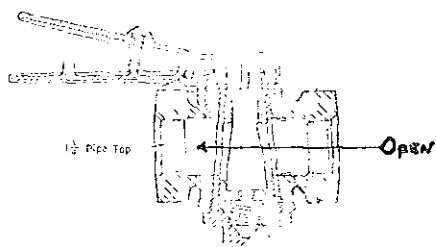
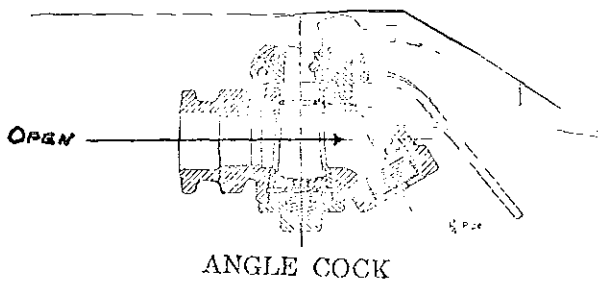
BRAKE PIPE END COCK

These cocks are manually-operated valves used to open or close the flow of air between the brake pipe and air hose at the ends of cars or locomotives All such cocks involved in the accident will hereinafter be referred to as angle cocks

3. The angle cock at the front of the fourth diesel-electric unit, B&M 1735, was of the non-locking type. It was broken off from the brake pipe at the threads, and was found with the handle at a 45-degree angle or in partially open position. No determination could be made as to whether the handle was in the 45-degree position, or in fully open or closed position, before the accident. If it was in fully closed position, the engineer would have had no control over the automatic brakes to the rear of the third locomotive unit. If it was in partially open position as described above, and all other angle cocks between the locomotive units and cars were in open position, the engineer (a) probably could have made a service application of the automatic brakes on all the locomotive units and the cars, and (b) probably could not have applied the automatic brakes of the last two locomotive units and the cars in emergency, due to the rate of air flow through the brake pipe being restricted by the partially open angle cock.
