RAILROAD ACCIDENT INVESTIGATION

REPORT NO. 4144

PENN CENTRAL COMPANY

FEBRUARY 17, 1968

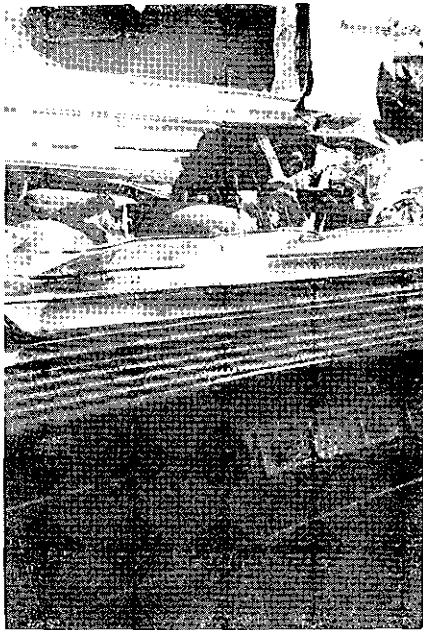
The truck driver was injured. One train passenger was killed and eleven other passengers were injured, as a result of the right rear corner of the truck penetrating the side sheeting of the coach.

The truck struck the train locomotive on the left side about 15 feet from the front end. The impact spun the truck around, causing the right rear corner of its flat bed to glance off the corrugated stainless-steel sheeting on the left side of the coach, about three feet from the front end. This corner of the truck struck the side sheeting again, at a point about 10 feet from the front of the coach. About four feet farther to the rear, the same corner of the truck penetrated the side sheeting of the coach, and tore a jagged hole lengthwise along the sheeting. The hole was about 24 feet long and extended rearward to approximately the middle of the car. The truck corner penetrated the side sheeting at a level slightly higher than the coach floor and struck about four seats alongside the side windows, dislodging those window seats and adjoining aisle seats. It also struck a side post between two window seats, shearing the post in two immediately below the window sill and wainscot support plate, and causing the broken side post to swing inward with portions of the window sill and wainscot support plate attached to the bottom. The broken side post stopped at a 45-degree angle with the broken off end over one of the dislodged window seats. All the doublepane windows on the left side of the front half of the coach were shattered or broken out completely. Except for the seat and window area adjacent to the hole torn in the side sheeting, the inside of the coach was not damaged significantly.

Portion of hole torn in side sheeting of train coach.

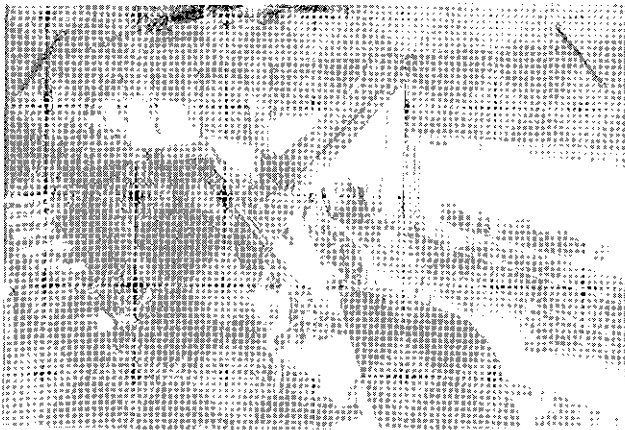
Interior view of damage to coach. Ground adjacent to coach visible through hole in side sheeting below window at right center.

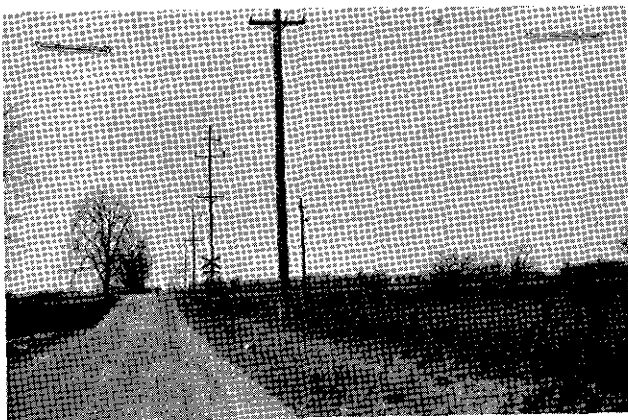
The rapidly approaching train was well within the truck driver's range of vision as his vehicle neared the crossing. As the motortruck passed three points within 100 feet of the track, trees and brush somewhat restricted the driver's view of the track northward. However, due to the proximity of the train to the crossing when the motortruck passed those points, the train remained within the driver's range of vision. Consequently, there does not appear to be anything which would have prevented the driver from seeing the train in sufficient time to realize that he could not safely traverse the crossing without stopping and waiting for the train to pass.

Truck driver's view of crossing from distance of 300 feet. Train approached crossing from the right.

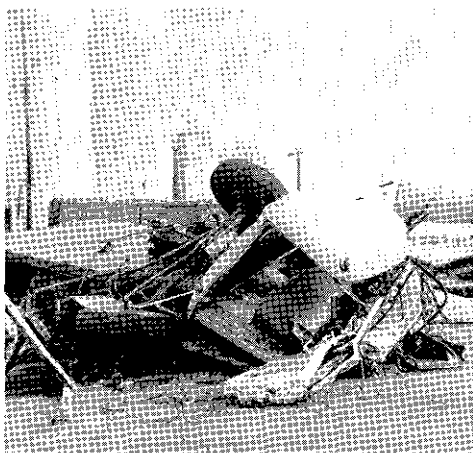
The motortruck overturned and stopped about 35 feet south of the accident point and 15 feet east of the main track. It was destroyed.

Examination of the motortruck revealed no defective condition of its brake system.

Motortruck (after removal from railroad right-of-way).
