NATIONAL TRANSPORTATION SAFETY BOARD

# RAILROAD ACCIDENT REPORT

PENN CENTRAL COMPANY  
COLLISION OF TRAINS  
N-48 AND N-49 AT  
DARIEN, CONNECTICUT  
AUGUST 20, 1969

REPORT NUMBER: NTSB-RAR-70-3

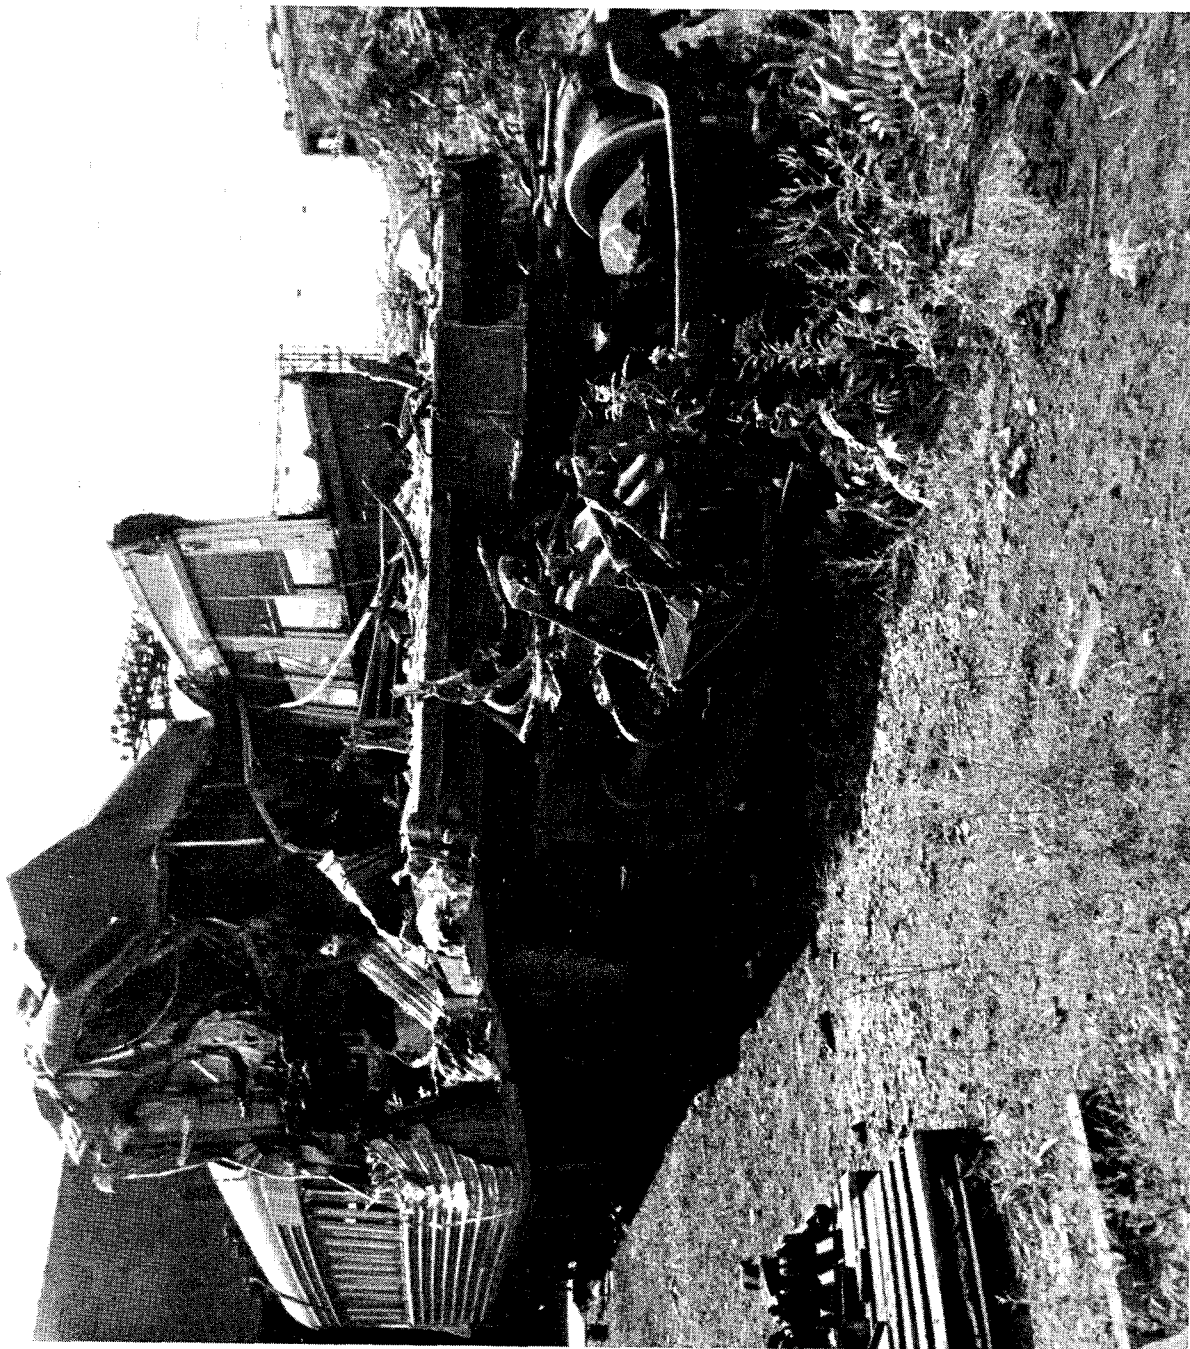
Figure No. 2

Because the leading car of N-49 passed through the superstructure of the leading car of train N-48, almost one-half of the first car of train N-48 was destroyed. The underframe of the first car of N-48 was broken off at the body bolster or at a point about 13 feet from the end of the car. The engineer's compartment, on the front platform on the end of the car was completely destroyed and this entire section of the car was forced approximately 20 feet to the rear. (See Figure 2, page 14.) The underframe of the second car of N-48 buckled and was moderately damaged. The third car was slightly damaged.

Damage to leading car of N-48

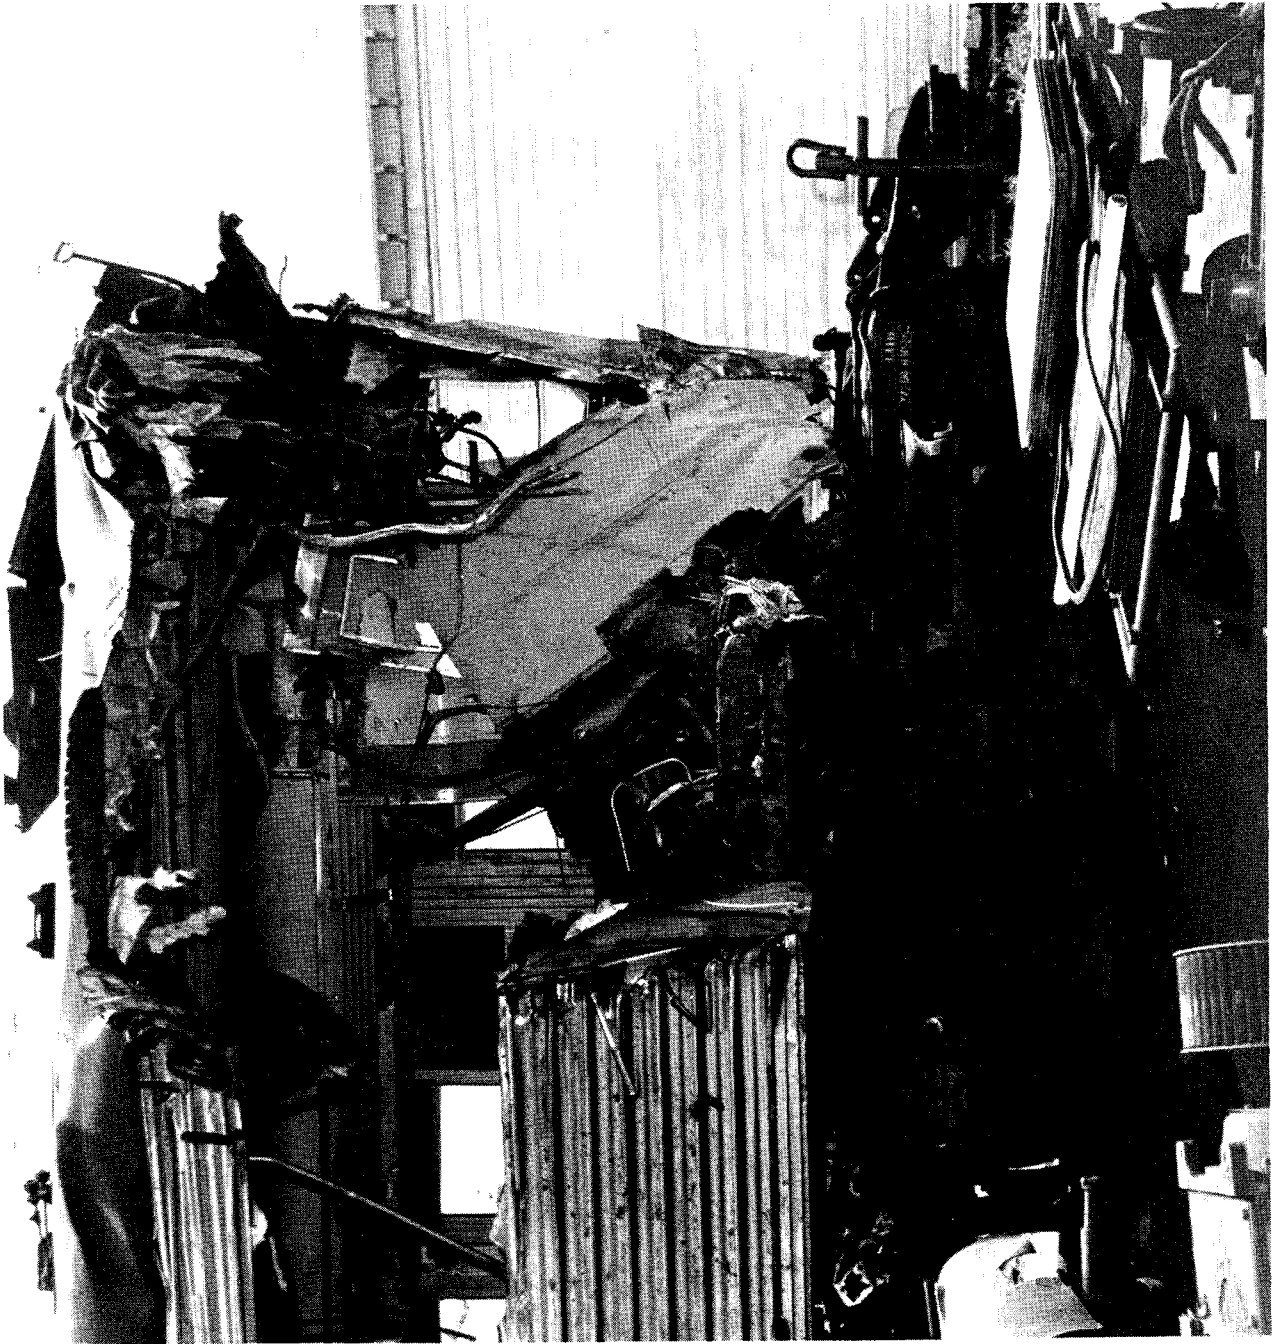
Figure No. 3

Damage to leading car of N-49

The impact caused the body of the leading car of N-49 to break away from the forward truck and to rise upwards. The car body mounted the underframe of the leading car of N-48 and passed partly through the superstructure. The force of the collision caused the leading car of each train to move laterally, the first car of N-49 to the south, and the first car of N-48 to the north. When the cars came to rest, they were side-by-side with the front end of the leading car of N-49 about 30 feet east of the front of the leading car of N-48. The momentum exchange of the impact moved the lighter, three-car train (N-48) backwards from the point of impact about 21 feet, while the heavier train came to a stop after a movement of 21 feet plus the distance of the collapsed superstructure of the first car of N-48, a total distance of about 40 feet. Much of the force of the impact was absorbed by the collapsing structure of the two leading cars, and the full force of the impact was not transmitted to the other cars in the train. This reduced the extent and severity of injuries to the passengers riding in the second and third cars of N-48.

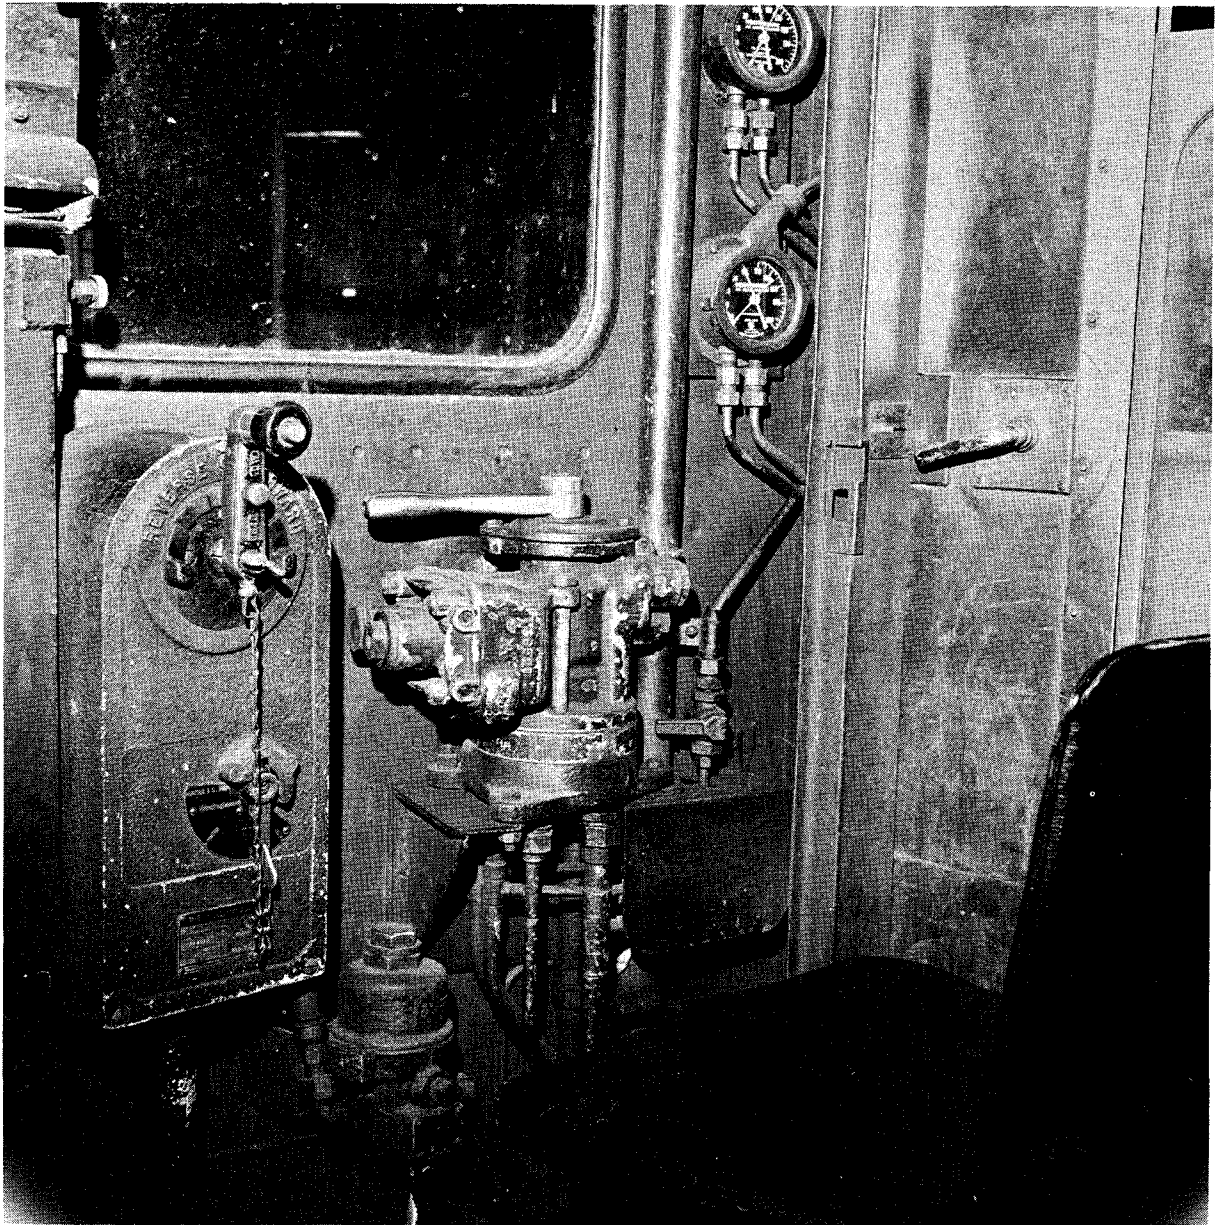
Figure No. 4

Interior view of engineer's operating compartment

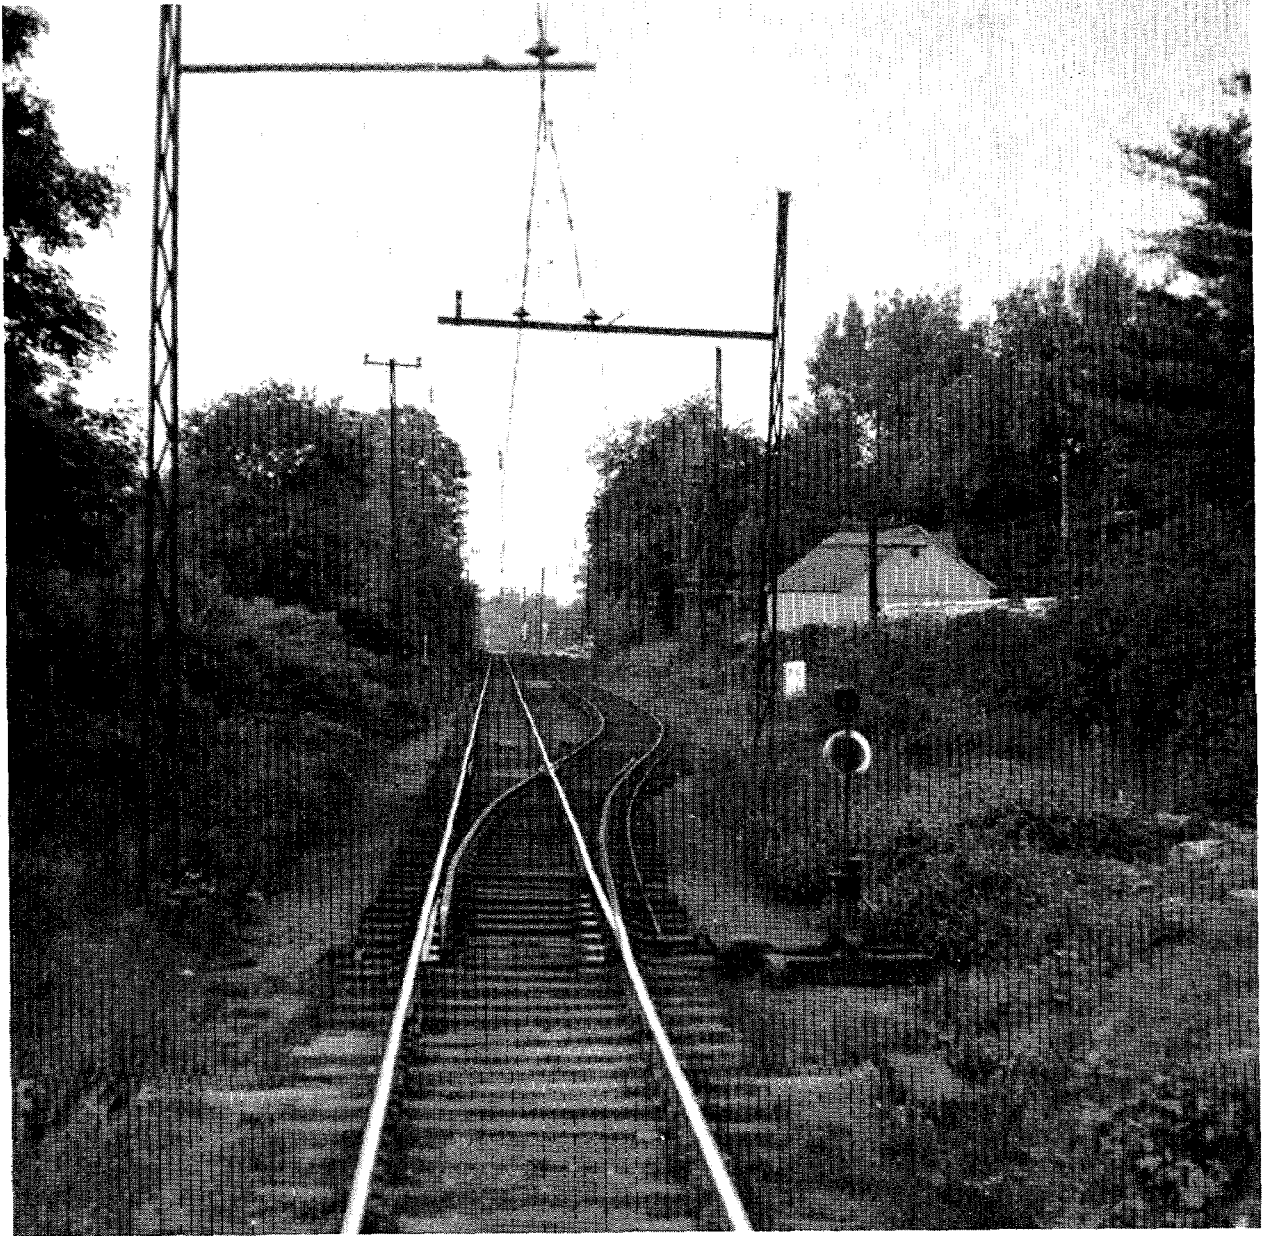
Figure No. 4-2

West switch of Dale siding  
Lined for the Main track

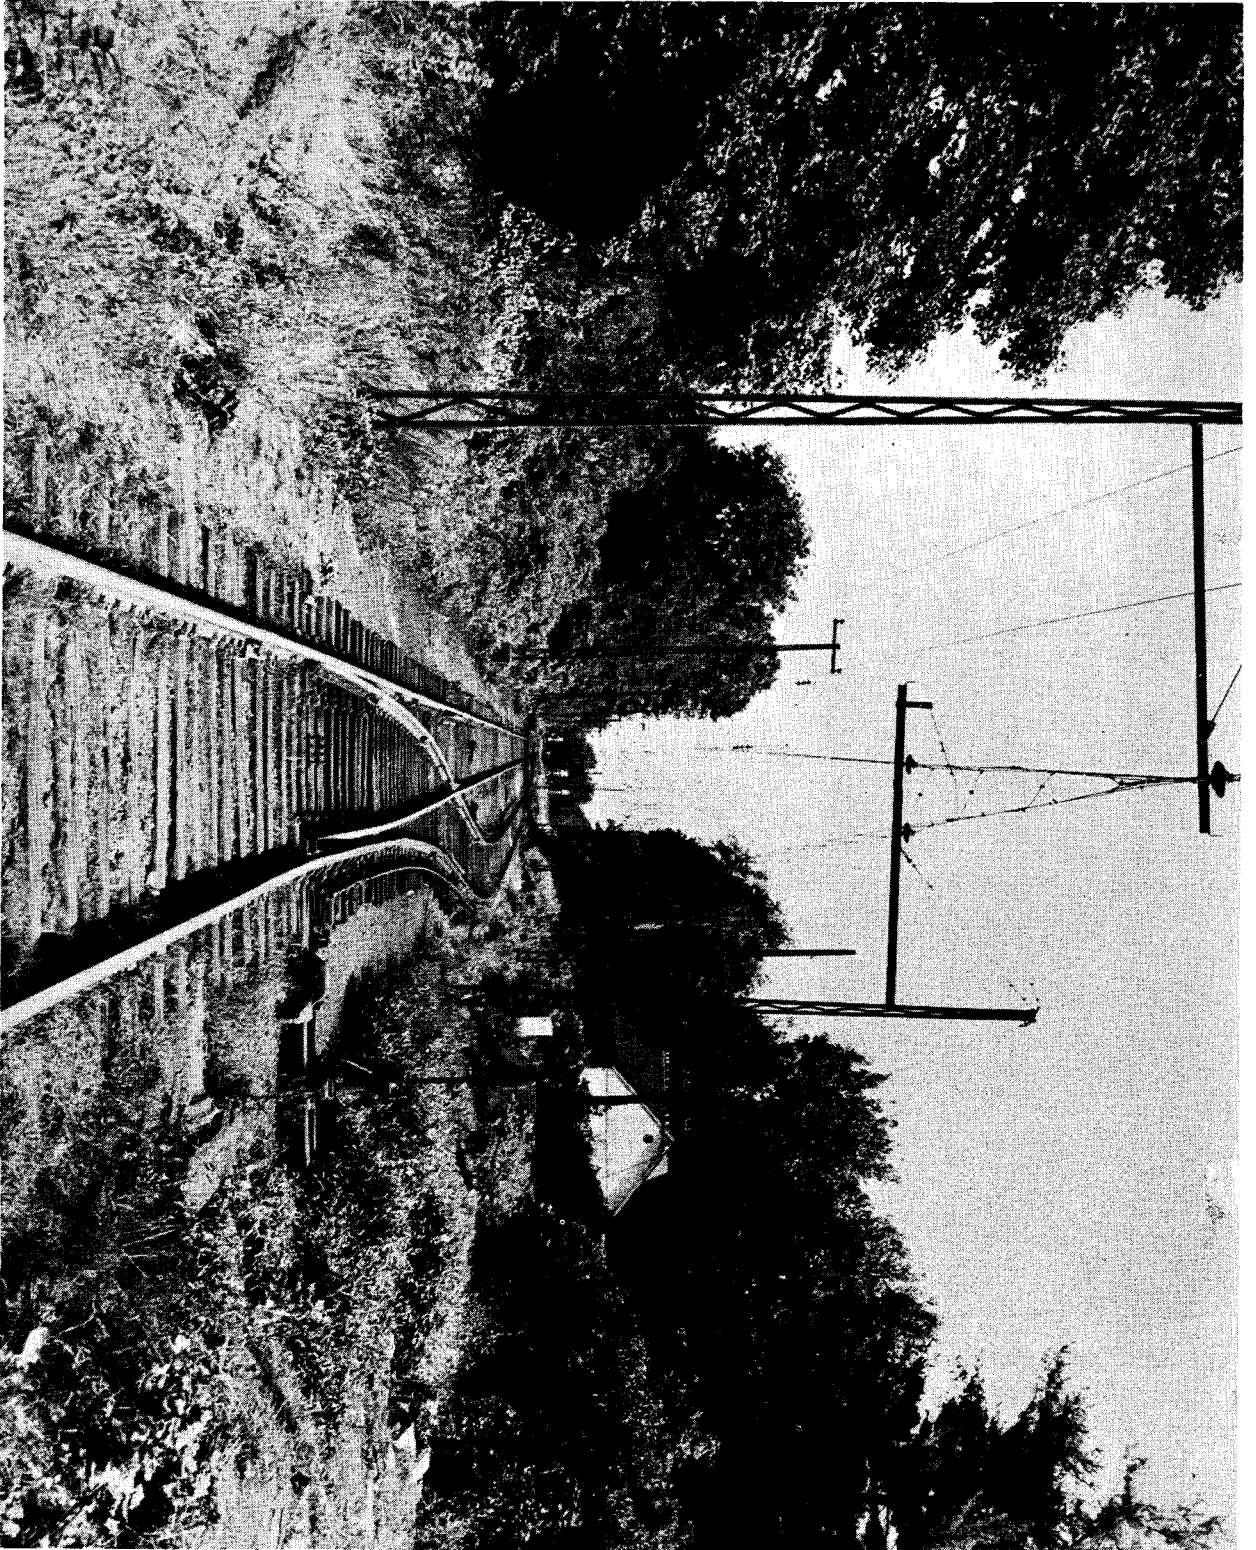
Figure No. 4-3, West switch of Dale siding lined for the siding

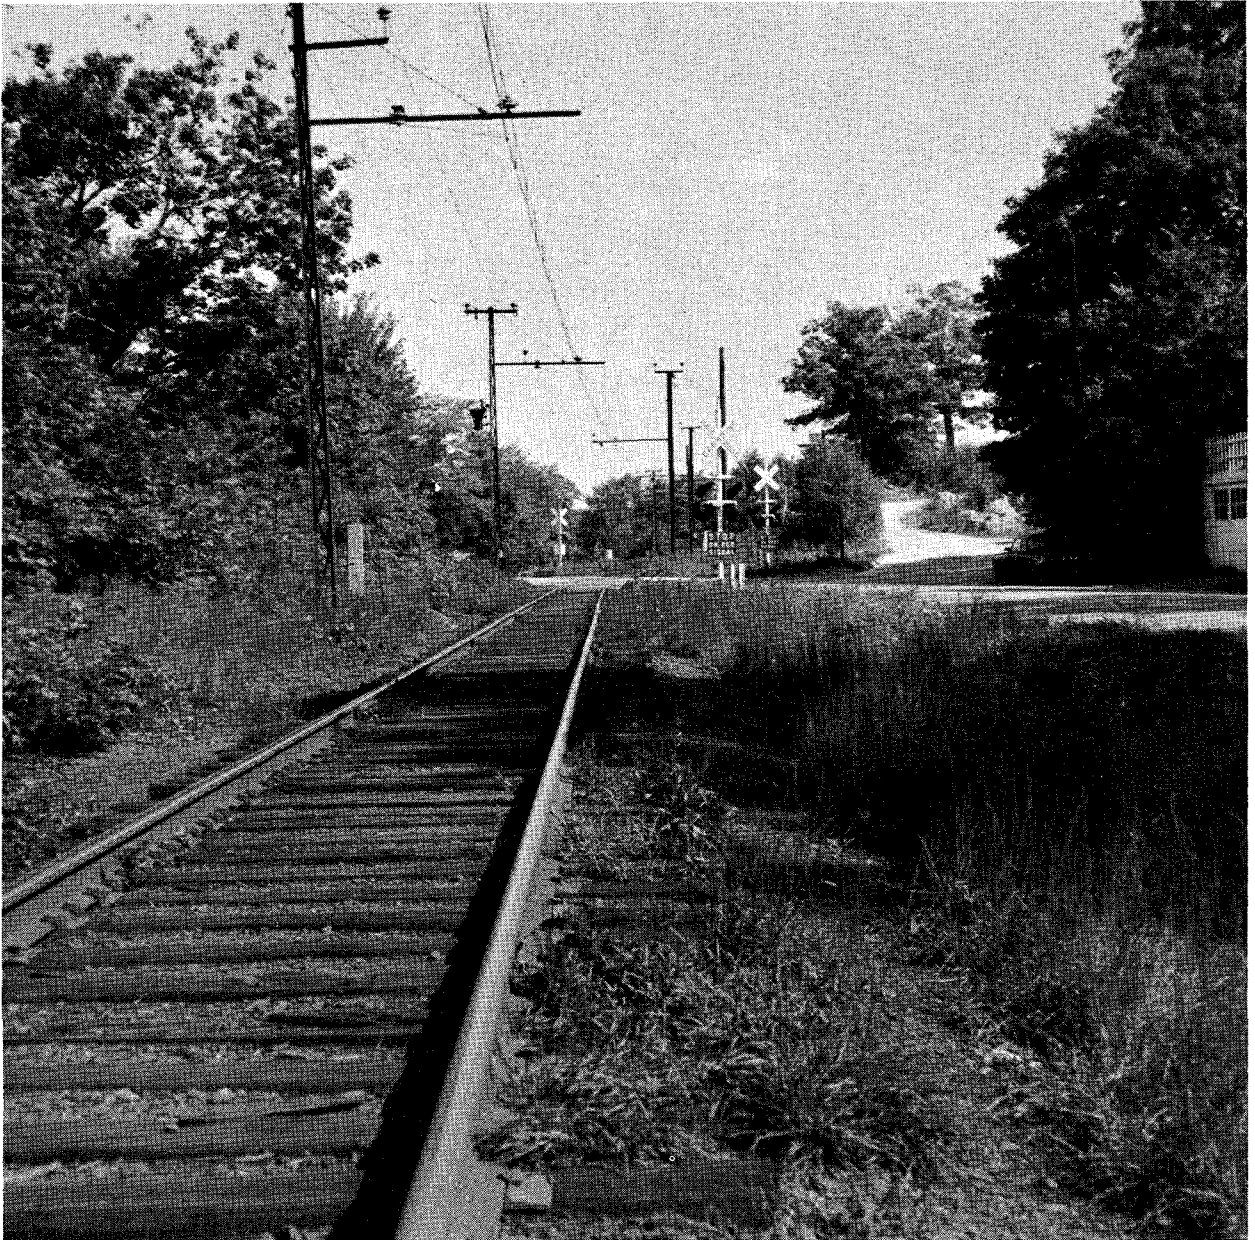
Figure No. 4-6

Hoyt Street Crossing as seen by the engineer of an eastbound train after passing Dale siding.
