RAILROAD ACCIDENT INVESTIGATION

REPORT NO. 4159

PENN CENTRAL COMPANY

GERMANTOWN, IND.

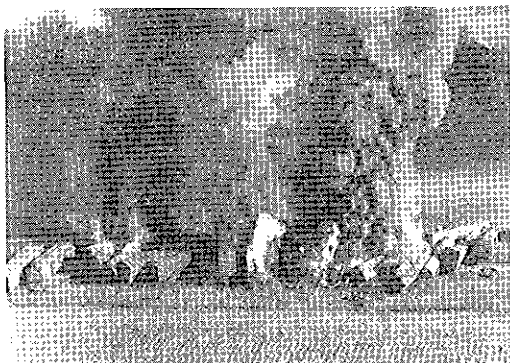
PLATE No. 3

The derailed cars stopped in two groups on or near the track structures, as indicated in Plate No. 2. The easterly group included the 36th car, a tank car loaded with butadiene, inhibited, a liquefied flammable compressed gas, and the 37th and 38th cars, box cars containing tanks loaded with liquefied ethylene, a flammable colorless gas. Due to punctures and loosened fittings, the contents of these three cars escaped and caught on fire, resulting in fire spreading to several other cars in the easterly group of derailed equipment (see Plate No. 3).

Easterly group of derailed cars.

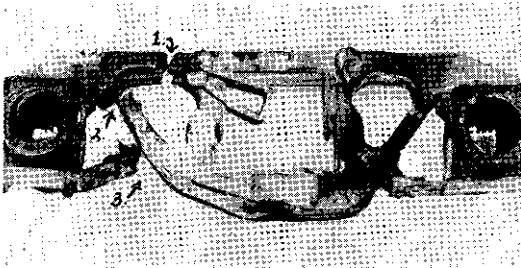
PLATE NO. 4

The side frame on the south side of the rear truck was found broken through at tension and compression members of the casting (see figures 1 and 2 of Plate No. 4).

Broken truck side frame of 13th car.  
 Fig. 1 - Broken compression member.  
 Fig. 2 - Broken tension member.  
 Fig. 3 - Broken journal box tie bar  
 bracket.

The frame met chemical composition requirements of AAR Specification M-201 for Grade B steel castings. It was found with a compression member and a tension member broken through at points about 16 and 28 inches from the frame center, respectively, and with a bracket for a journal box tie bar broken through at the point where it was attached to the tension member. See Plate No. 4 for fracture areas.
