RAILROAD ACCIDENT REPORT

**PENN CENTRAL COMPANY
TRAIN SECOND 115 (SILVER STAR)
DERAILMENT AT
GLENN DALE, MARYLAND
JUNE 28, 1969
ADOPTED: JUNE 10, 1970**

Report Number: NTSB-RAR-70-1,

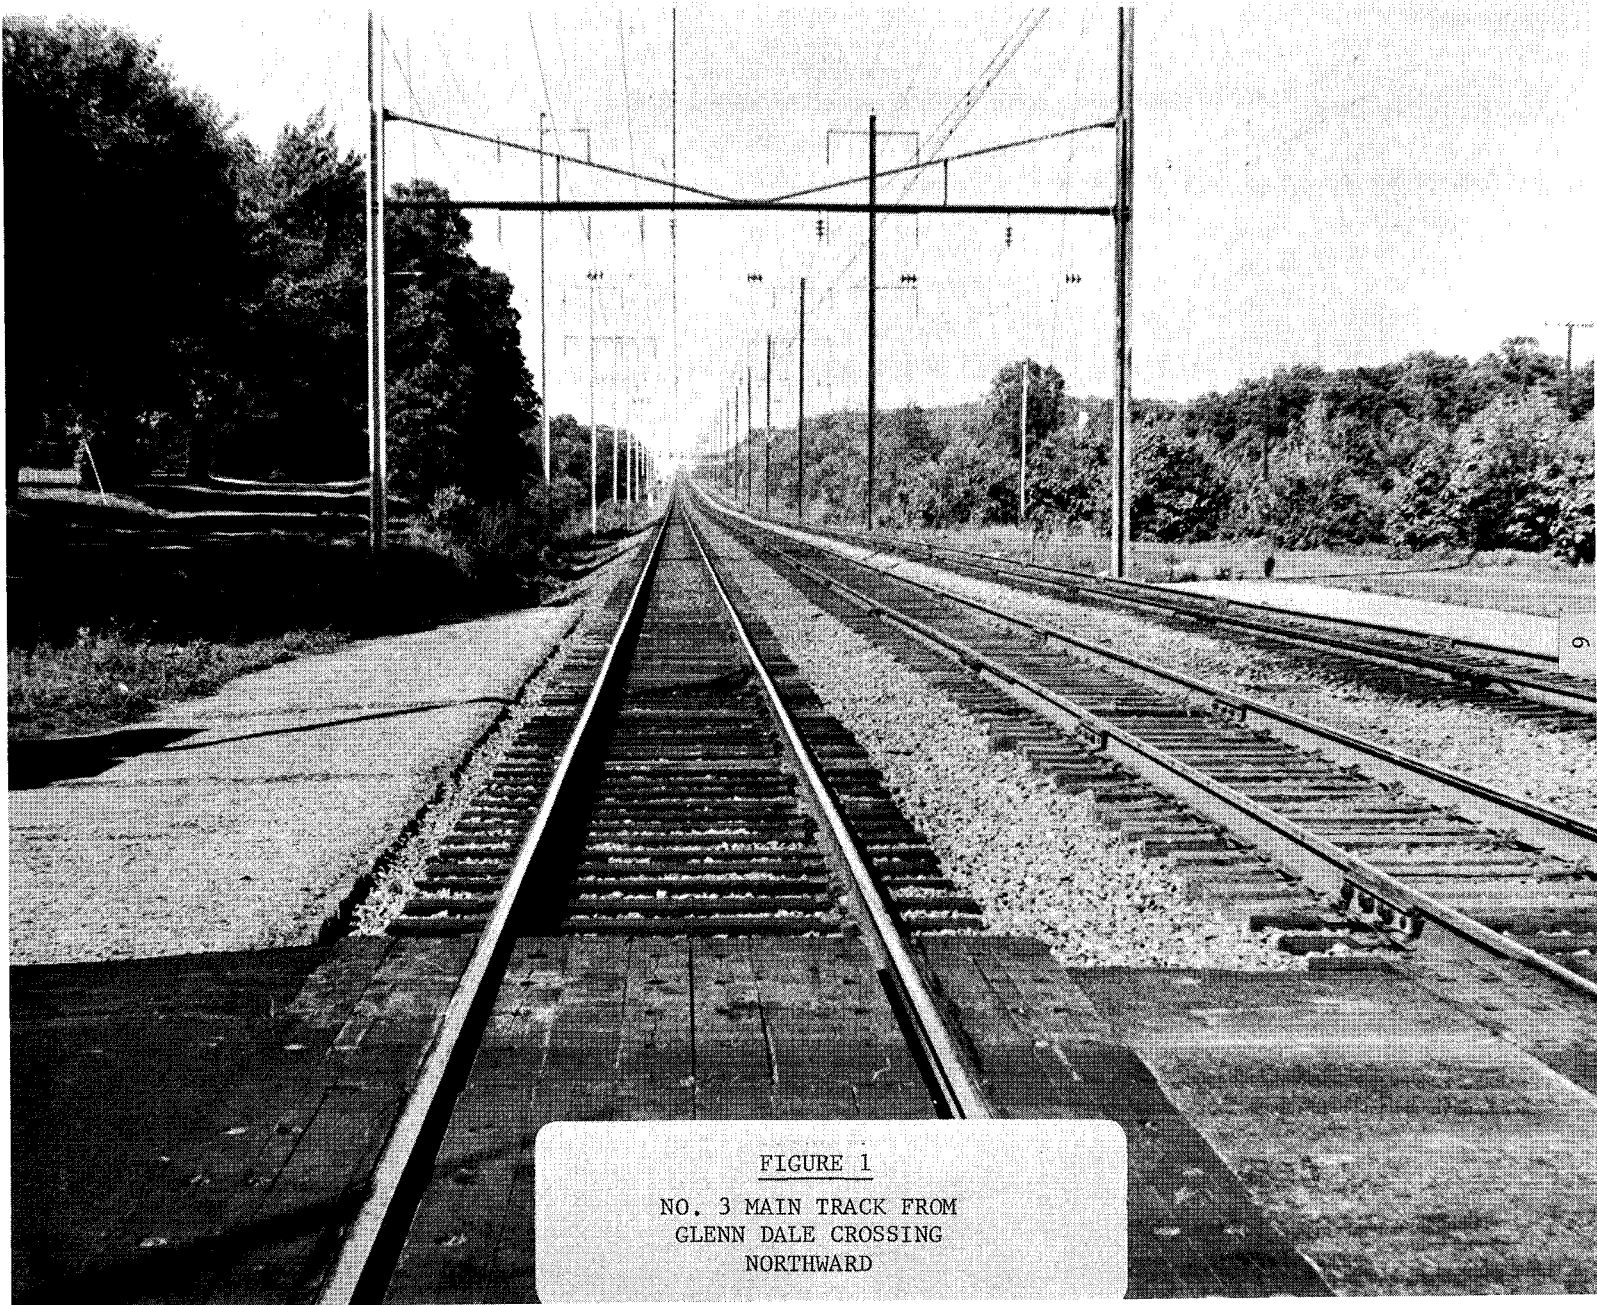
FIGURE 1
NO. 3 MAIN TRACK FROM
GLENN DALE CROSSING
NORTHWARD

On April 16, 1969, the track north of the crossing was retamped because of settlement. The tamping was done by hand with tamping picks, but no new ballast was added. Photographs (see figure 1, page 6) and observation indicated insufficient ballast in the buckled area to meet the requirements of the Penn Central's recommended standards.

The photograph on page 6 was taken by a Penn Central Claim Agent on May 26, 1969, in connection with another matter. It accurately depicts the crossing and the track north of the crossing as it was on June 28 before the accident. A slight misalignment can be seen in the east rail about 40 feet north of the crossing.

The level of the ballast where the track buckled varied from flush with tops to 3 inches below the tops of the crossties. Figure 1 on page 6 clearly shows that the ballast in the intertrack space does not meet the recommended standard for ballast in either C.E. 78 or M.W.1. This photograph was taken on May 26, 1969, and no ballast was added between that date and June 28, 1969. The tops of rails of the Nos. 2 and 3 tracks north of the crossing were at the same level. It is apparent from the photograph that the ballast left much of the ends of the crossties of No. 2 track exposed, which is an indication that a similar condition existed for the east end of the ties on No. 3 track. The ballast was not flush with the ends and did not extend outward in the level configuration for any distance. This condition was also observed by Safety Board personnel on the day of the accident. There is no indication that the amount of ballast below the bottom of the crossties was deficient. However, there is some doubt about the density of the ballast below the crossties. At the time when the crossing was rebuilt, new crossties were installed north of the crossing; the track was raised about 1 1/2 inches and tamped with an on-track mechanical tamper. Shortly thereafter, on April 16, 1969, it was necessary to retamp the track north of the crossing because it had settled. This tamping was done by hand with tamping picks. In this operation, the track was not jacked up but the crossties were tamped raising them tight to the rail. No additional ballast was added so that the effect was that the ties rose in the ballast, reducing the amount of ballast coverage. That reduced the frictional forces on the sides of the crossties and the weight resistance at the ends of the crossties.

Observations of the ballast shortages were made by Safety Board personnel during the investigation, and were confirmed by other surveys of nearby track. This caused concern for the safety of the track used by the Metroliner during the period of high summer temperatures. (See Appendix 4.) On July 18, 1969, the Safety Board recommended that the Penn Central Company "inspect all of its track in the Washington-New York Corridor and in other areas where welded rail is installed to insure that a full ballast section as described in Penn Central Plan 70003 is present, and that a full ballast section be provided where deficiencies are found." Additional ballast was added to the welded rail track in the Glenn Dale area shortly after the accident and after the Safety Board's recommendation, bringing the ballast up to the manual-recommended level.

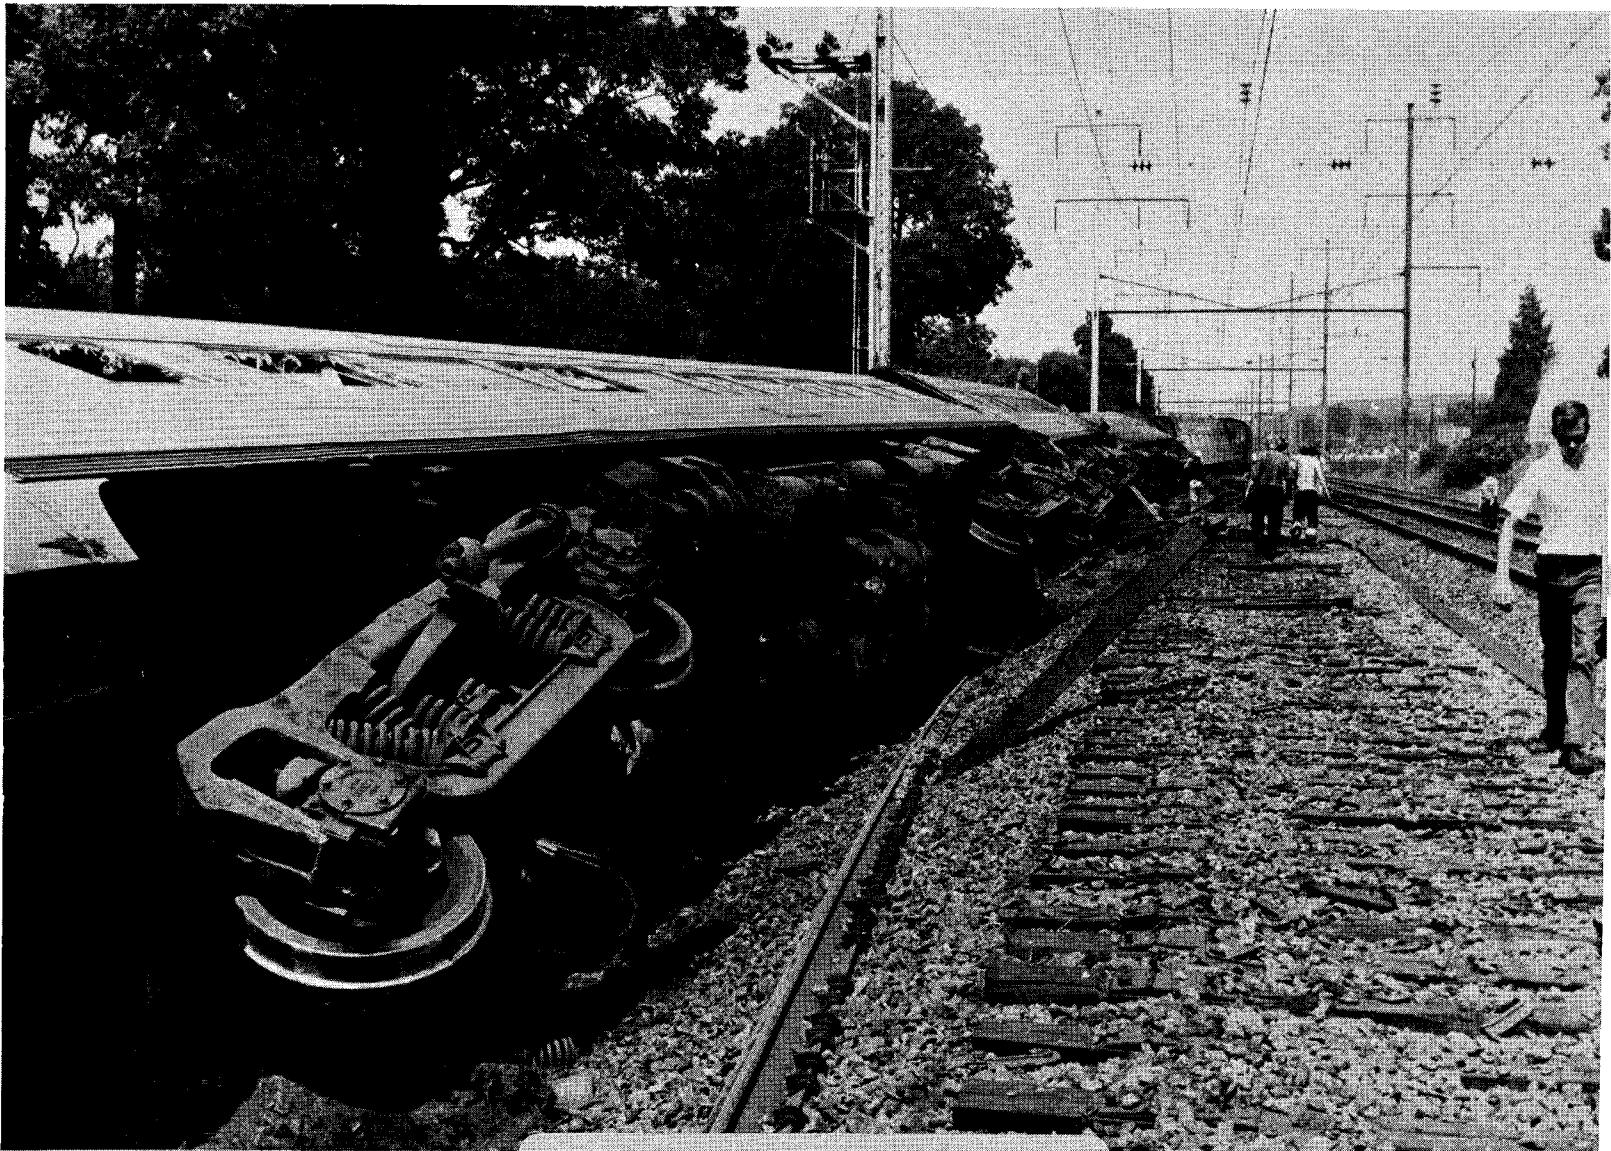
FIGURE 3

The six rear cars received no significant structural damage from the derailment. Appurtenances such as batteries, air reservoirs, and generators were heavily damaged and, in some cases, torn off. The right sides of the 13th, 14th, and 15th cars were damaged and a few window glasses were broken when these cars overturned.

OVERTURNED CARS WITH
13TH CAR IN FOREGROUND

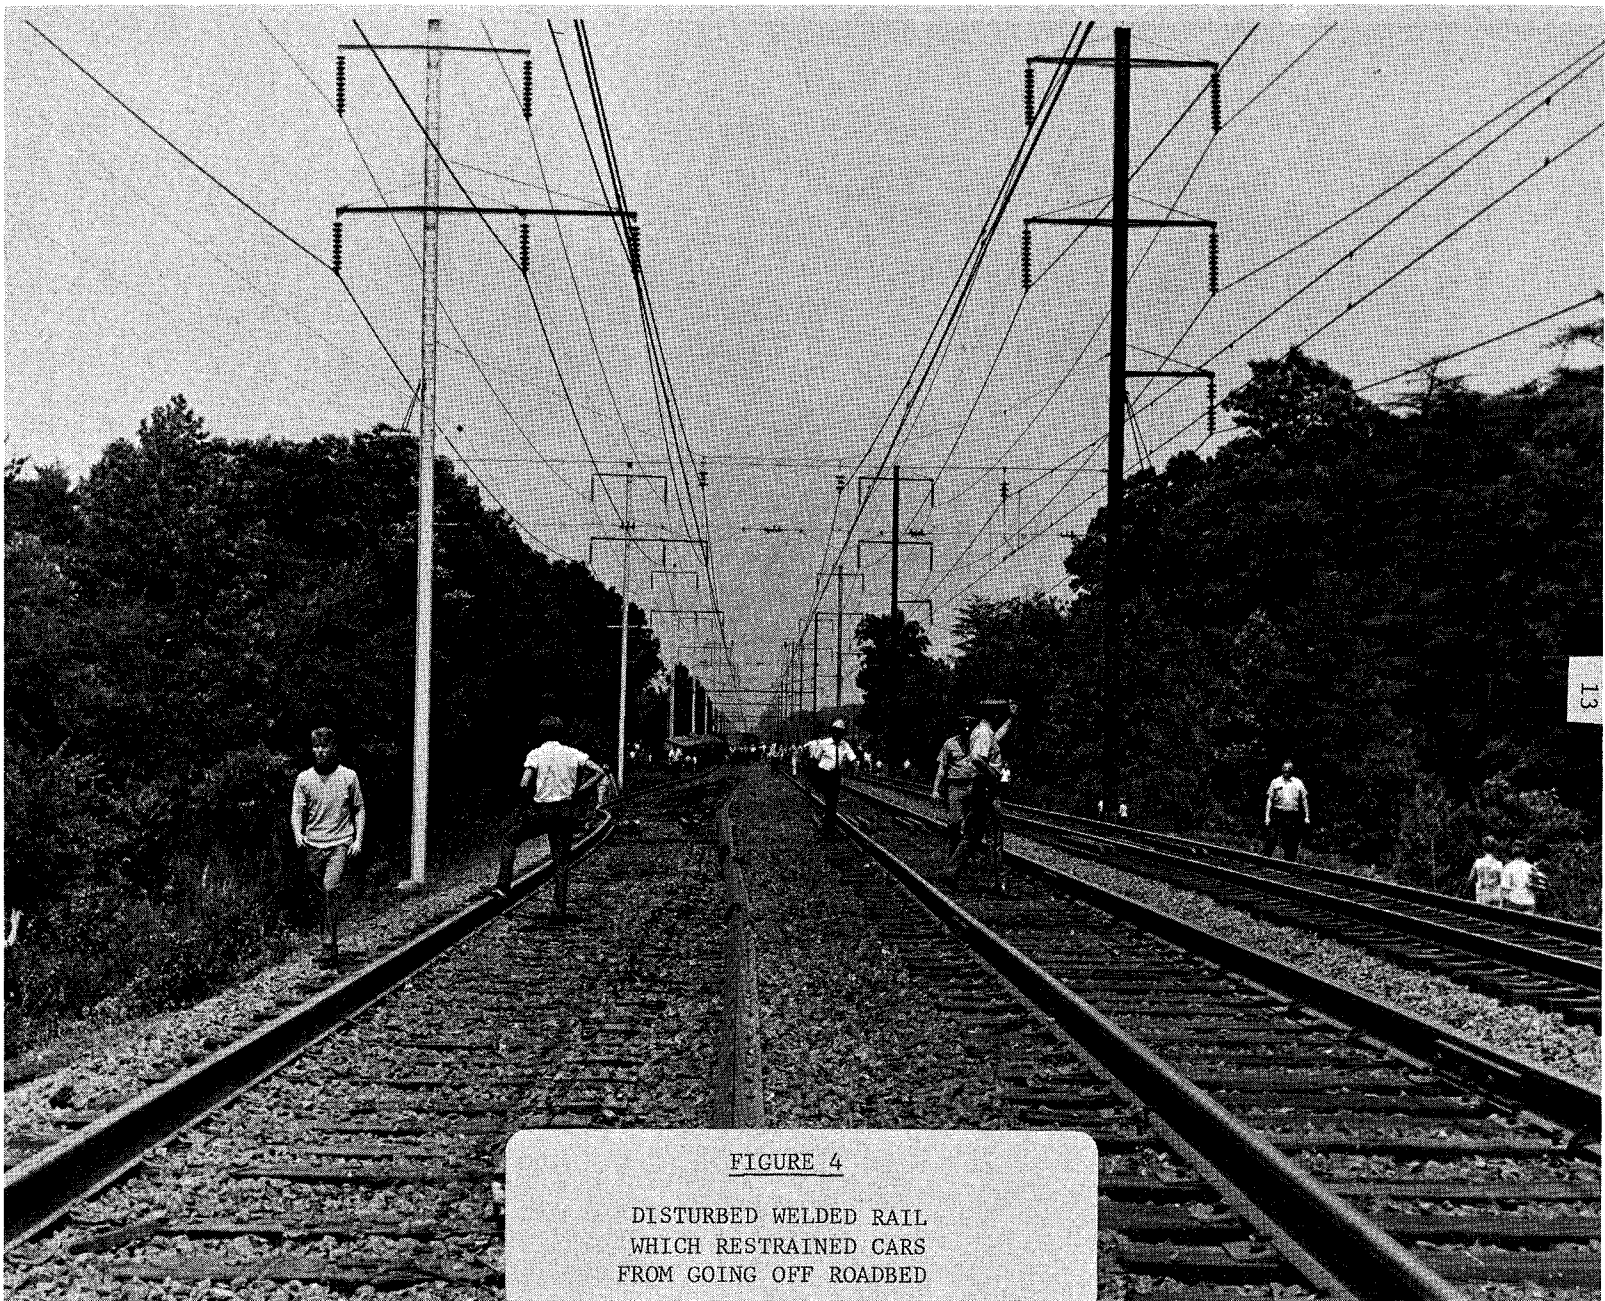
FIGURE 4

DISTURBED WELDED RAIL
WHICH RESTRAINED CARS
FROM GOING OFF ROADBED

It can be seen from Figure 4 on page 13 that the restraint of the welded rail on the west side also played a significant part in keeping the cars in line with the track structure at a second point. This illustration clearly implies that some derailed cars on the front part of the train had moved down off the track structure toward catenary supports during the slowing of the cars but were restrained and led back up to the structure and thereafter remained on the track structure. In the illustration the movement of the cars was toward the viewer.

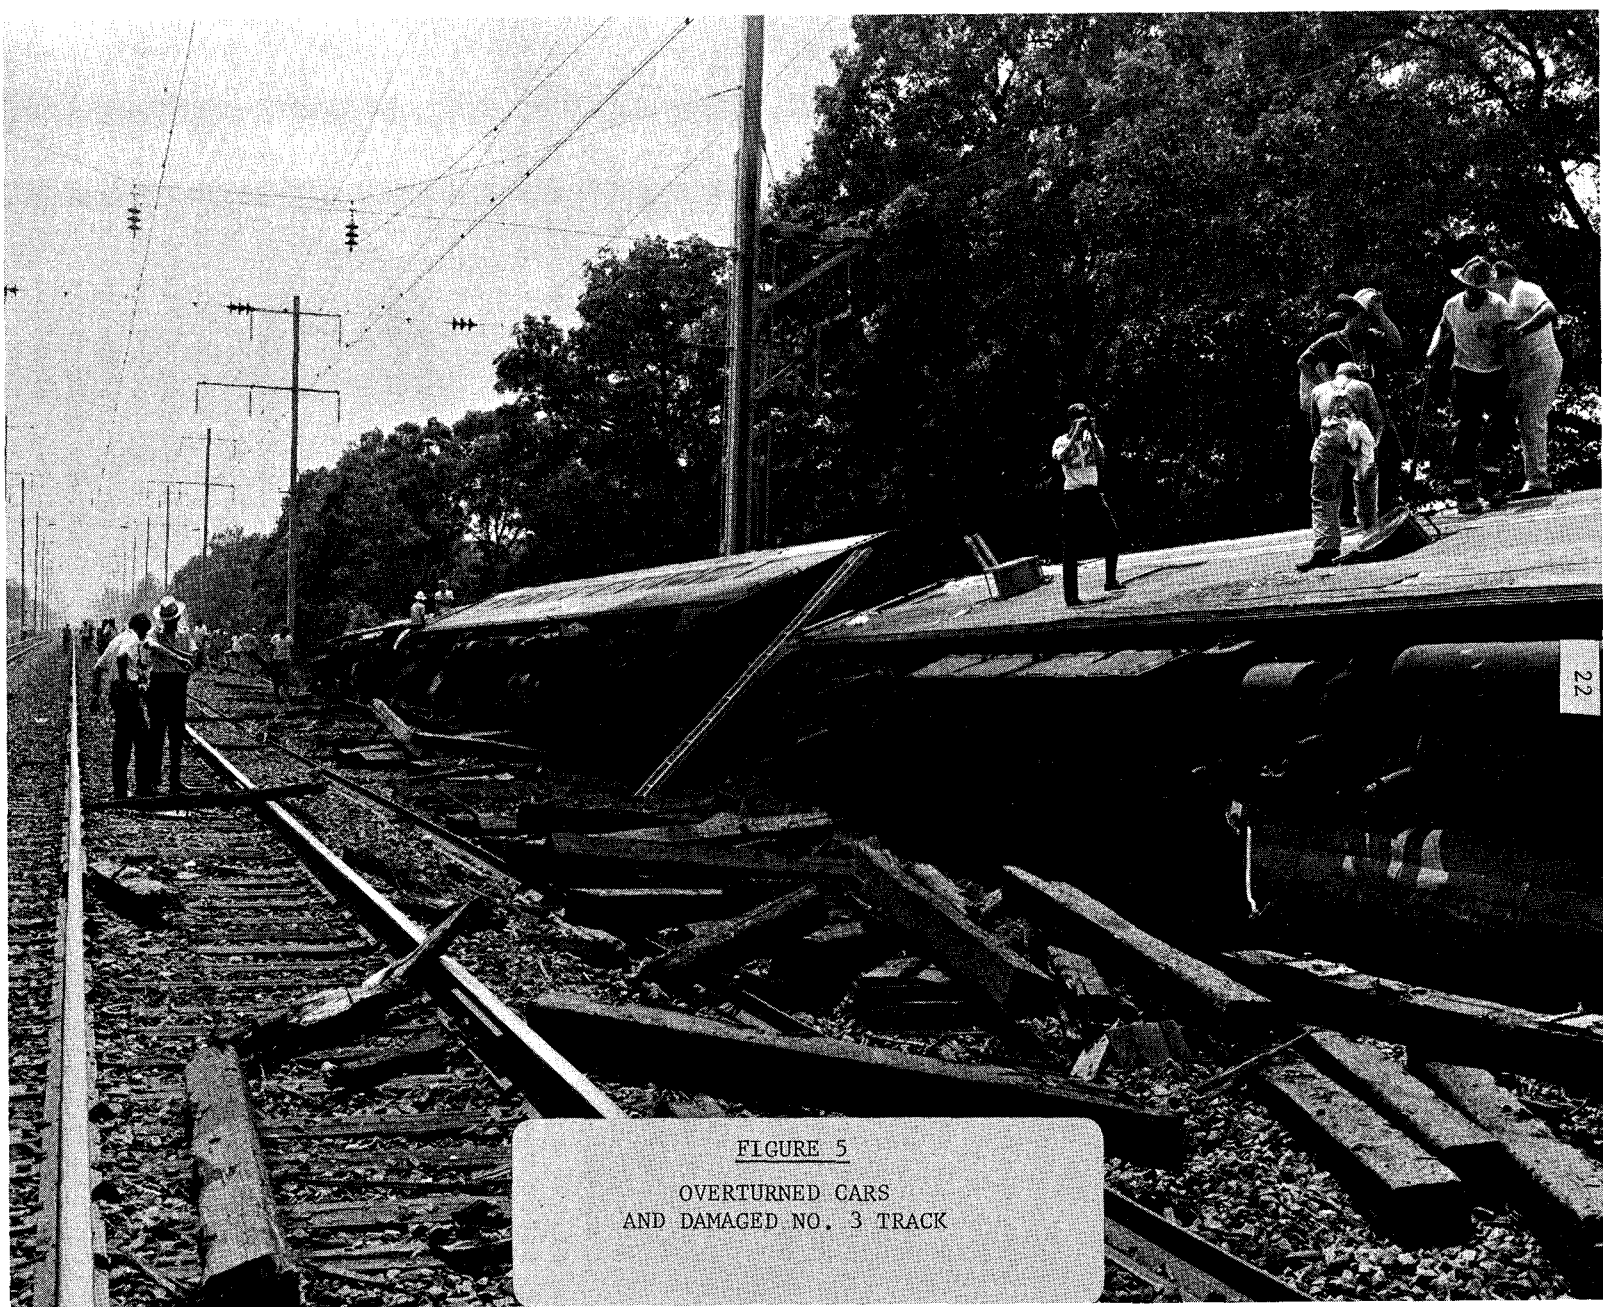
No. 3 track south of the crossing was badly damaged by the derailment. For a distance of about 1,565 feet, the rail was completely torn out, the crossties torn out or badly damaged, and the ballast seriously plowed up by the derailed wheels. Beyond this, for an additional 1,780 feet, the rail was damaged and overturned. There was less damage to crossties and ballast in this area.

FIGURE 5
OVERTURNED CARS
AND DAMAGED NO. 3 TRACK

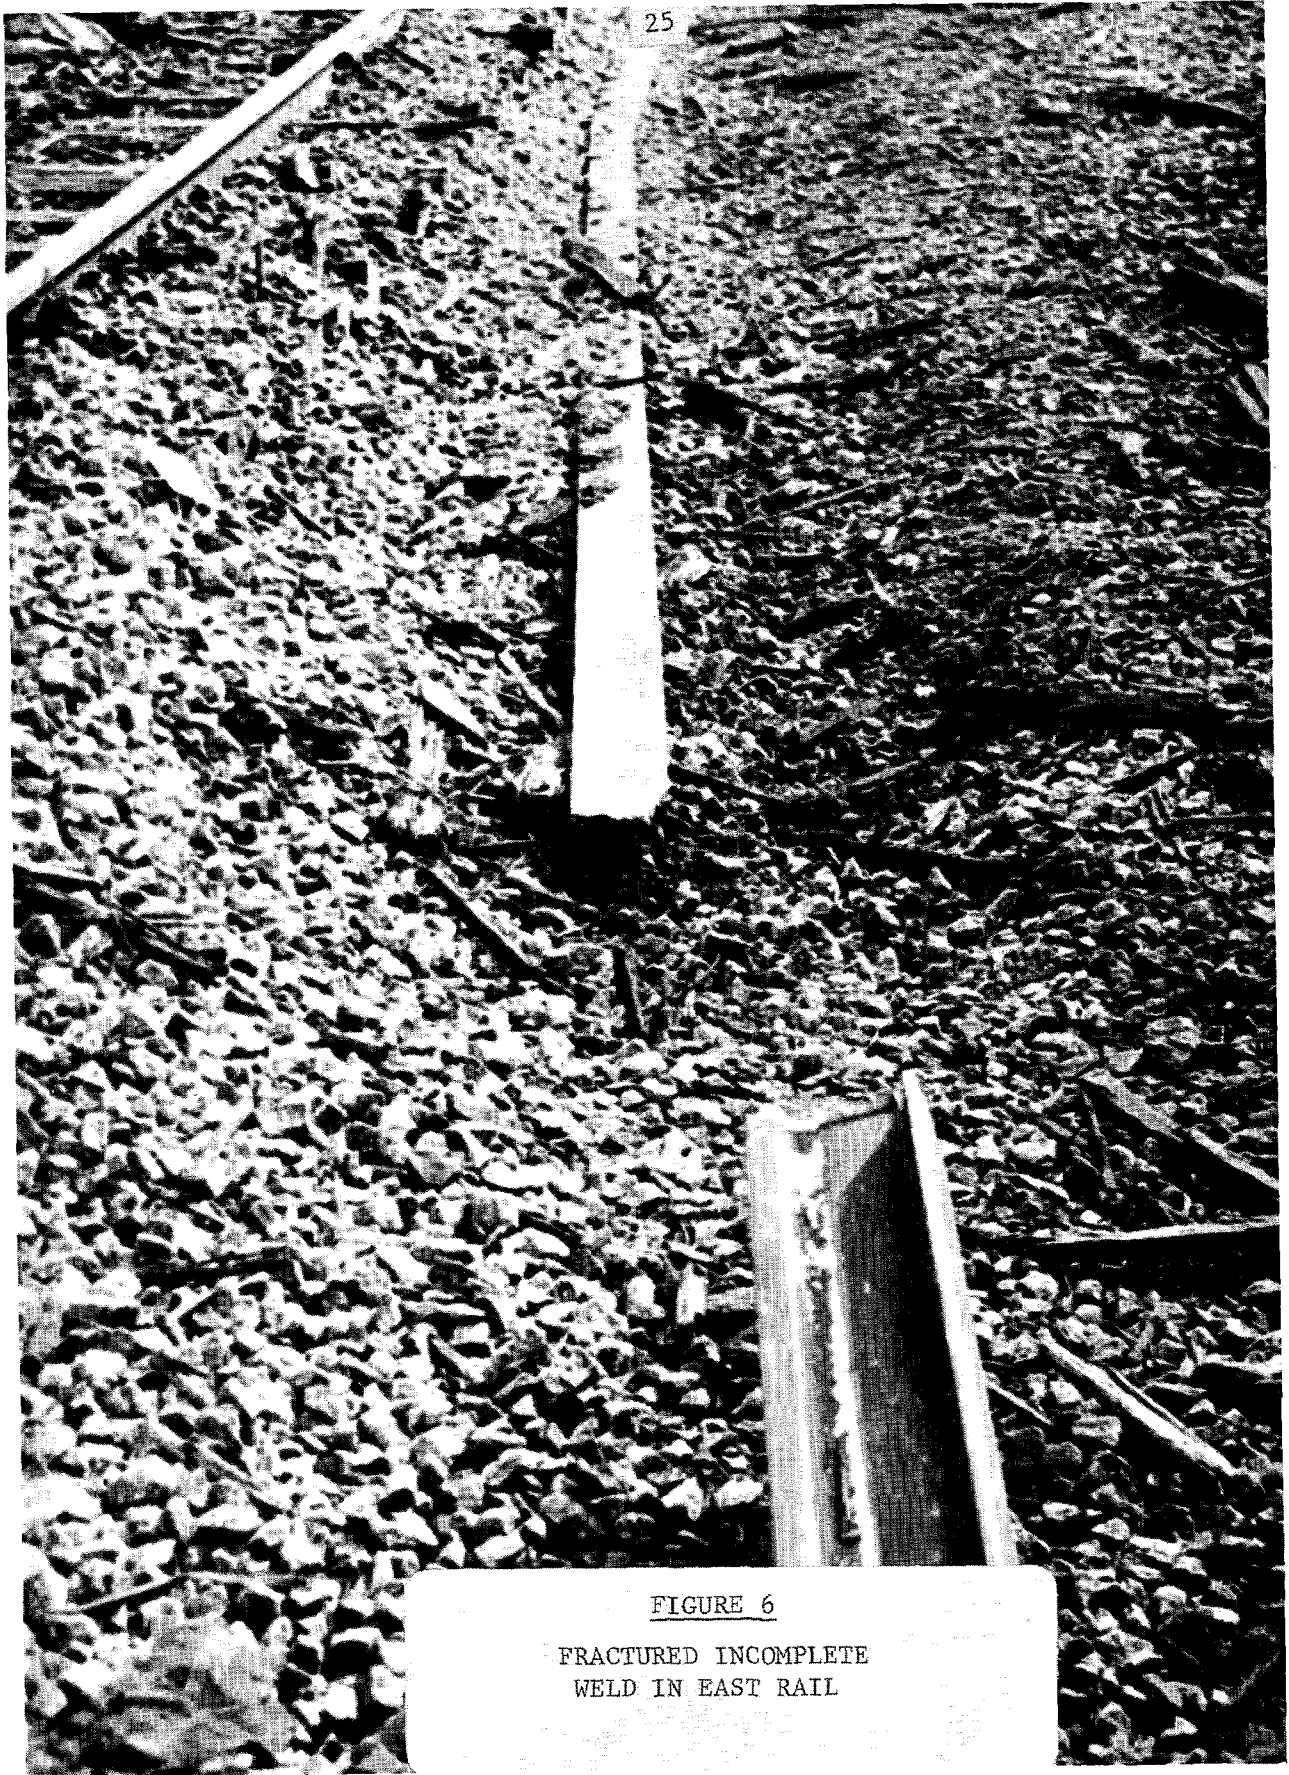
Examination of the broken rail indicated clearly that about two-thirds of the area of the head had not fused to any significant degree during the welding cycle. The lack of fusion was attributed to poor rail end preparation and non-uniform heat distribution around the rail head during that particular weld cycle.

The east rail overturned to the east, and a number of wheels ran on the web of the rail; however, any possible bowstring restraining effect from this rail was lost when the partially fused weld fractured, as can be seen in Figure 6. The fractured east rail remained in place and is somewhat to the east (left) in its original position. If this rail had exhibited significant restraining effect against the movement of the train off the track structure, it is believed that it would have been displaced to the west. Such displacement was shown by the rail which did not fracture.

FIGURE 6
FRACTURED INCOMPLETE
WELD IN EAST RAIL

A magnetic particle test of the incomplete weld was made at the time of welding but did not indicate the presence of a surface crack. A possible explanation for the lack of crack detection may be the presence of flame-washed material resulting from post-weld finishing operations which filled in or sealed the surface of the crack. An in-track test by the Sperry rail flaw detector recorded the same indication for the incomplete weld as for a complete weld. It would appear that the material reached a temperature necessary to produce fusion, since sufficient upset occurred to allow the weld to be partially completed, but part of the surfaces did not fuse. It appears that there is no way to detect such incompletely fused weld except by a tensile test before installation or by devising some new test which would reveal the brittleness factor.

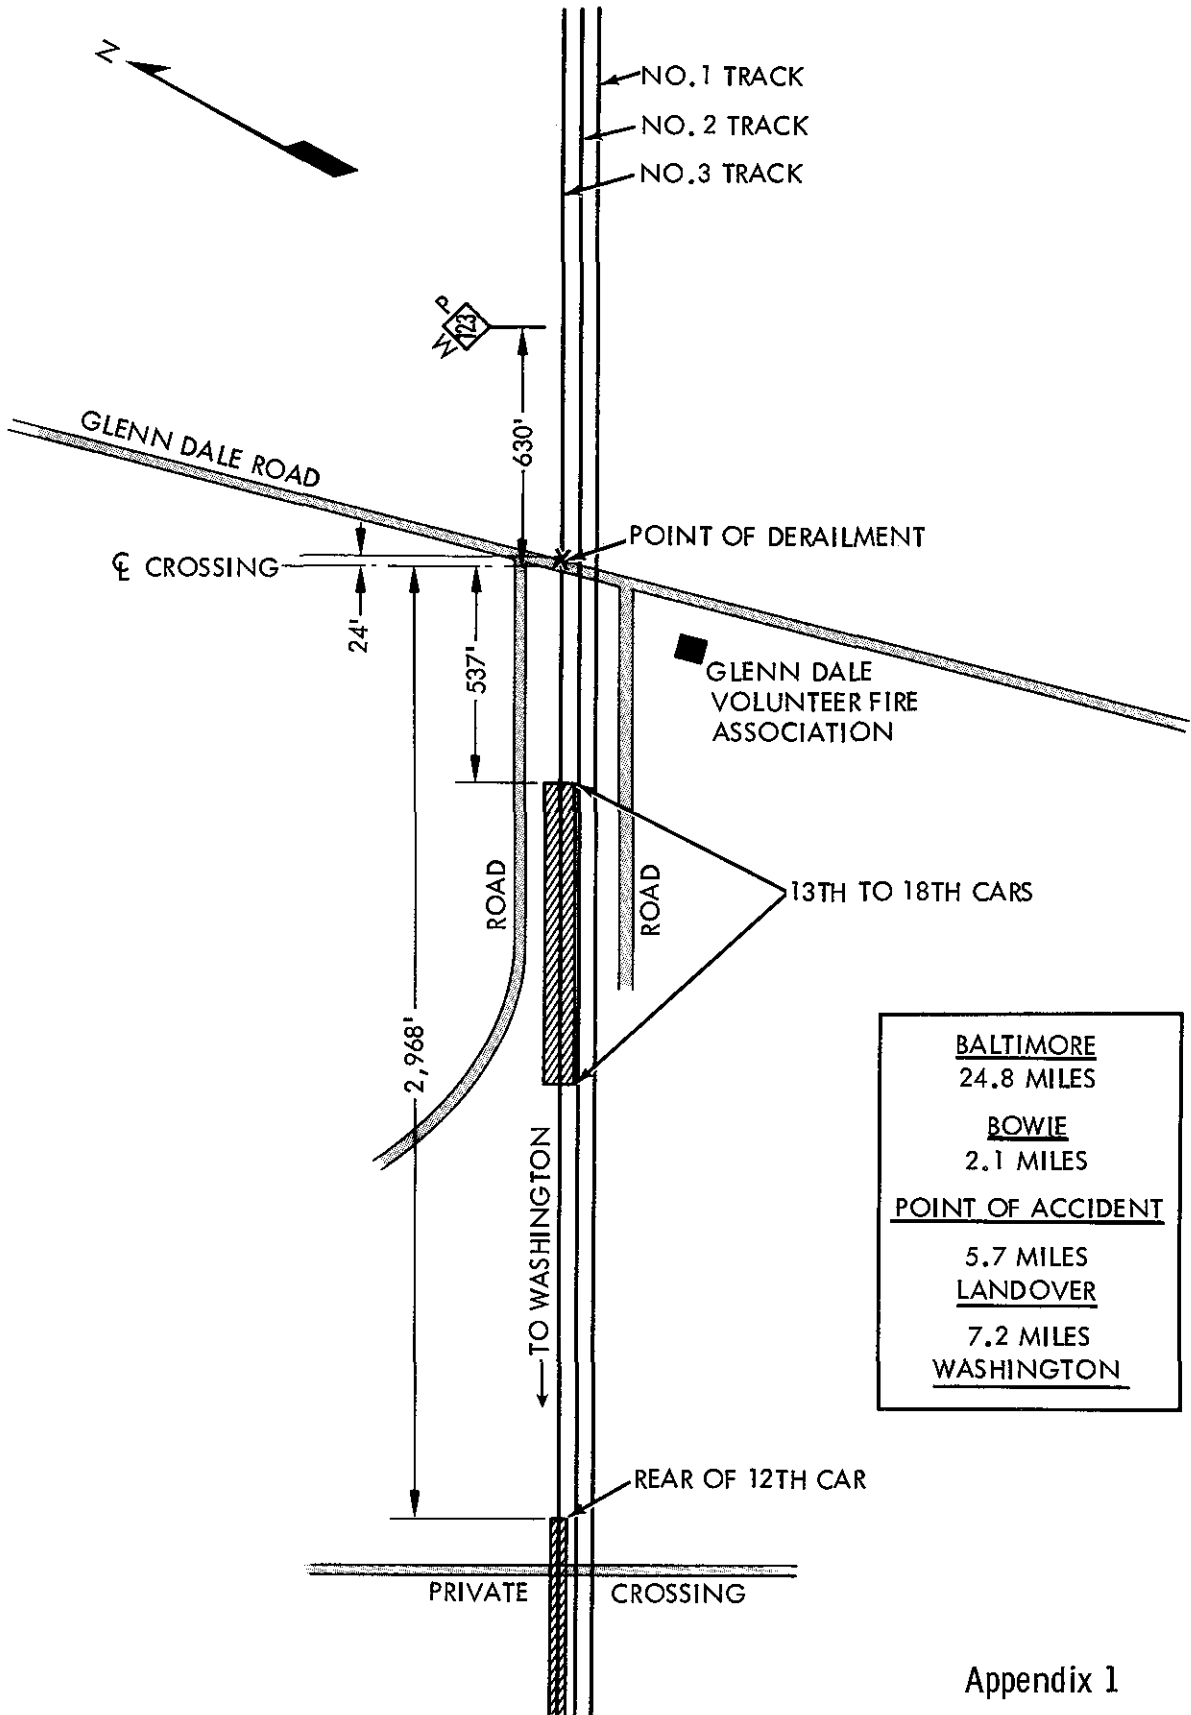
- CAR NO. 8 - SAL 6271 - COACH - REAR WHEELS DERAILED
- 9 - SCL 5622 - COACH - ALL WHEELS DERAILED
- 10 - SCL 5212 - COACH - ALL WHEELS DERAILED
- 11 - SCL 5850 - TAVERN - ALL WHEELS DERAILED
- 12 - SCL 5900 - DINER - ALL WHEELS DERAILED
- 13 - SCL 5270 - COACH - OVERTURNED
- 14 - RFP 861 - COACH - OVERTURNED
- 15 - PRR RARITAN RIVER - SLEEPER - OVERTURNED
- 16 - SCL POLK COUNTY - SLEEPER - PARTIALLY OVERTURNED
- 17 - SAL RALEIGH - SLEEPER - TILTED
- 18 - BO MOCKINGBIRD - ALL WHEELS DERAILED
