RAILROAD ACCIDENT INVESTIGATION

REPORT NO. 4145

PENN CENTRAL COMPANY

LANDISVILLE, PA.

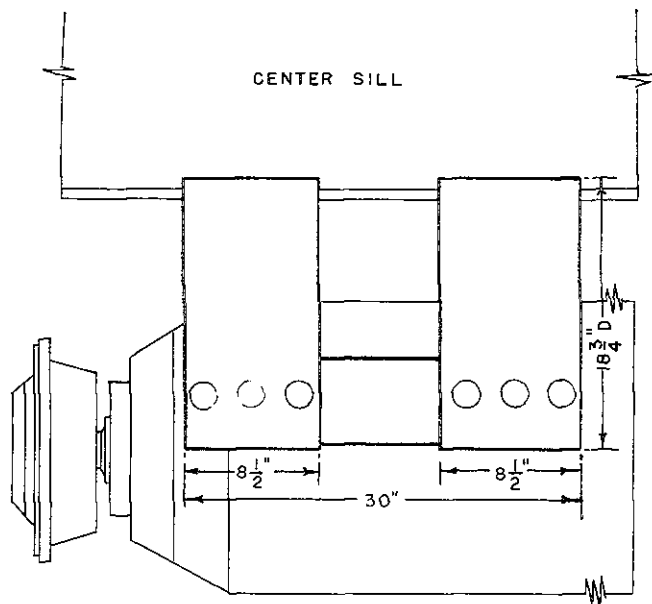
SKETCH "A"

The cylinder-shaped generator was  $47\frac{1}{2}$  inches long,  $18\frac{3}{4}$  inches in diameter, and weighed about 1,760 pounds. It had been suspended under the car by two steel brackets attached to the center sill at a point eleven feet ahead of the center of the rear truck. Each steel bracket had two arms, for securing the bracket to the center sill. (See sketches "A" and "B" appended to this report.)

The welds for securing the arms of the north generator bracket to the center sill were broken, and the arms of the south bracket were broken through their holes. These breaks permitted the generator to fall to the track structure, causing the derailment.

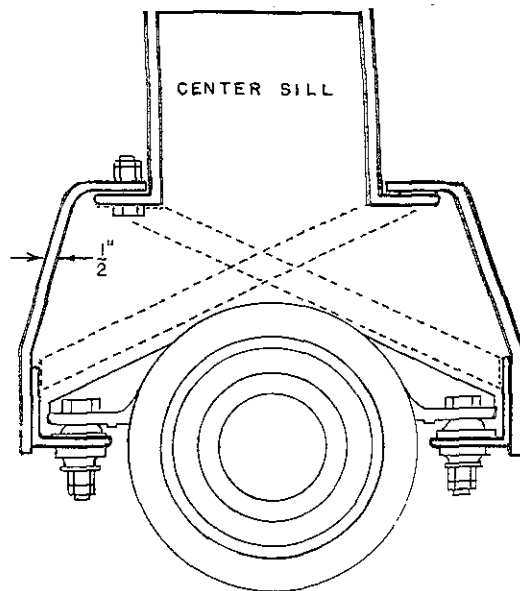
SKETCH "B"

The manufacturer's blueprint specifications call for three 13/16-inch holes to be bored in the top end of each arm of the brackets, for securement of the brackets to the webs of the center sill by bolts or rivets applied through the arm holes and holes in the webs of the center sill. Examination revealed that the arms of the bracket supporting the south side of the generator had been secured to the center sill in accordance with the manufacturer's blueprint specifications. Two bolts and four rivets used for securing this bracket to the car were found in their respective holes in the south web of the center sill. Holes in the north web of the center sill showed little or no evidence of bolts or rivets having been used to secure the north bracket of the generator to the center sill. From all indications, this bracket had been secured to the center sill by welds, instead of bolts or rivets.

The manufacturer's blueprint specifications also called for the generator brackets to be diagonally braced by two metal bars, as indicated by the dotted lines in sketch "B". No trace was found of the aforesaid braces having been applied as called for in the specifications.

The derailment occurred due to the breaking of the welds securing the arms of the north generator bracket to the center sill of the car. Inspection of the bracket indicates that the welds broke because of the use of faulty welding techniques, which resulted in insufficient fusion of fillet weld metal with the bracket metal. The generator brackets apparently were not braced as called for in the manufacturer's blueprint specifications, and the absence of this bracing may have been a causal factor with respect to the breaks in the welds.

It is recommended that the Penn Central Company and all other railroads operating passenger cars instruct their mechanical department employees to thoroughly examine generators applied to such cars, to determine whether the generators are properly secured
