1-
RAILROAD ACCIDENT INVESTIGATION,

11
REPORT NO. 4154

PENN CENTRAL COMPANY

NEW CARLISLE, INDIANA

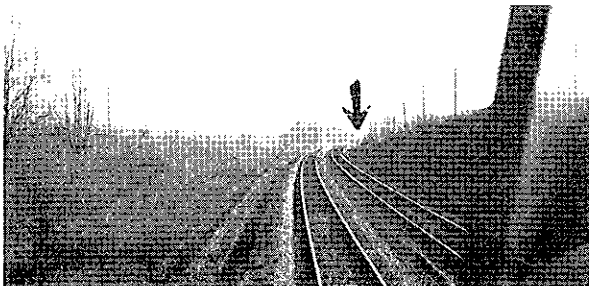
Plate No. 2

Because of track curvature and trees alongside the railroad, a caboose standing at the collision point cannot be seen from an approaching eastbound locomotive at a distance greater than 3288 feet. See Plate No 2 below

3288 feet from collision point (arrow)

5. No. 6 moved in the manual block at excessive speed and had insufficient braking distance to stop short of a collision after the fireman saw the caboose of Extra 2372 East and called a warning to the engineer. Inasmuch as the caboose could have been seen from a distance of 3288 feet and the speed of No. 6 was not reduced significantly before the collision, it is evident the fireman of No. 6 first saw the caboose ahead at a distance considerably less than 3288 feet.

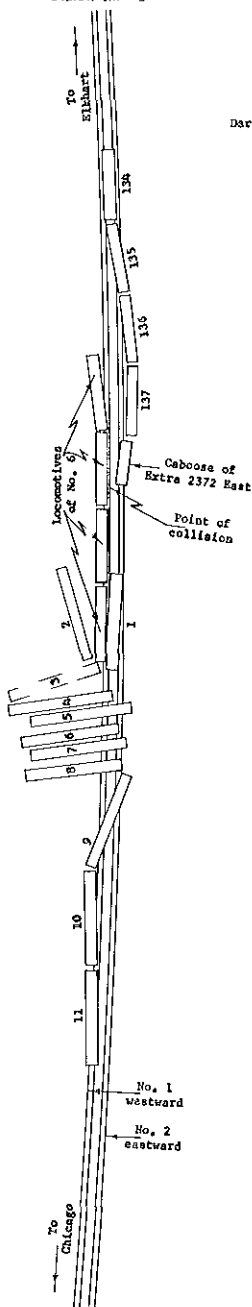
Derailed cars of No. 6

1st car	=	MEVX-9700
2nd "	"	-5744
3rd "	"	-6777
4th "	"	-6808
5th "	"	-9641
6th "	"	-9625
7th "	"	-9789
8th "	"	-6905
9th "	"	-6753
10th "	"	-9666
11th "	"	-6972

Derailed cars of Extra 2372 East

134th car	=	PALE-42918
135th car	=	NWC-749910
136th car	=	NWC-749896
137th car	=	PALE-42940

The caboose and four rear cars of Extra 2372 East were derailed. They stopped in various positions on or near the structure of the main tracks, as indicated in Plate No. 3. The caboose and the last two cars were destroyed. The third and fourth cars ahead of the caboose were moderately damaged.

No. 6 stopped with the front end about 115 feet east of the collision point. The four diesel-electric units and first 11 cars were derailed. The locomotive units stopped upright and in line on the north side of track No. 1, adjacent to and paralleling that track. The derailed cars stopped in various positions on or near the structures of the main tracks (See Plate No. 3). The first locomotive unit was destroyed (See Plate No. 4 below) and the other three units were heavily damaged. Of the 11 derailed cars, six were substantially damaged; three moderately damaged, and two slightly damaged.
