RAILROAD ACCIDENT INVESTIGATION

REPORT NO. 4164

PENN CENTRAL COMPANY

JANUARY 9, 1970

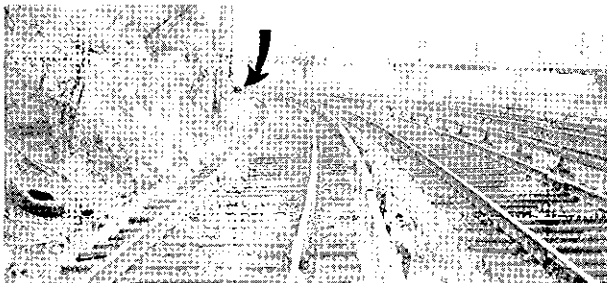
An embankment, 10 to 20 feet high, is adjacent to the north side of track No. 3 in the collision area. Because of the embankment and track curvature, the engineer of an eastbound train on track No. 3 cannot see a railroad car standing at the collision point at a distance greater than approximately 340 feet (see photo on the following page).

View eastward on track No. 3 (at left),
340 feet to collision point (arrow).

No. 710 passed signal 733E, as authorized, and entered a 4°36' curve soon afterward. Although the rear end of No. 706 was standing in the block of signal 733E at a point in the curve where it could have been first observed at a distance of about 340 feet, the engineer of No. 710 stated he did not see No. 706 before reaching a point about two car lengths (170 feet) distant, indicating that he might not have been keeping a careful lookout ahead.

6 Although the rear of No 706 was visible from a distance of about 340 feet, the engineer of No 710 did not take prompt action to reduce the speed of his train when No. 706 came into view
