RAILROAD ACCIDENT INVESTIGATION

REPORT NO. 4158

PENN CENTRAL COMPANY

WELLINGTON, OHIO

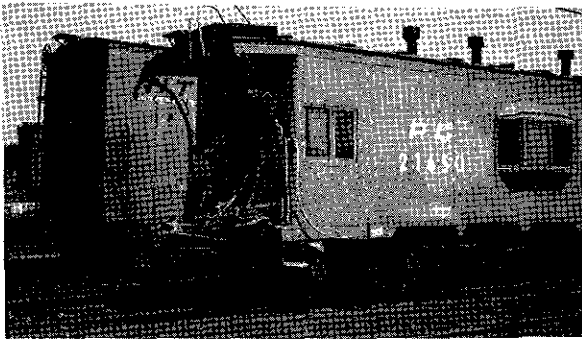
The caboose and rear car of this train were derailed. The caboose overrode the underframe at the front of the first diesel-electric unit of Extra 3099 East, struck and demolished the control compartment of that diesel-electric unit, and stopped upright on the front portion of the unit. It was slightly damaged (see photo next page). The rear car stopped upright on and in line with the structure of track No 2. It was also slightly damaged.

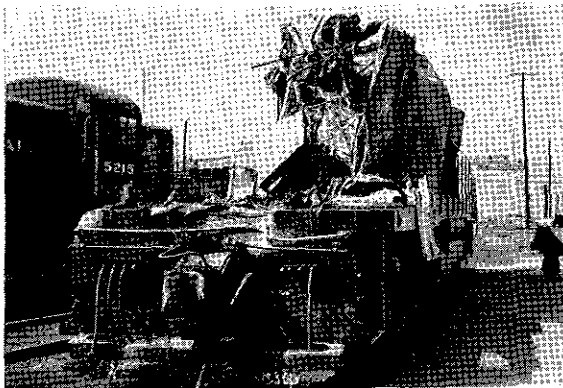
No equipment of this train derailed. Practically the entire control compartment at the front of the first diesel-electric unit was sheared off and knocked to the ground on the south side of track No. 2, as a result of being struck by the caboose of Extra 7339 East. The first diesel-electric unit was heavily damaged (see photo below).

Safety to crew members in the control compartment of a switcher or road-switcher type diesel-electric unit at the front of a train would be improved substantially if the unit were provided with a buffer device of sufficient size and

strength to protect the control compartment in the case of a slow-speed collision, and to afford some protection in a high-speed collision
