# RAILROAD ACCIDENT REPORT.

COLLISION OF PENN CENTRAL FREIGHT TRAIN  
OV-8 WITH AN OPEN DRAWBRIDGE  
CLEVELAND, OHIO  
MAY 8, 1974,

NATIONAL TRANSPORTATION SAFETY BOARD  
Washington, D. C. 20594  
REPORT NUMBER: NTSB-RAR-75-3

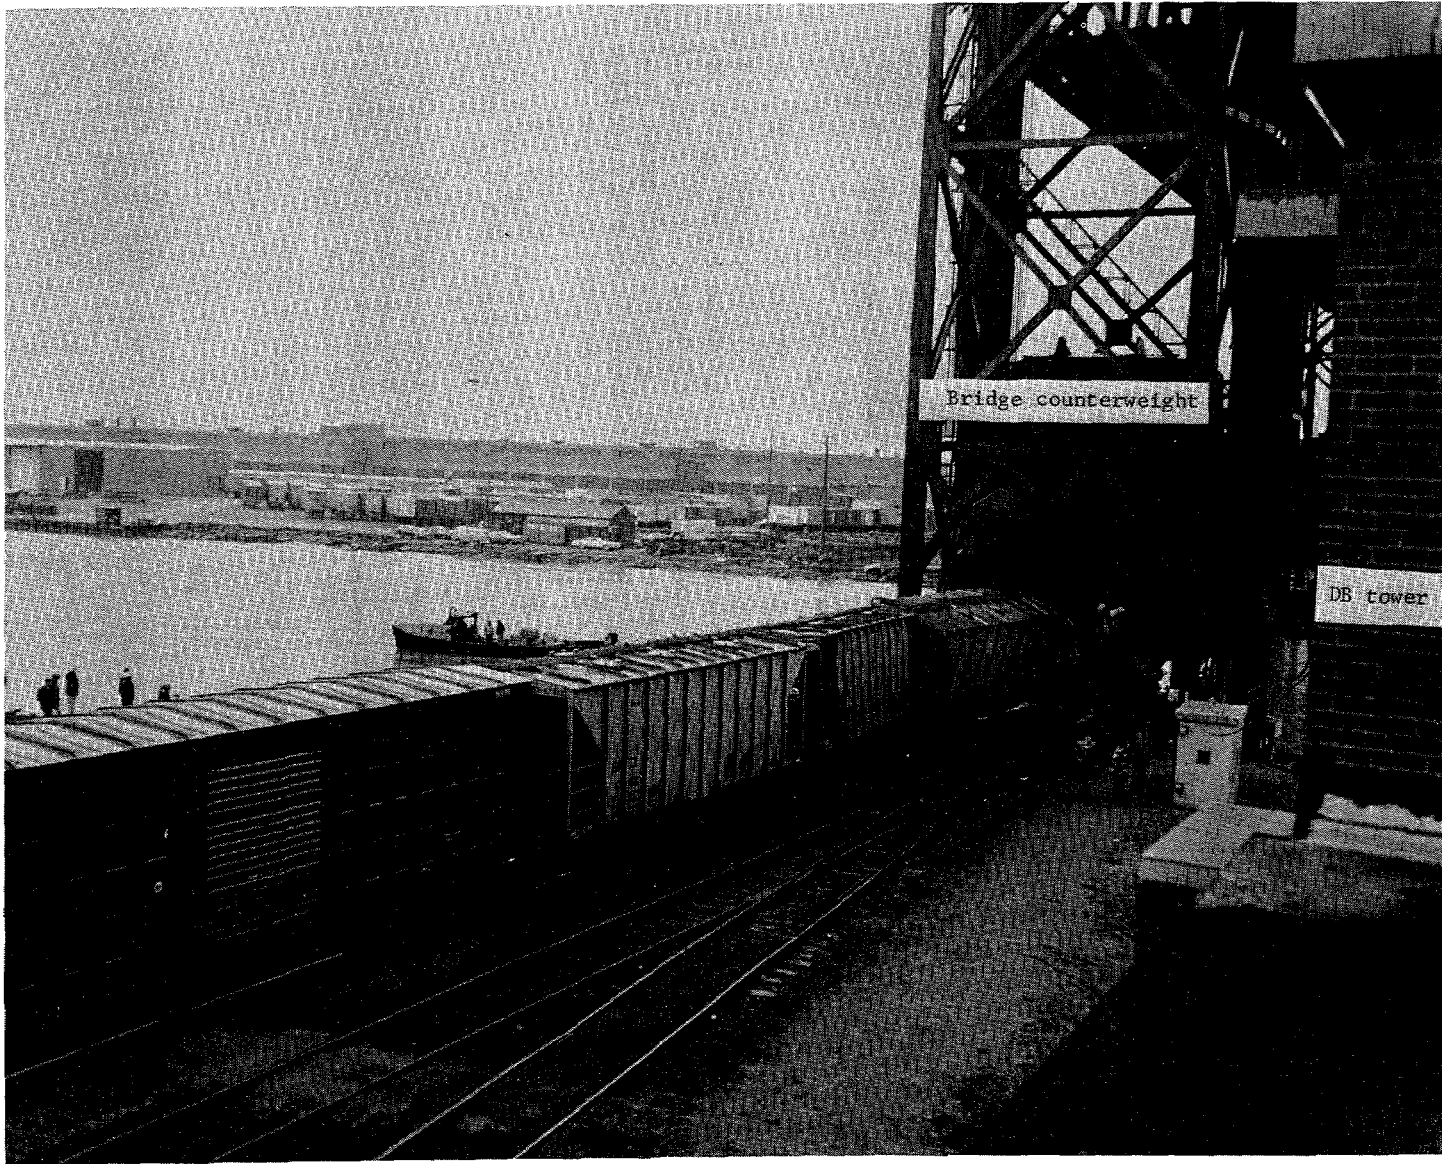
Following that conversation, the DB operator remembered that a U.S. Corps of Engineers' boat had been awaiting passage through the bridge channel since 3:20 a.m., and he immediately opened the bridge. When the bridge was raised, the bridge counterweight was within 5 feet of the track. At 3:56 a.m., train OV-8 collided with the bridge counterweight. (See Figure 1.)

Figure 1. View of wreckage looking east toward Cleveland and the Cuyahoga River.

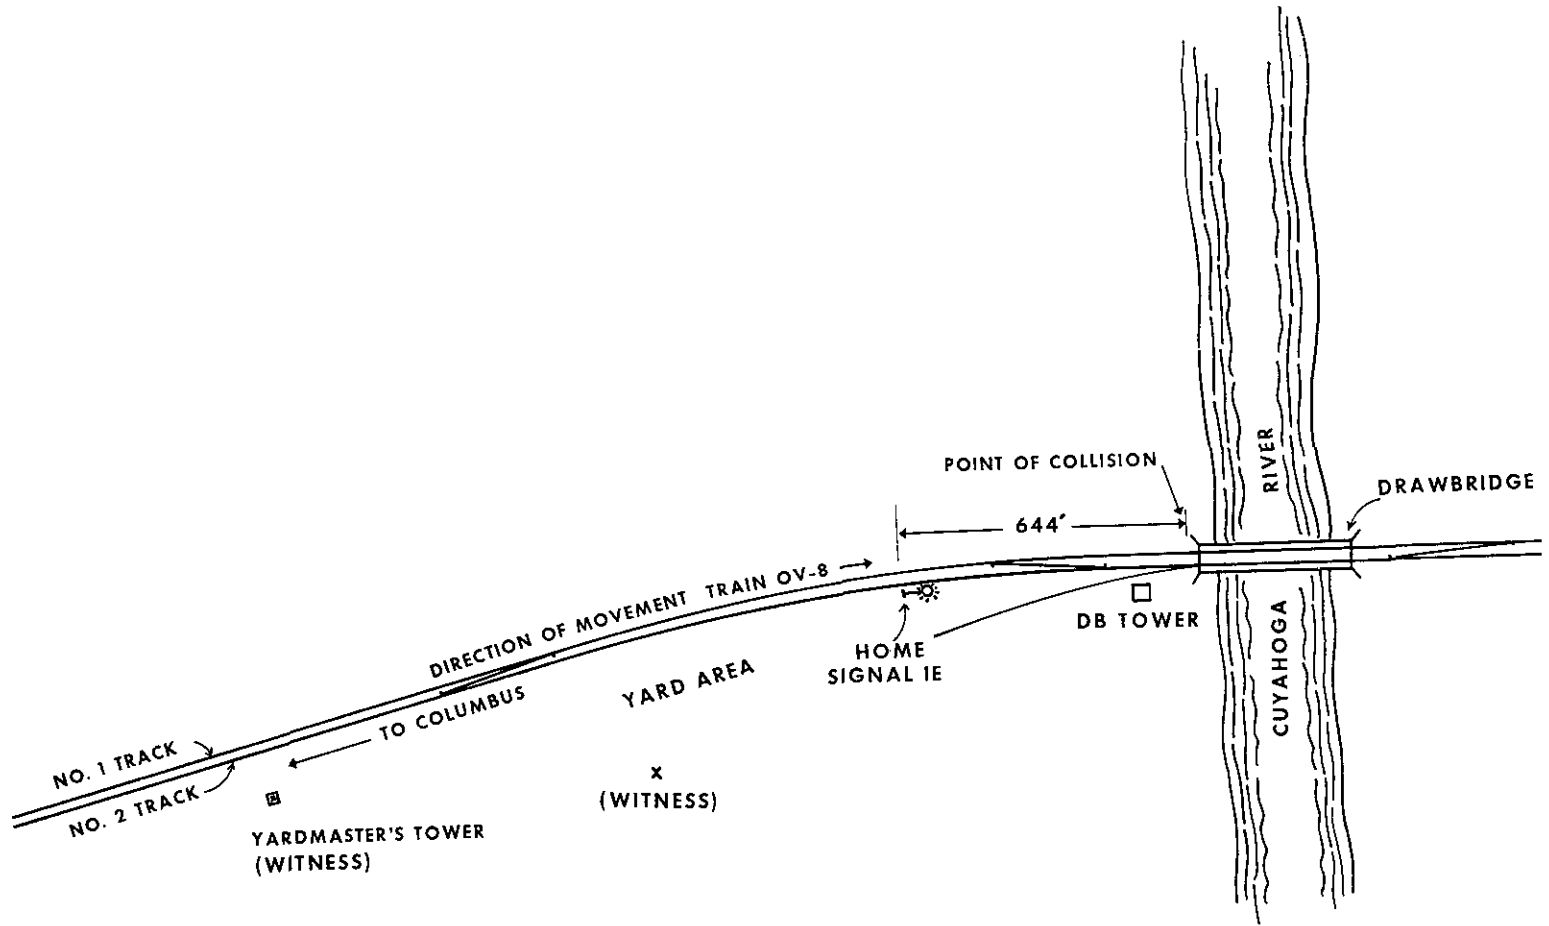
**FIGURE 2**  
SKETCH OF  
ACCIDENT AREA  
CLEVELAND, OHIO

The track curves west of the bridge. About 2,577 feet west of the bridge, there is a 0°16' curve to the left for eastbound trains. The curve is 338 feet long and is followed by 1,004 feet of straight track. A 1°03' curve turns to the right, continues for 819 feet and ends 416 feet from the bridge. Straight track extends from that point across the bridge. Figure 2 shows the general layout of the facilities pertinent to the accident and the locations of the witnesses to the collision.

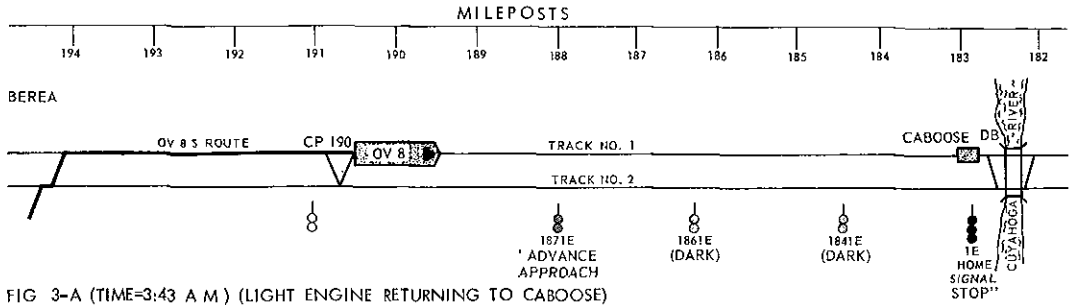
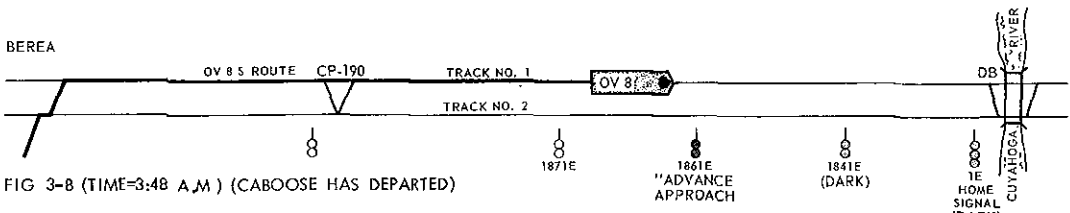
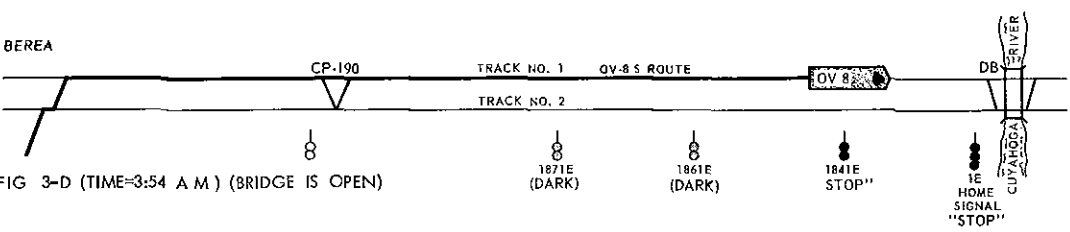
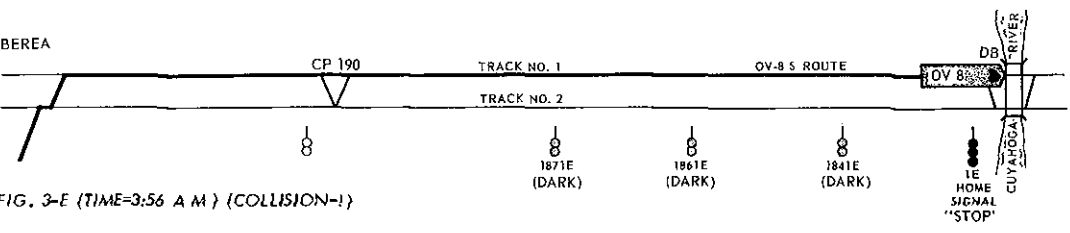
FIGURE 3

The system supplemented automatic block signals and automatic train stop. With approval of the Federal Railroad Administration (FRA), the automatic train stop was removed in 1971. The automatic signals of the traffic control system are the color-light type which are lighted only when a train is within the approach circuit for the signal. (See Appendix B.) The locations of the involved signals are shown in Figure 3.

From CP-190 to the collision, OV-8 averaged 33.3 mph. At this speed, the light engine and caboose had cleared the DB tower when the engineer of OV-8 was first able to see signal 1861E. The time was about 3:48 a.m. The position of OV-8 and the signal indications are shown in Figure 3-B. Thus, the engineer could have concluded that the traffic conditions ahead of him were improving since he had observed two "advance approach" signals in succession.

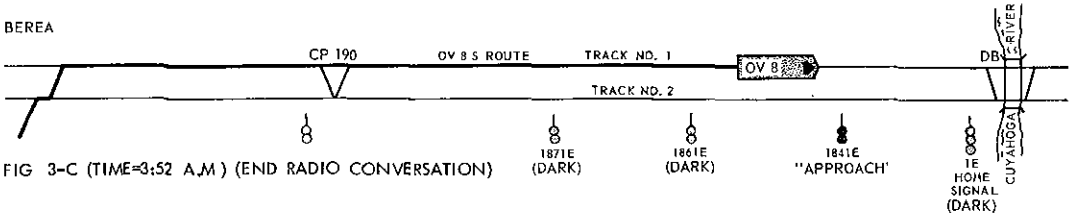
FIG 3-C (TIME=3:52 A.M.) (END RADIO CONVERSATION)

About 3:52 a.m., the radio conversation between the engineer and the DB operator took place, which indicated the route was clear ahead. Figure 3-C shows the position of OV-8 and the signal indication at that time. The "approach" indication of signal 1841E would suggest to the engineer that the home signal was not yet displayed for the route; however, in view of a message that says "all clear ahead of you..." and "you can highball right along," an engineer could reasonably conclude that the route ahead would improve, unless a broken rail or some other obstruction unknown to the DB operator existed.
