RAILROAD ACCIDENT INVESTIGATION,

REPORT NO 4186,

PENN CENTRAL TRANSPORTATION COMPANY

MARCH 2, 1972

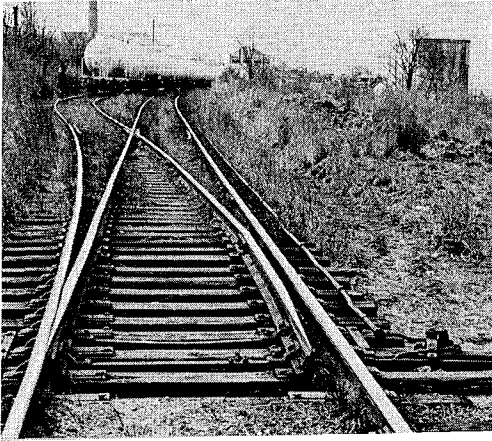
The collision occurred on the secondary track, approximately 1.3 miles south of Ferry Street and 42 feet north of the switch of the spur track serving the Fall River Gas Company.

View southward along secondary track. Switch of spur track serving Fall River Gas Company is in foreground. The collision occurred 42 feet north of that switch.

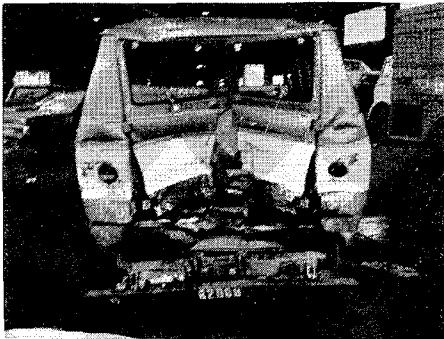
Highway-rail car.

The coupler at the front of the locomotive penetrated the double door at the rear of the highway-rail car (see following photograph). The car derailed to the west, remained upright, and was pushed forward on the track structure by the train. It eventually stopped upright on and in line with the structure of the secondary track in front of the train locomotive.

According to the carrier's estimate, the cost of damages to the highway-rail car was \$1000.
