**NATIONAL
TRANSPORTATION
SAFETY
BOARD**

RAILROAD ACCIDENT REPORT

**PENN CENTRAL TRANSPORTATION
COMPANY**

TRAIN COLLISIONS

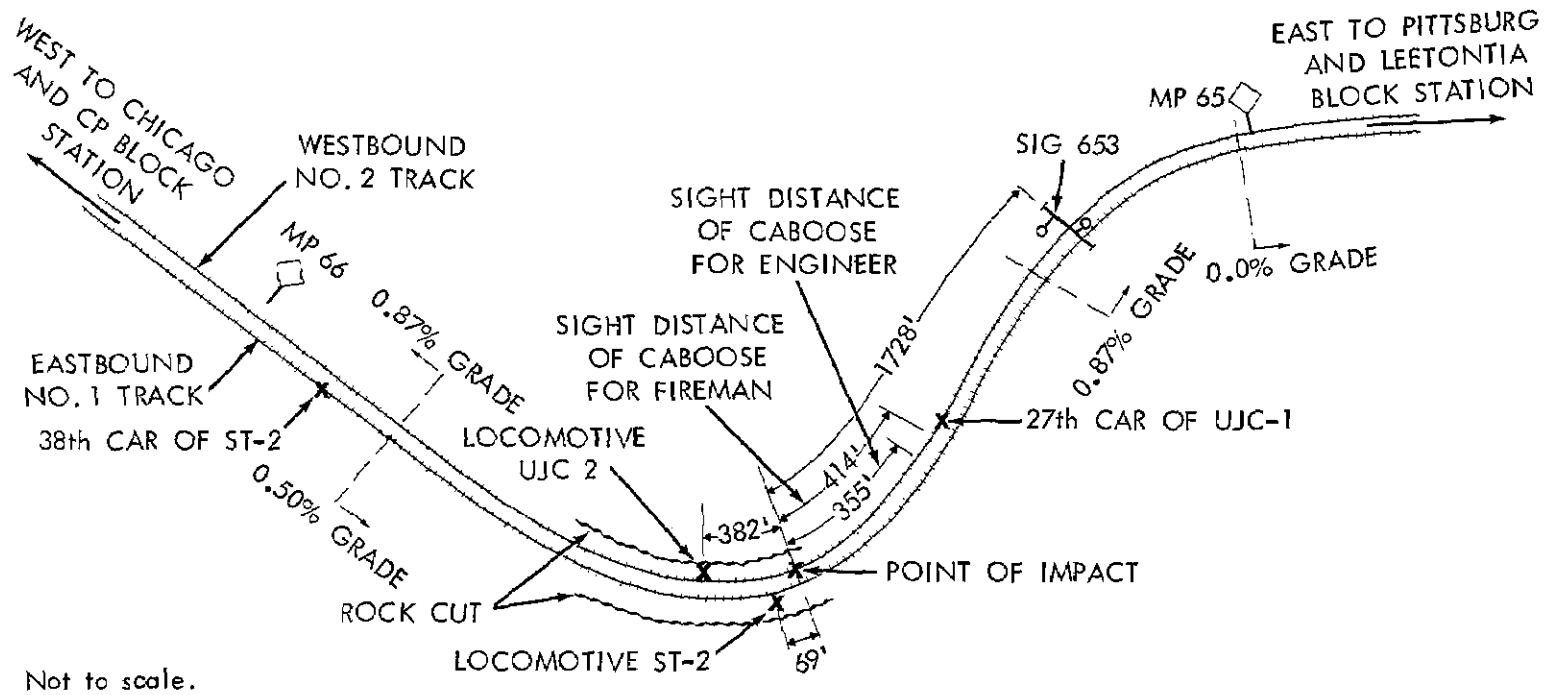
Figure 1. Pertinent points in connection with the accident involving Penn Central Transportation Company's Extra 6330 West, Extra 2278 West, and Extra 6259 East near Leetonia, Ohio, June 6, 1975.

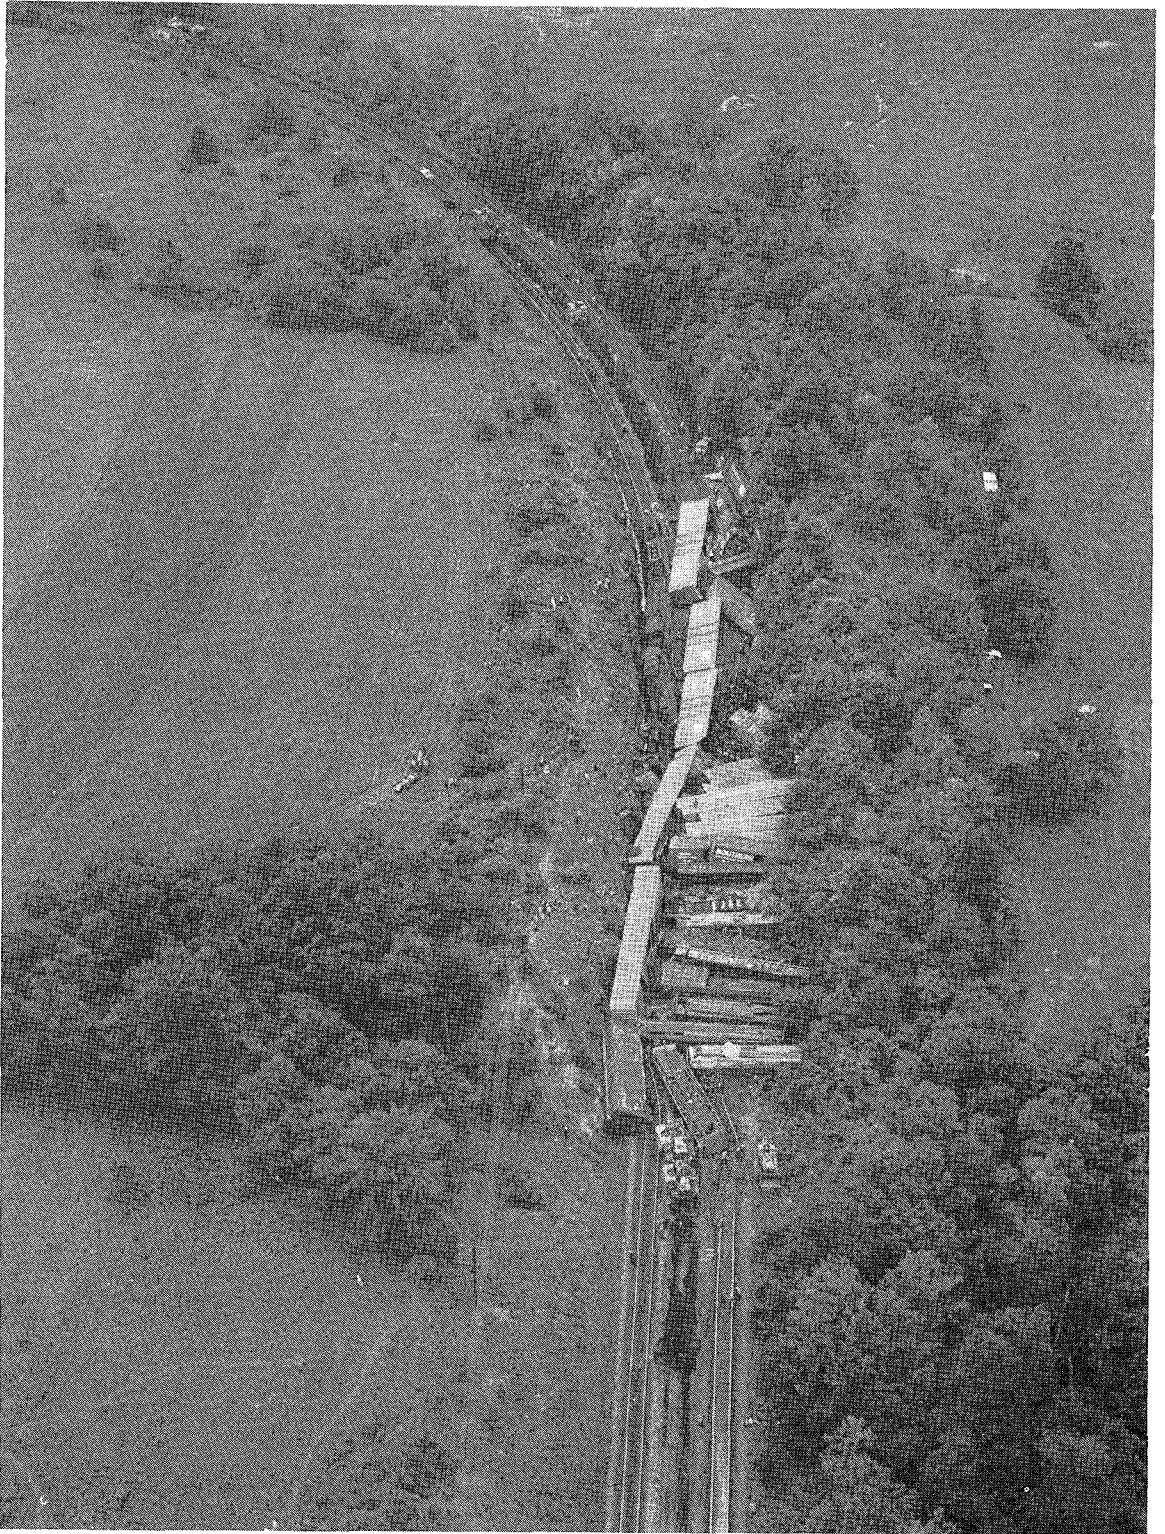
The accident site is about 2.5 miles west of Leetonia block station and the town of Leetonia, Ohio. (See Figures 2 and 3.) The accident occurred in a rock cut which is on a 0.50-percent ascending grade westward, in a 4°5' curve to the right. There are two adjacent tracks, one eastbound and one westbound. The point of impact was 1,728 feet west of signal 653. At this point the tracks run through a cut. The walls of the cut are sheer rock. The inside (north) wall of the cut is about 35 to 40 feet high at the point of impact. The clearance between the rock wall and the north rail of the No. 2 track westbound is 6 to 8 feet.

Figure 2. View of the accident site as seen from the west.

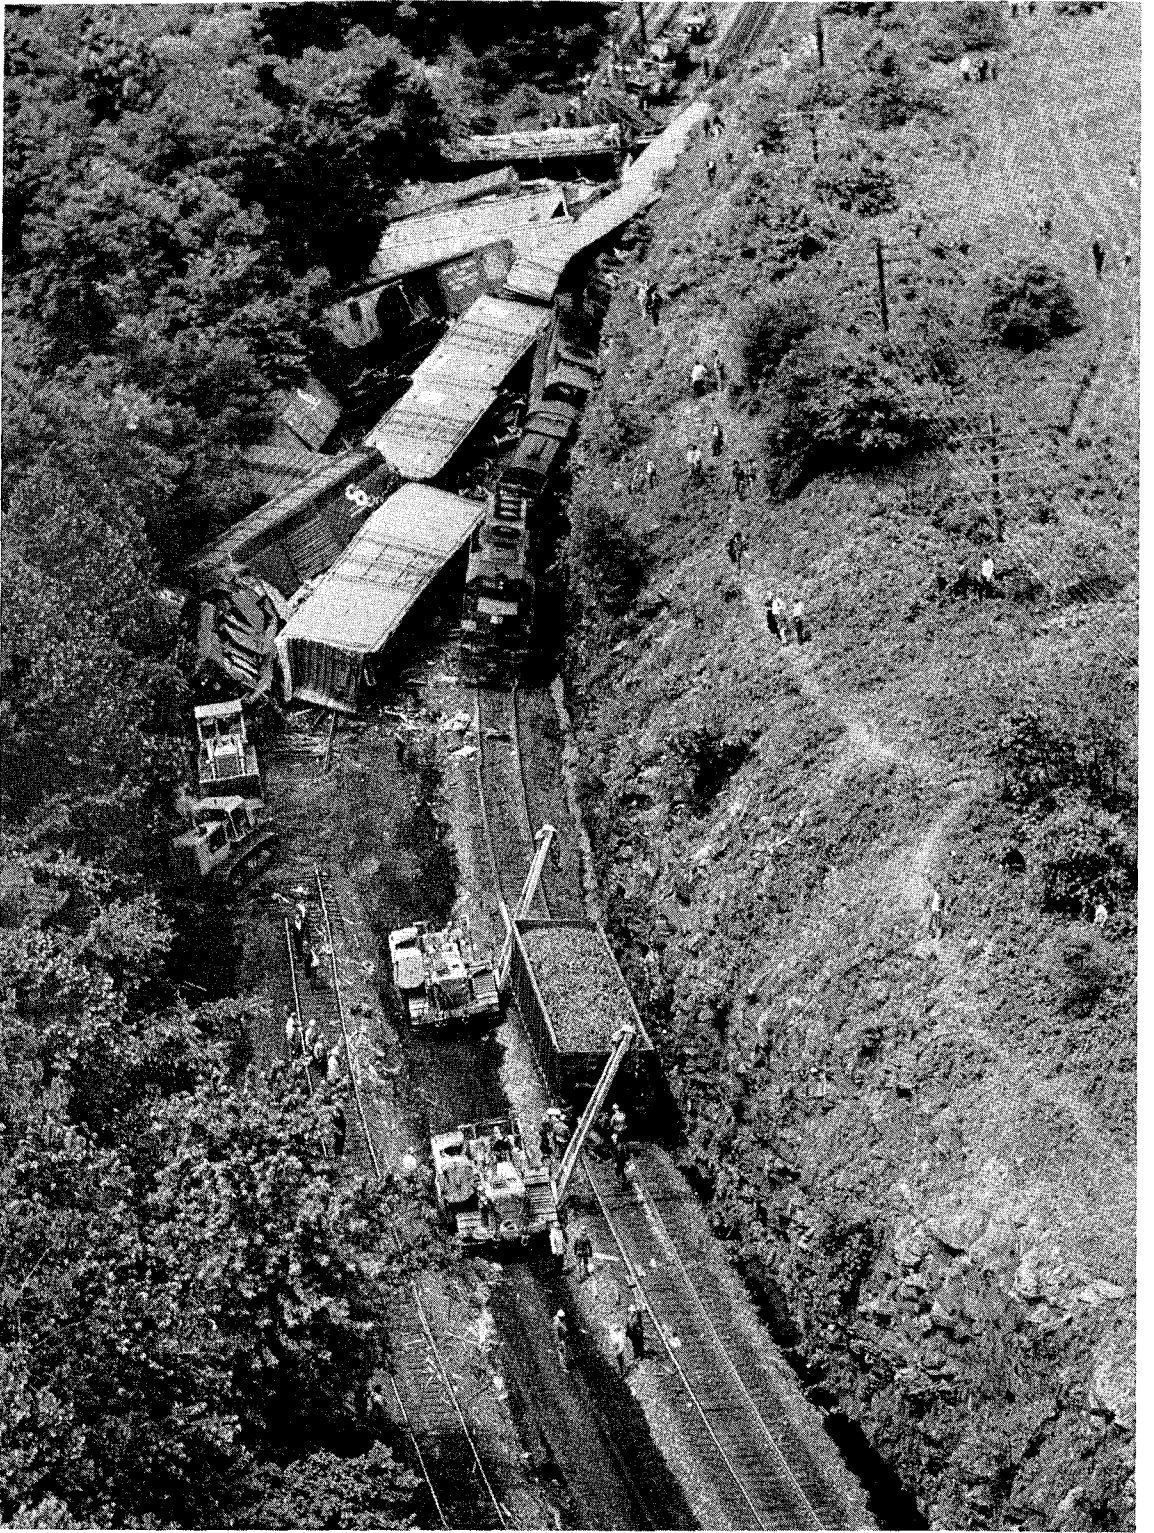
Figure 3. View of the accident site as seen from the east. The point of impact is off the bottom of the photograph.

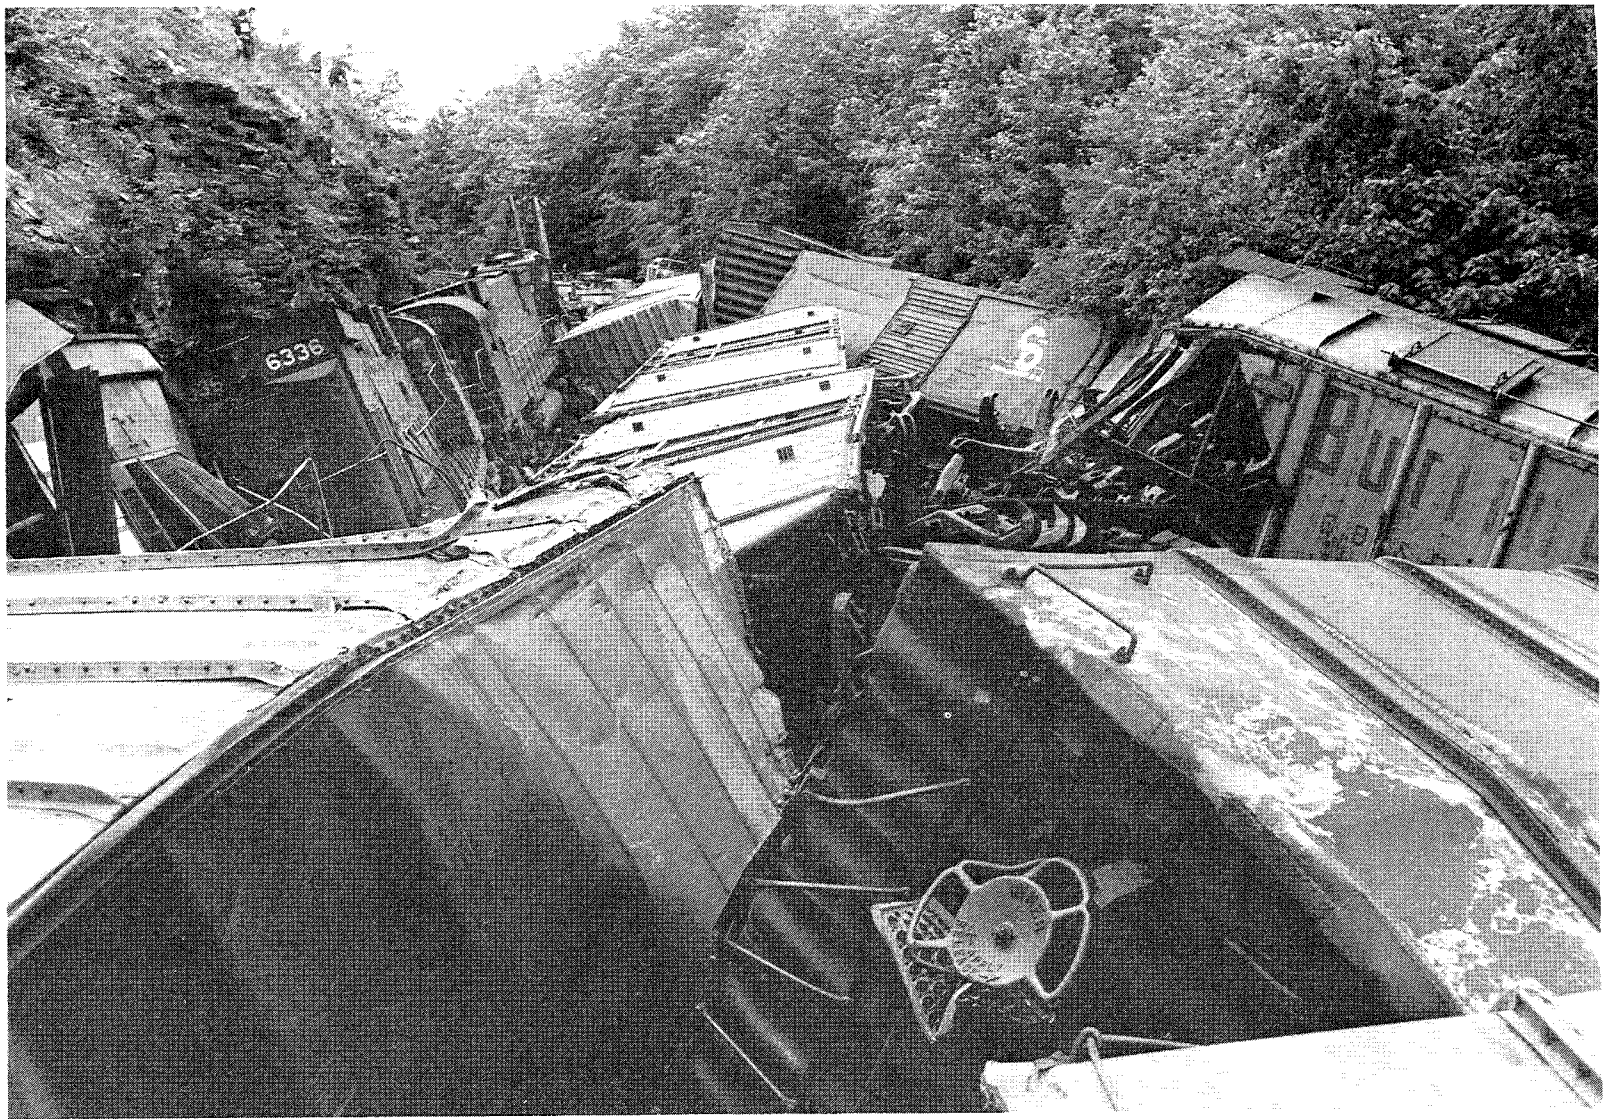
The locomotive cabs of unit 6330 on Extra 6330 West and unit 6259 on Extra 6259 East were crushed by the forces of the impact and by cars jamming them against the walls of the cut. The cabs were not sheared from the frames of the locomotives, and all of the crewmen who remained in the cabs survived.

Twenty-two cars and one locomotive unit were demolished. (See Figure 4.) Damage to equipment and facilities and the costs associated with clearing the wreckage were estimated to be \$1.25 million, which is broken down as follows:

Figure 4. General view of accident, showing locomotive of Extra 6330 West and cars of Extra 2278 West. View is toward the east.

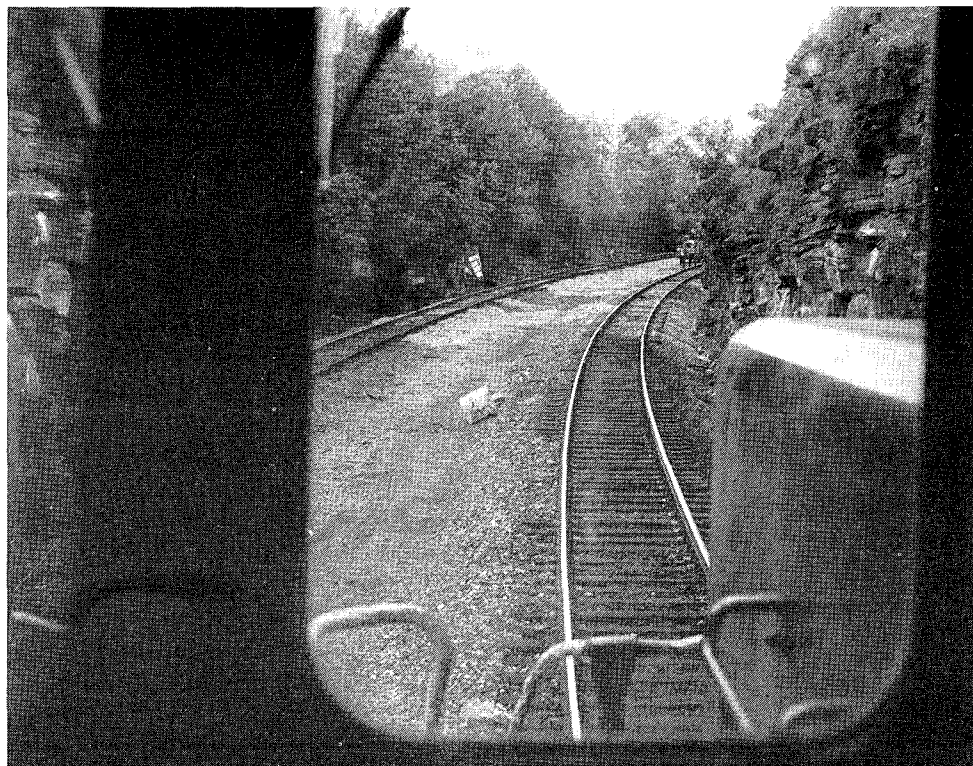
Train Tests -- Several tests were conducted after the accident to determine Extra 6330 West's stopping distances, its sight distances both to signal 653 and to the rear of Extra 2278 West, and its minimum possible speed. (See Table No. 1 for the results of the visibility tests. Also, see Figure 5.)

Figure 5. Fireman's view from the approaching locomotive to the point of impact. Men standing in the foreground represent the position of the caboose of Extra 2278 West.
