# NATIONAL TRANSPORTATION SAFETY BOARD

## RAILROAD ACCIDENT REPORT

HEAD-ON COLLISION OF TWO  
PENN CENTRAL TRANSPORTATION  
COMPANY FREIGHT TRAINS

REPORT NUMBER: NTSB-RAR-76-10

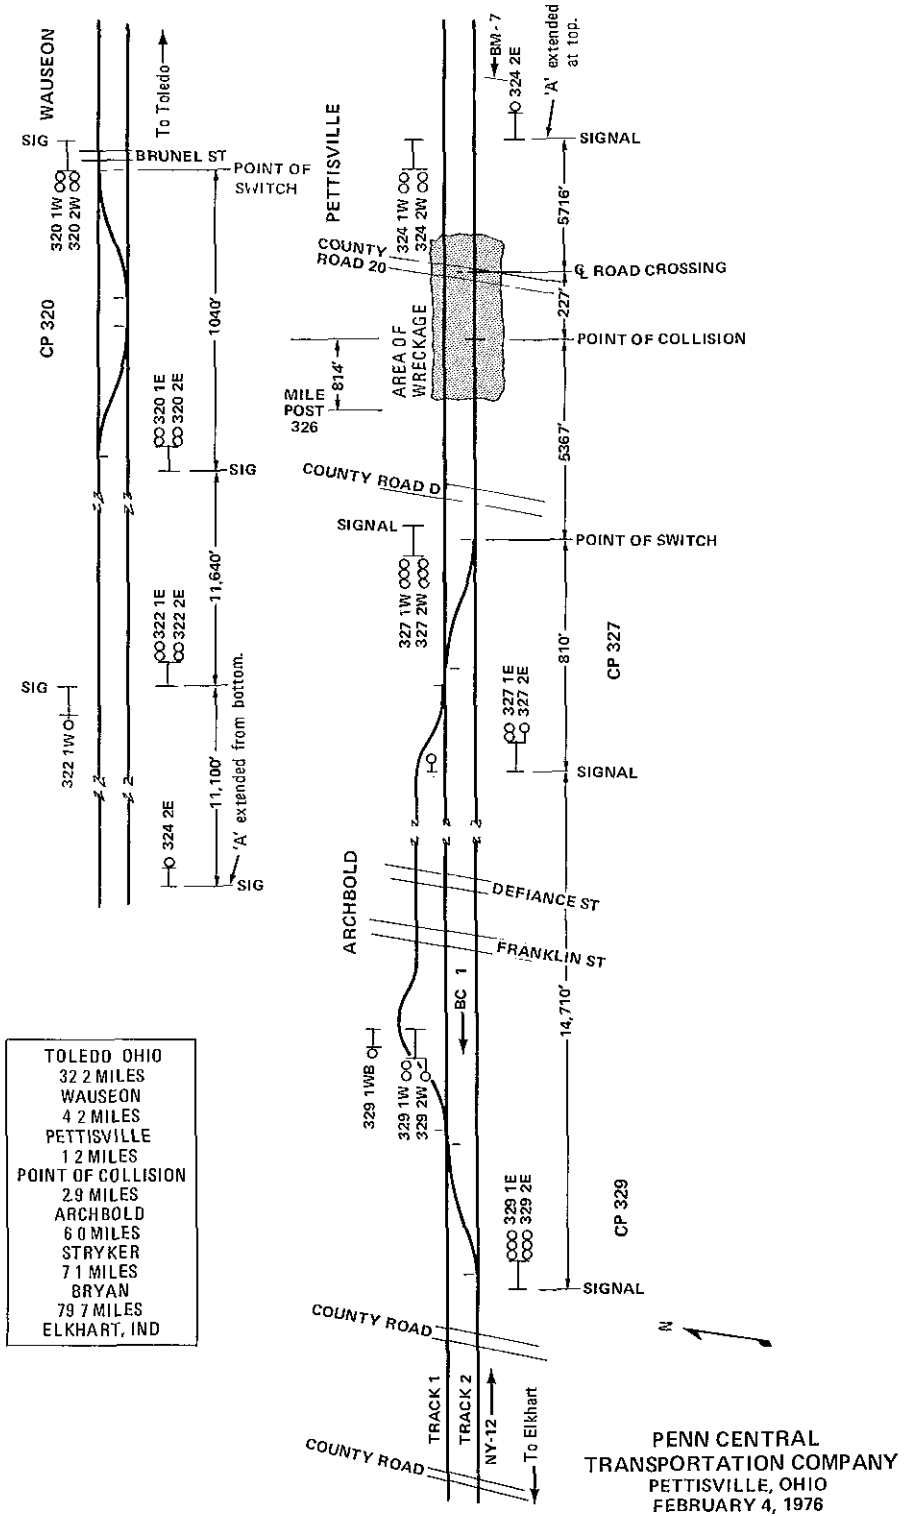
Figure 1. Track layouts at and near accident site.

About 11:43 p.m., BM-7 was moving west on track 2 in the vicinity of CP 320 and NY-12 was moving east on track 2 in the vicinity of CP 329 near Archbold. The train dispatcher planned to have train BM-7 cross over from track 2 to track 1 at CP 327 so that NY-12 could proceed east on track 2. (See figure 1.)

The train dispatcher can cause the controlled signals to display a stop- or a proceed-type aspect. Once the dispatcher or the track occupancy causes the controlled signals at CP 327 and CP 329 to display a stop aspect, they will not display a proceed aspect until the dispatcher activates the circuit. Other intermediate signals function as automatic-block signals. The signals are approach lighted. (See figure 1.)
