✓
REPORT NO. 4162

PENN CENTRAL TRANSPORTATION COMPANY

RIDGEWAY, OHIO

APRIL 18, 1969

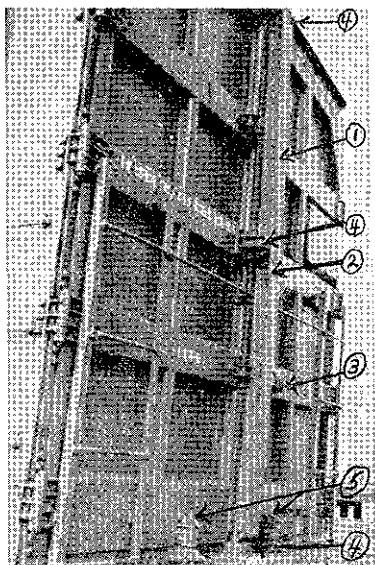
1. Vertical locking bar
2. Bar pivot point
3. Bar locking arm
4. Bar stops
5. Auxiliary locks

End door arrangement similar to that of NP 4627. Overlapping door at left.
