# RAILROAD ACCIDENT REPORT

PENN CENTRAL COMPANY  
Electrocution of Juvenile Trespasser  
On Penn Central Tracks  
at Washington, D.C.

May 14, 1971

NATIONAL TRANSPORTATION SAFETY BOARD  
Washington, D. C. 20591  
REPORT NUMBER: NTSB-RAR-72-3

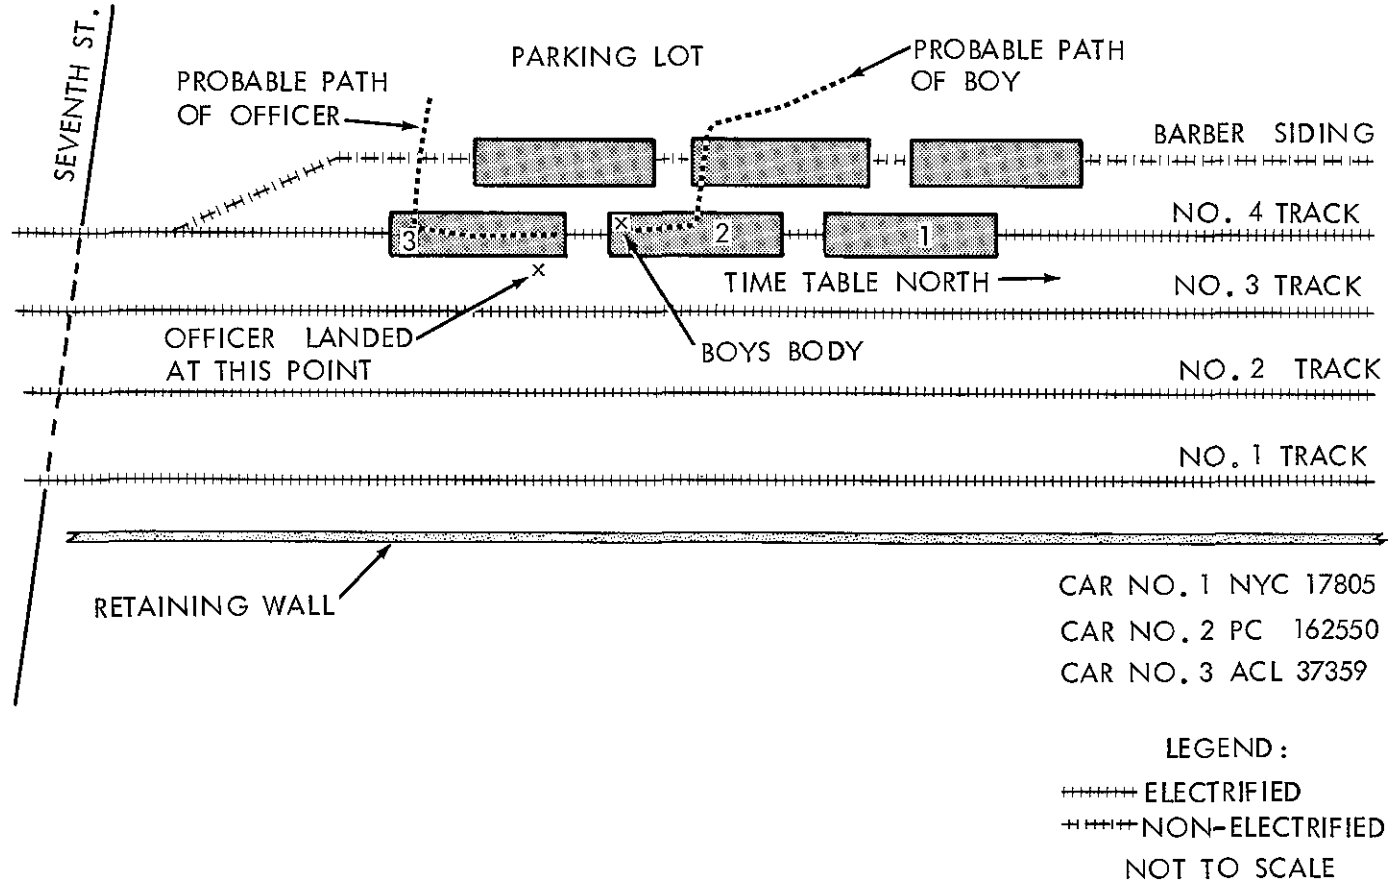
Figure 1.—Plan view of accident area showing location of cars

At the scene of the accident, which is approximately 250 feet north of the Seventh Street bridge, there are five tracks. (See Figure 1.) From west to east there is a side track (Barber Siding) which serves several industries in the vicinity, a secondary running track designated No. 4 track, a southbound main track designated No. 3 track, a northbound main track designated No. 2 track, and a secondary running

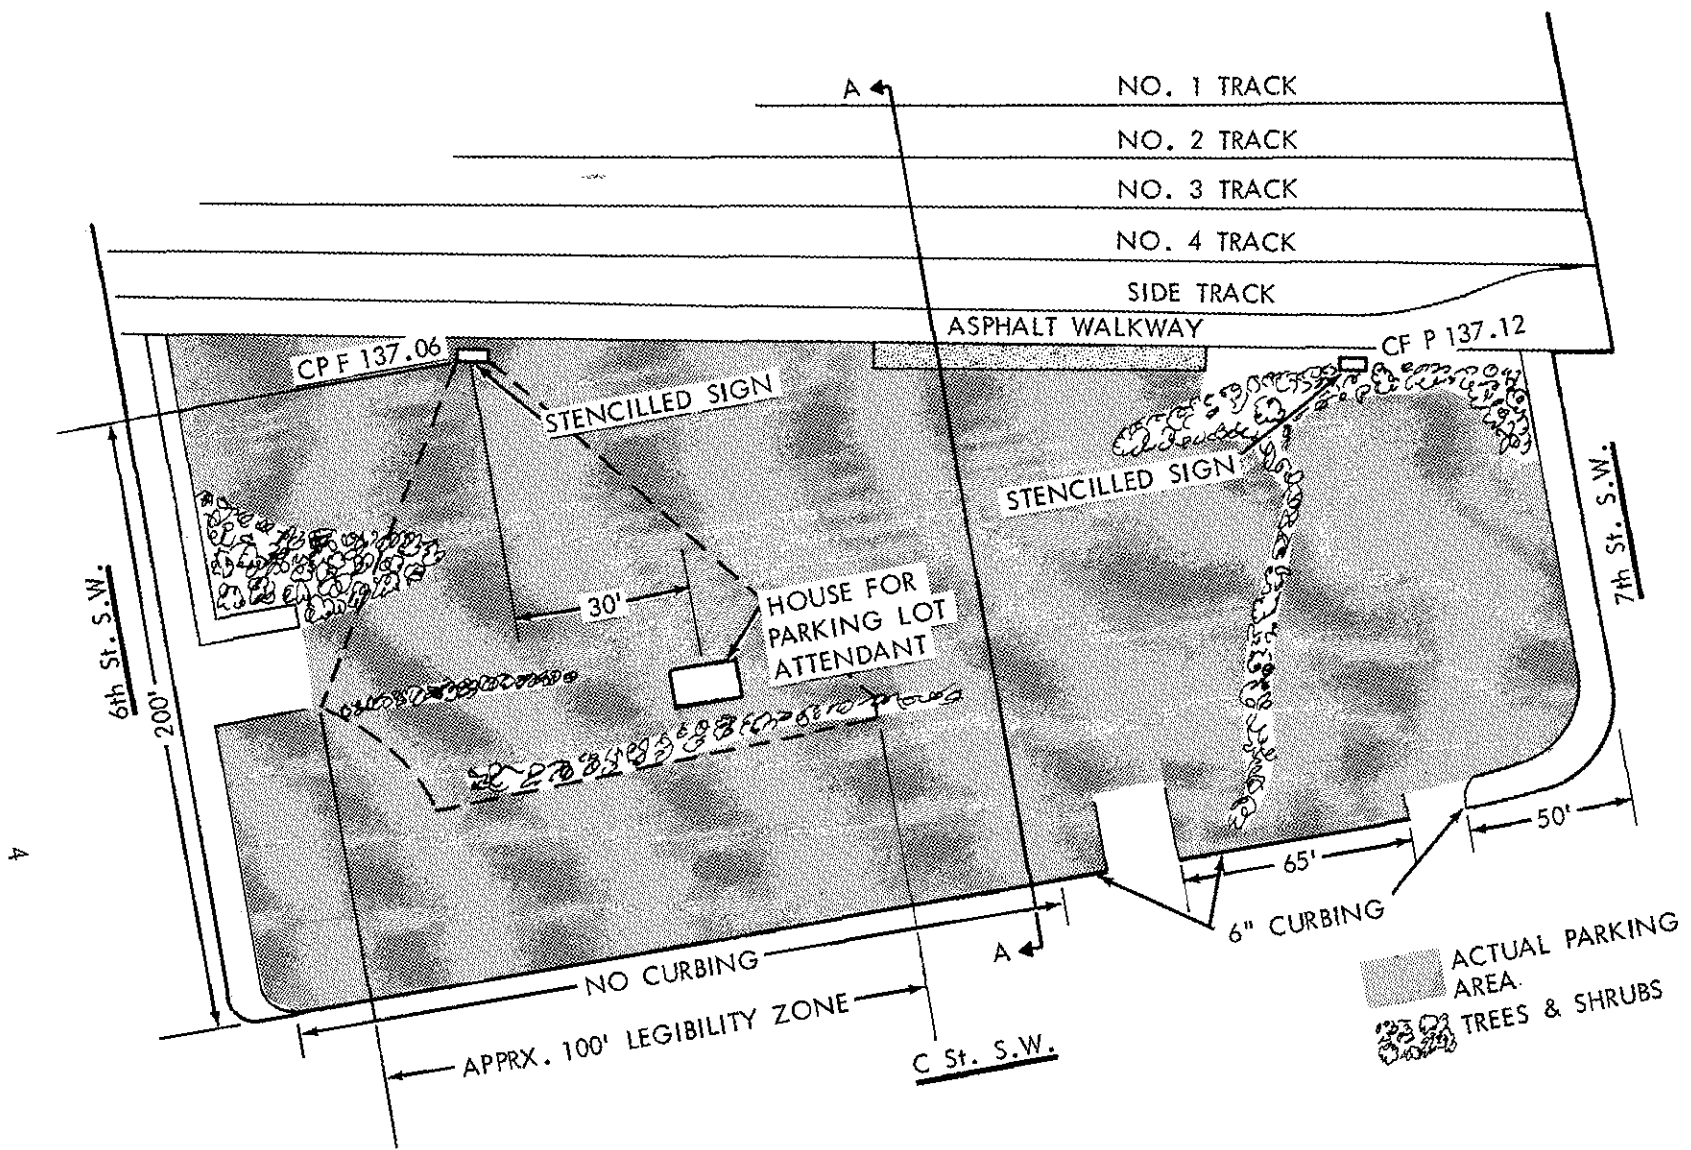
Figure 2.—Plan view of parking lot area—no scale

The stencilling on catenary pole CP-F 137.12 cannot be seen from the parking lot area. (See Figure 2 ) Dense vegetation blocks the view and one would have to go to the base of the pole to see the sign During the growing season, the sign cannot be seen from the parking area because of tree foliage. Access to the pole is impeded because of undergrowth and an embankment.

The approximate range of visibility and zone of sign legibility for the stencilled sign on CP-F 137-06 are shown by the dotted line in Figure No. 2

The sign on the north pole, CP-F 137.06, has lost most of its conspicuousness due to deterioration. It has a limited zone of legibility as can be seen in Figure 2. The contour of the parking lot contributes to the limited zone of legibility. One cannot see the sign from "C" Street until he approaches within approximately 100 feet, and this is dependent upon his path of approach. If an approach is made from "C" Street via the driveway entrance, the sign would not be seen unless one were going into the lot consciously looking for that particular warning sign. These signs were inadequate as a method of warning against trespass because they could easily be passed without being seen.

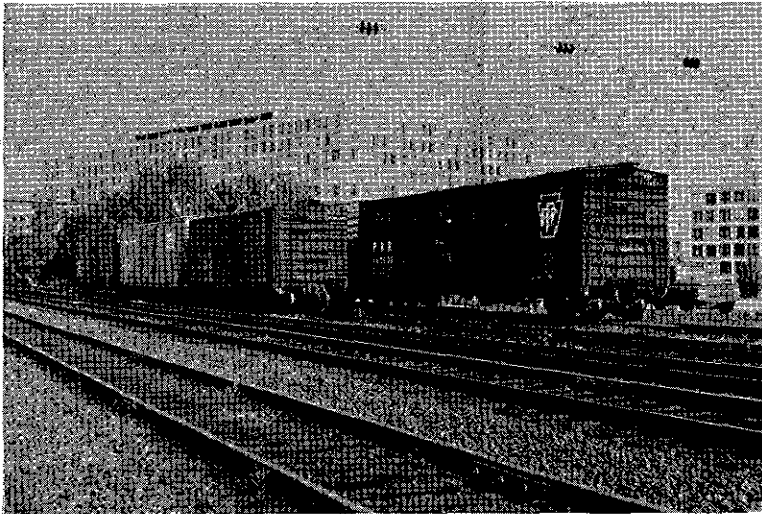
**Figure 4.—Rear of Yard Draft on No. 4 track and cars on Barber Siding at time of accident.**

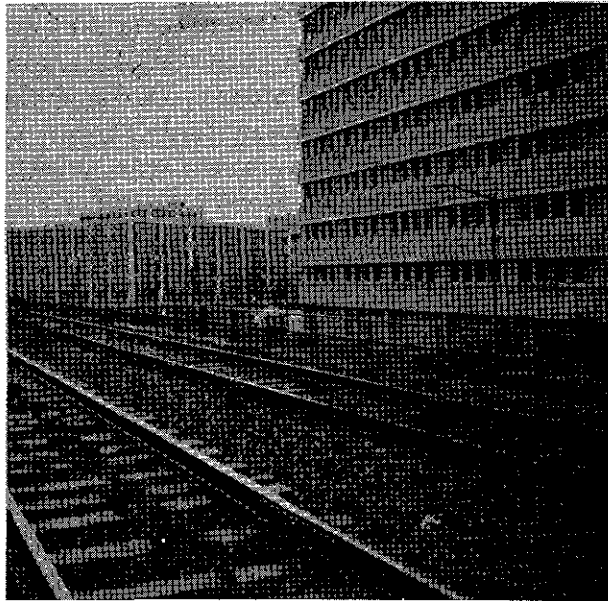
The Penn Central track structure is built on fill or a viaduct from just south of Seventh Street, S.W. to the Virginia Avenue Tunnel. Access to the track facilities on the east side of the track, north of the Seventh Street bridge, is restricted because of the retaining wall paralleling Virginia Avenue, S.W. The wall is about 15 feet high and has a pipe rail fence atop it. The fence includes a 15-inch high wire mesh in the bottom portion of the two rail fence. (See Figure 5.)

Figure 5.—Track structure and retaining wall on east side at the scene of the accident.

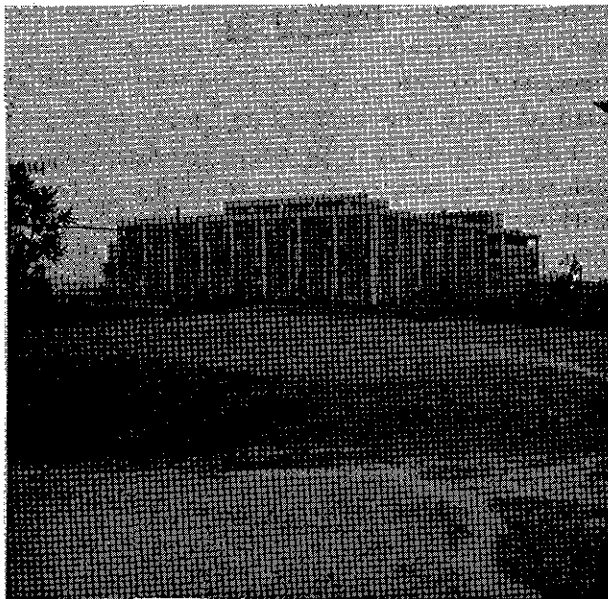
Figure 6.—Parking lot area adjacent to Sixth Street Yard and point of accident.

“C” Street, S.W. and Sixth Street, S.W. The parking lot can be entered from either “C” Street or Sixth Street. The lot is unfenced at the street and there is no fence between the lot and the railroad tracks. Figure 6 shows the parking

lot area There are no barriers nor impediment to ready access Neither are there any prominent warning signs indicating a hazardous area because of train traffic and/or high voltage Small stencilled "NO TRESPASSING" lettering 2½ inches high was found on two catenary poles designated CP-F 137.06, and CP-F 137.12 The stencilling is about 5½ feet above ground level. (See Figures 7 and 8.)

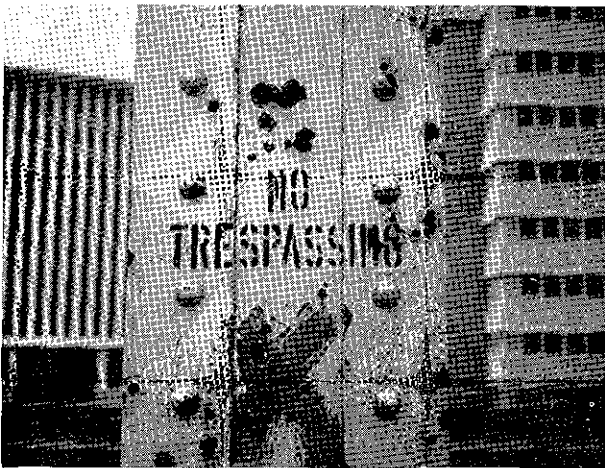
Figure 7 —Catenary Pole CP-F-137 06, 171 feet north of scene of accident Lettering is 5½ feet above top of ground

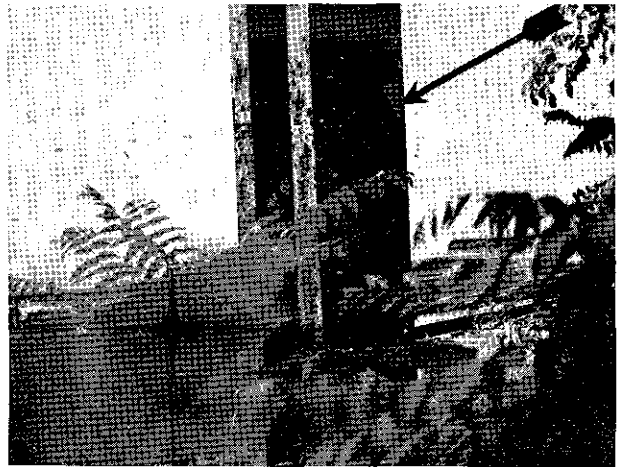
Figure 8.—Catenary Pole CP-F-137.12, 146 feet south of scene of accident.

CP-F 137 12, is not visible from any approach through the parking lot. The boldness of the letters and the contrast of the background have deteriorated substantially, making the sign less conspicuous. In the immediate foreground of the sign is a prolific growth of trees and bushes, and the foliage effectively blocks the sign to view from any point in the area. In order to see the sign one must deliberately and with some effort climb the embankment so he is immediately in front of the pole where the sign is stencilled. It is totally ineffective and serves no purpose in warning would-be trespassers.

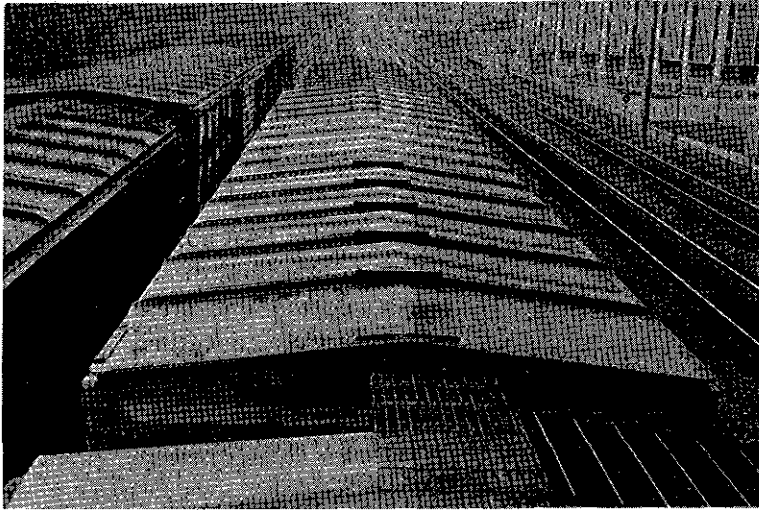
**Figure 9.—Cars on Barber Siding from which the youth jumped to cars on No. 4 track.**

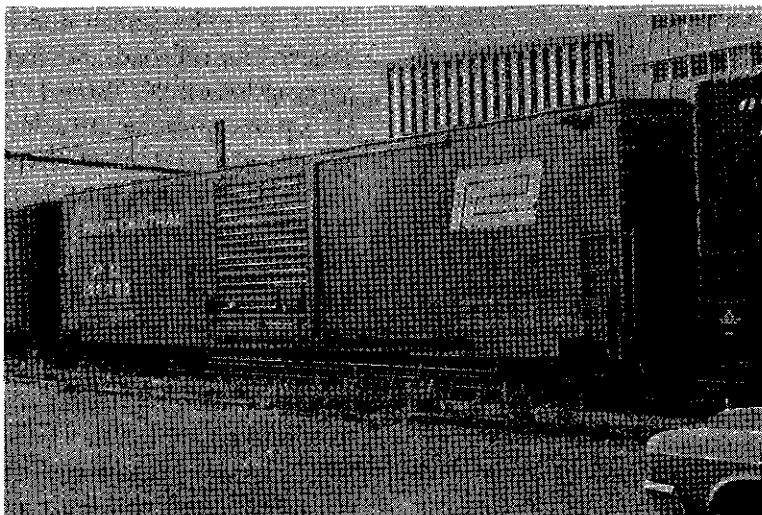
**Figure 10.—Foreshortened ladder on PC 162550 as required by FRA Docket 34468**

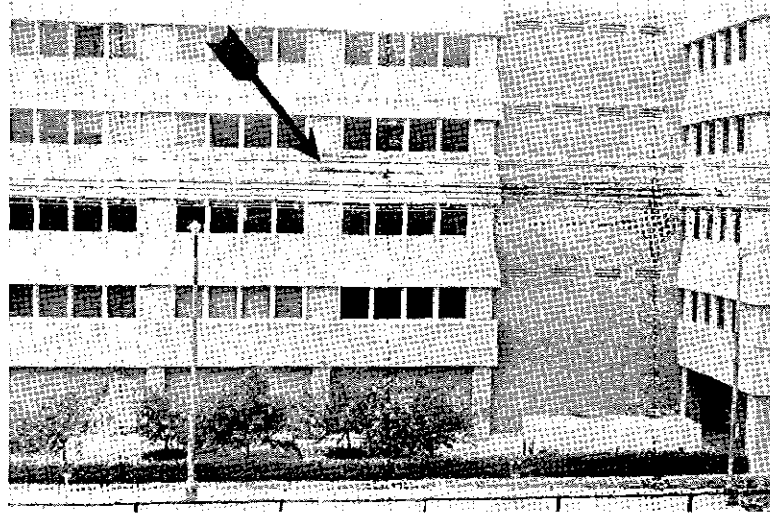
Figure 11 —Burn marks on catenary trolley where the youth contacted the wire

A burn mark was evident on the trolley wire 1 foot 9½ inches from the south end of the car. The burn marks on the car spread from the center of the car westerly to the edge of the roof indicating where the youth was at the instant of contact, and where his body

landed. Figure 11 shows the burn marks on the trolley wire, and Figure 12 shows burn marks on the car.

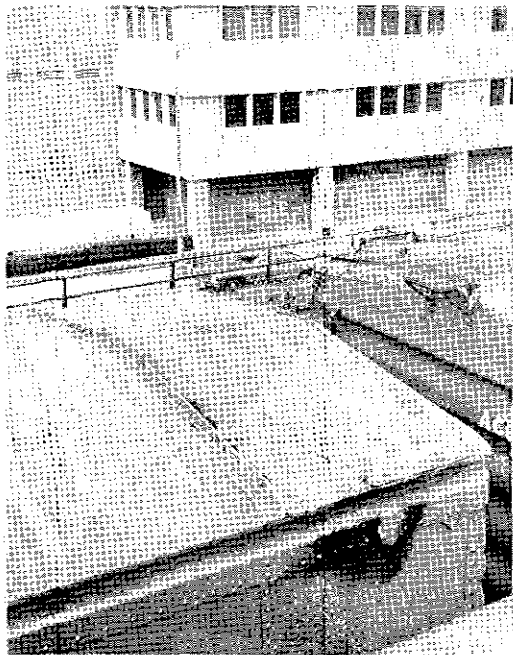
Figure 12 —Burn marks on PC 162550 where the body of the youth landed.

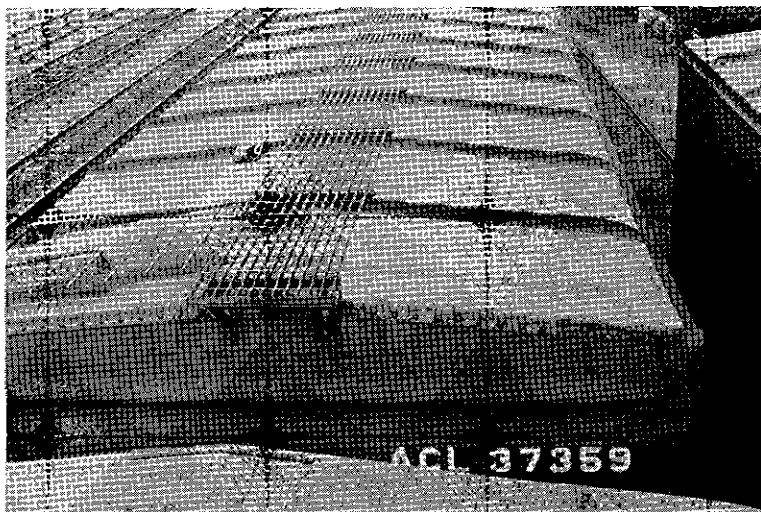
Burn marks were found on the trolley wire 2 feet 8 inches from the north end of ACL 37359. Burn marks were also found on the running board of ACL 37359 immediately under the burn marks on the catenary trolley. This particular burn mark does not show in Figure 11 but it would have been the position of the sergeant when he made electrical contact. Figure

Figure 13.—Burn marks on ACL 37359 caused by the police officer at the time of contact with trolley wire. Note his cap.

13 shows burn marks on ACL 37359 made by the police officer. Figure 14 is an overall general view of the accident area.

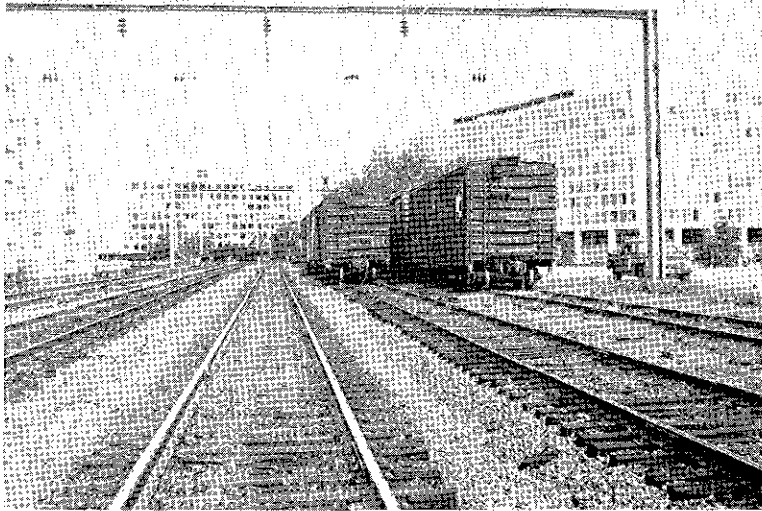
**Figure 14** —General view of the accident area and the catenary propulsion system. CP-F-137 06 is in the right foreground.
