INTERSTATE COMMERCE COMMISSION

Ex Parte No. 173

ACCIDENT AT WOODBRIDGE, N. J.

Accident at Woodbridge, N. J., on February 6, 1951, caused by excessive speed on a curve of a temporary track.

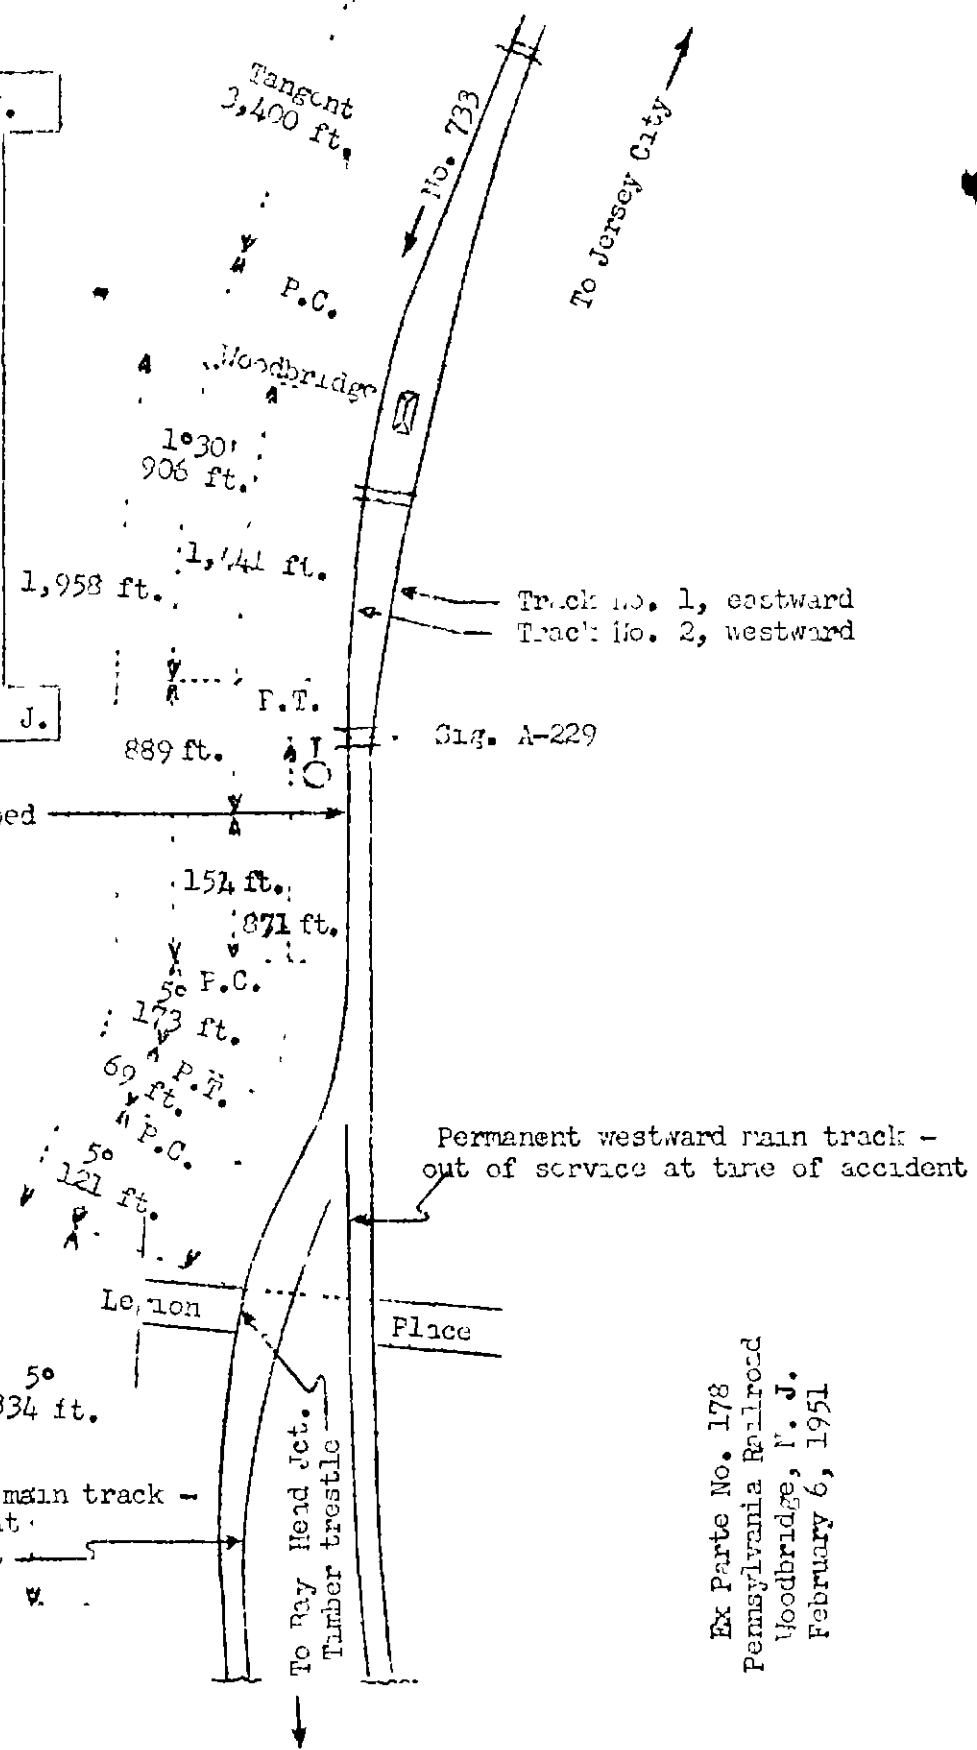
East end of temporary roadbed (2,767 ft.) westward

Temporary eastward main track - not in service at time of accident
