RAILROAD ACCIDENT INVESTIGATION

Report No 4118

THE PENNSYLVANIA RAILROAD COMPANY

JUNE 9, 1967

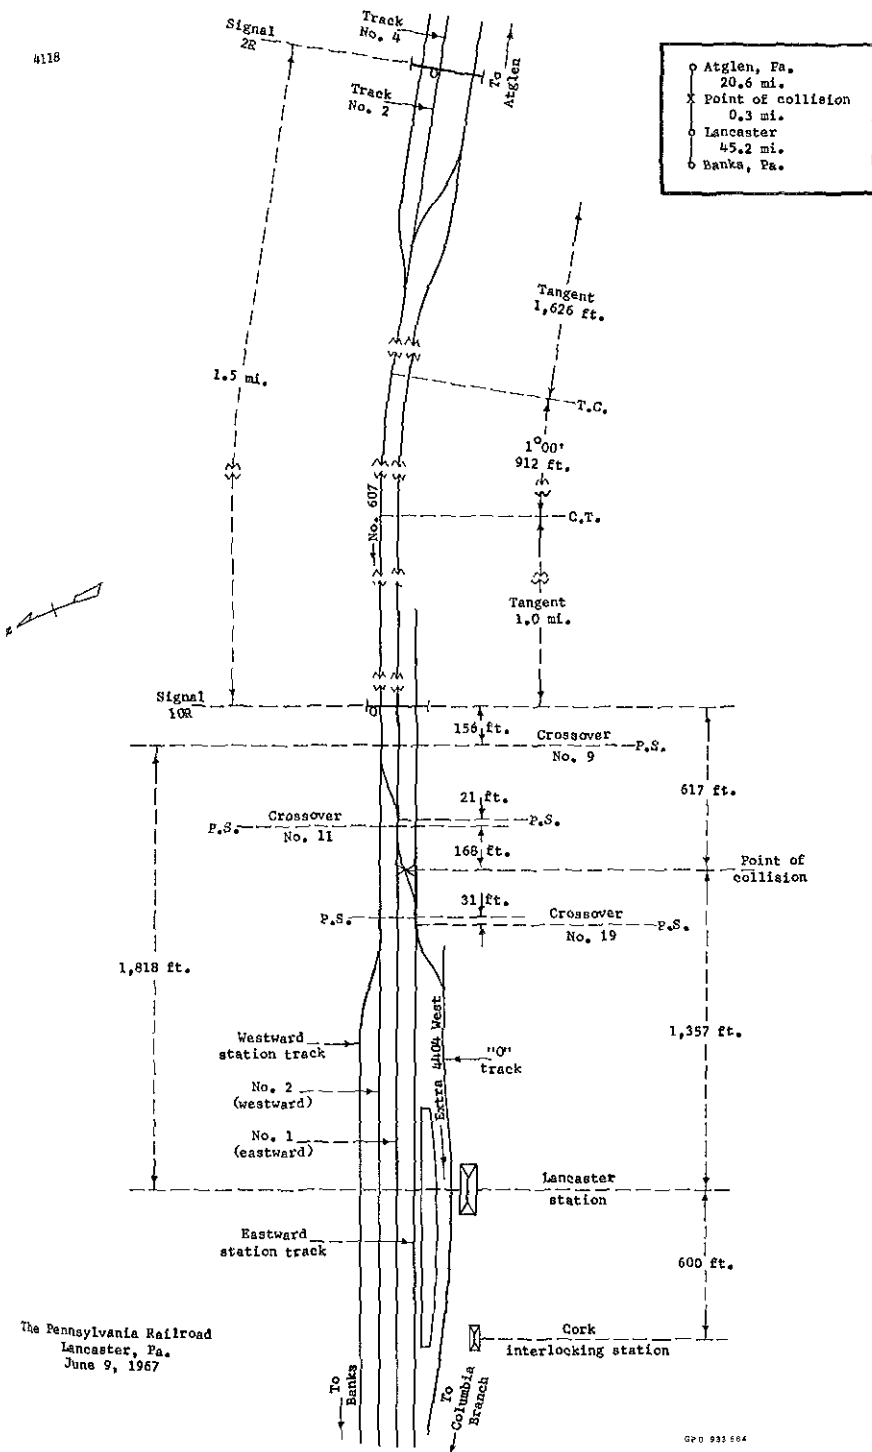
The Pennsylvania Railroad
 Lancaster, Pa.
 June 9, 1967

The collision occurred on crossover No. 11, within Cork interlocking limits, 168 feet west of the east switch of crossover No. 11 and 1,357 feet east of the Lancaster station.

- Atglen, Pa. 20.6 mi.
- X Point of collision 0.3 mi.
- Lancaster 45.2 mi.
- Banks, Pa.
