RAILROAD ACCIDENT INVESTIGATION

Report No 4112

THE PENNSYLVANIA RAILROAD COMPANY

OCTOBER 26, 1966

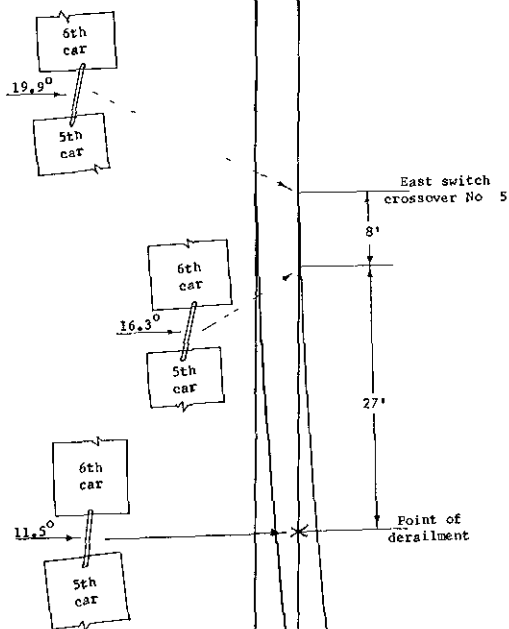
coupler angle between long piggyback flat cars moving westward over the crossovers is considerably in excess of the specified 13-degree angle, at the switch of the east turnout of crossover No. 5 and throughout most of the distance between that switch and the derailment point. (See print attached to this report). This condition evidently resulted in considerable increase in the lateral force transmitted to the rear truck of the 5th car of Extra 6120 West as it moved on the east turnout of crossover No. 5. The increased lateral force transmitted to the rear truck of the 5th car combined with the force being transmitted to that car from the accumulated weight of the buffing action of the cars to the rear, while moving on the 0.83 percent descending grade, evidently was sufficient to cause the wheels of the rear truck of the 5th car to raise from the rails of the east turnout of crossover No. 5 and to derail, resulting in the general derailment.

Approximate coupler angles at rear of 5th car,
at various locations on crossover No. 5
