RAILROAD ACCIDENT INVESTIGATION

REPORT NO. 4129

THE PENNSYLVANIA RAILROAD COMPANY

AUGUST 4, 1967

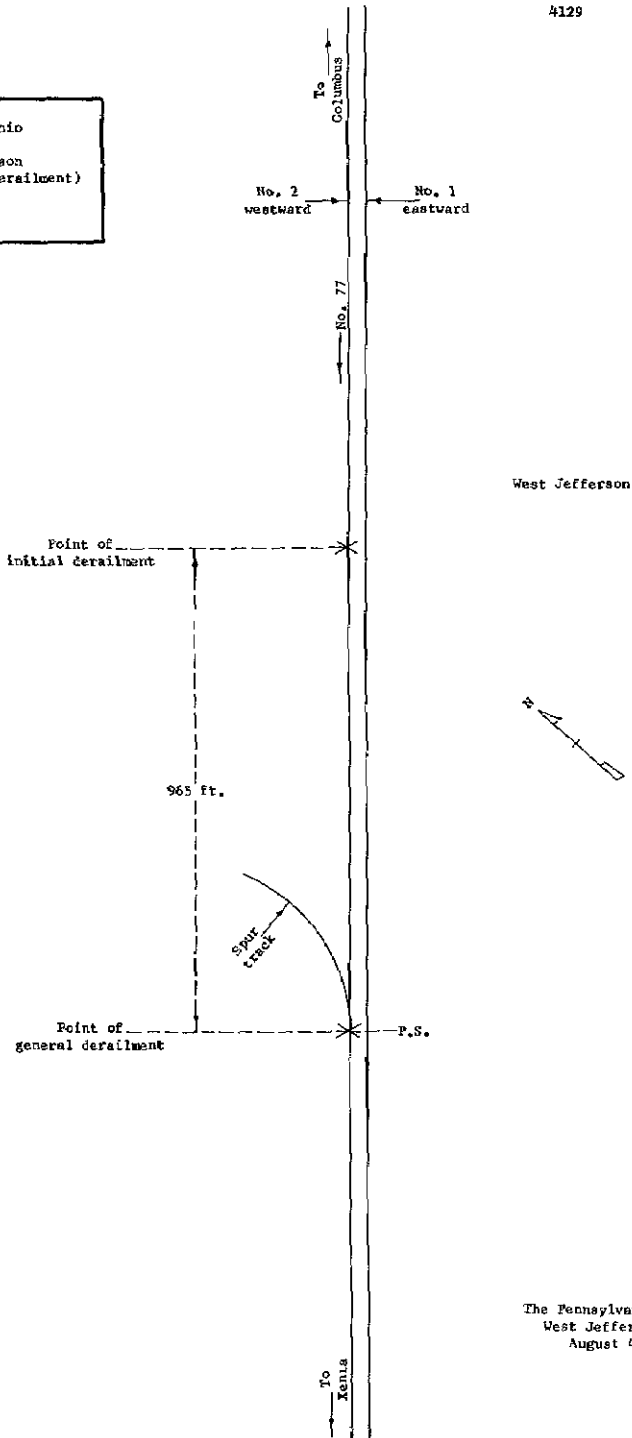
The Pennsylvania Railroad
 West Jefferson, Ohio
 August 4, 1967

The initial derailment occurred on track No. 2, 965 feet east of the spur-track switch at West Jefferson. The general derailment occurred at the spur-track switch

The first mark of derailment was a wheel mark on the top of a rail anchor on the gage side of the north rail, 965 feet east of the spur-track switch. It indicated that a pair of wheels, apparently the front wheels of the rear truck of the 6th car, had derailed to the south at this point. Two and one-half feet west of the initial derailment point, a flange mark appeared on a tie plate on the field side of the south rail. Two and one-half feet farther westward, a pair of wheel marks appeared on the tops of the ties, 7 inches from the gage side of the north rail and 4 inches from the field side of the south rail. These marks extended westward on the ties to the frog of the spur-track turnout. Scrape marks appeared on the south side of the frog and curved closure rail. They extended westward on the curved closure rail to a point two feet east of the heel of the switch, indicating that the derailed pair of wheels had been diverted southward at the frog, causing the general derailment. Westward from the spur-track switch, the structure of track No. 2 was destroyed for a distance of 840 feet
