INVESTIGATION NO. 3090  
THE PENNSYLVANIA RAILROAD COMPANY  
REPORT IN RE ACCIDENT  
AT ALBION, PA., ON  
MARCH 31, 1947

Railroad: Pennsylvania  
Date: March 31, 1947  
Location: Albion, Pa.  
Kind of accident: Side collision  
Trains involved: Freight : Freight  
Train numbers: Extra 9724 East : Extra 9709 West  
Engine numbers: 9724 : 9709  
Consists: 47 cars, cabooses : 17 cars, cabooses  
Estimated speeds: 5 m. p. h. : 10 m. p. h.  
Operation: Timetable, train orders and  
manual-block system  
Track: Single; tangent; 0.6 percent  
descending grade westward  
Weather: Clear  
Time: 4:30 a. m.  
Casualties: 4 injured  
Cause: Failure properly to control  
speed of train in accordance  
with manual-block authority  
and approaching meeting point

Accident at Albion, Pa., on March 31, 1947, caused by  
failure properly to control speed of train in  
accordance with manual-block authority and  
approaching a meeting point.

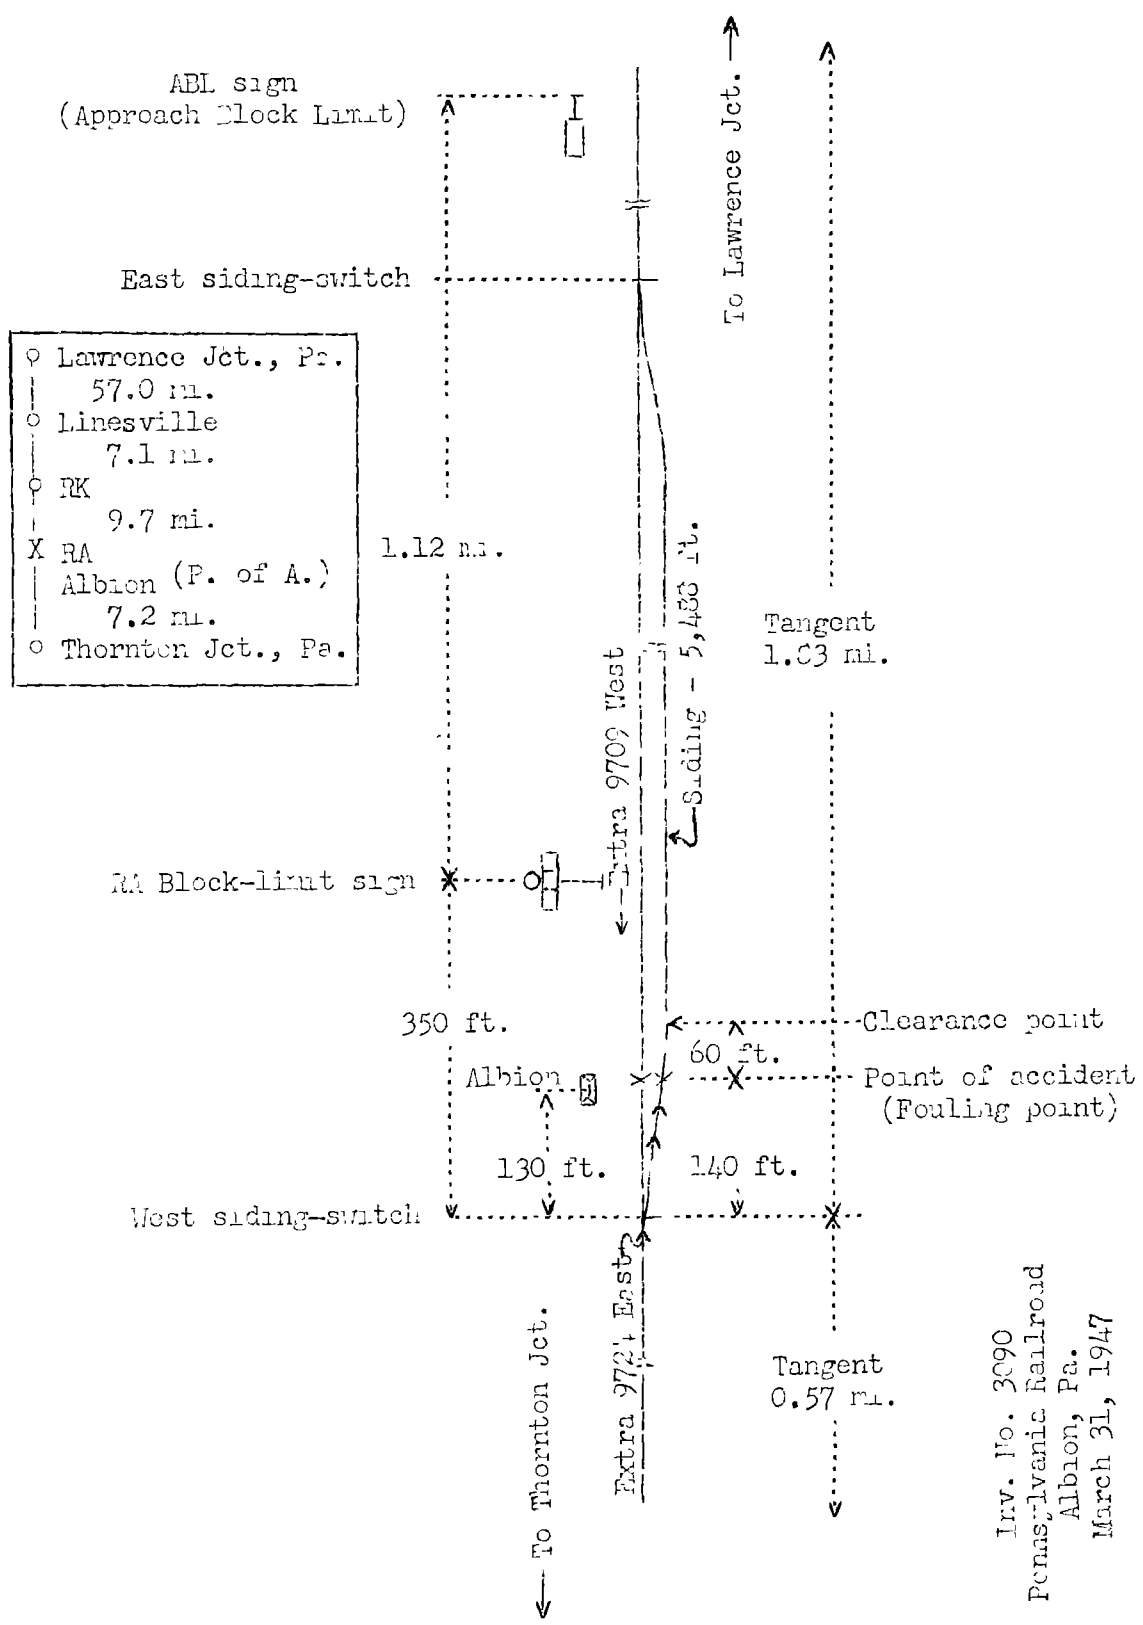
Inv. No. 3090  
 Pennsylvanic Railroad  
 Albion, Pa.  
 March 31, 1947

and a caboose, departed from Linesville, the last open office, at 3:45 a. m., passed the approach block-limit sign east of Albion, passed the block-limit sign at Albion, where it was required to wait until Extra 9724 East had been met and until manual-block authority to proceed was received, and while moving at an estimated speed of 10 miles per hour it struck Extra 9724 East at the fouling point of the main track and the west siding-switch and 210 feet west of the block-limit sign.

The crews of both trains held copies of train order No. 6, which established Albion as the meeting point between Extra 9724 East and Extra 9709 West, and the order included the instruction for Extra 9724 East to take siding at the meeting point. Under the rules, Extra 9709 West was required to stop clear of the block-limit sign, located 350 feet east of the west siding-switch, until Extra 9724 East had been met and manual-block authority to proceed was received. As Extra 9724 East was entering the siding at the west switch, Extra 9709 West passed the block-limit sign and struck the twentieth car of Extra 9724 East at the fouling point of the turnout.
