## INTERSTATE COMMERCE COMMISSION

REPORT OF THE DIRECTOR OF THE BUREAU OF SAFETY CONCERNING  
AN ACCIDENT ON THE PENNSYLVANIA RAILROAD AT ALTOONA, PA.,  
ON JULY 30, 1933.

December 5, 1933.

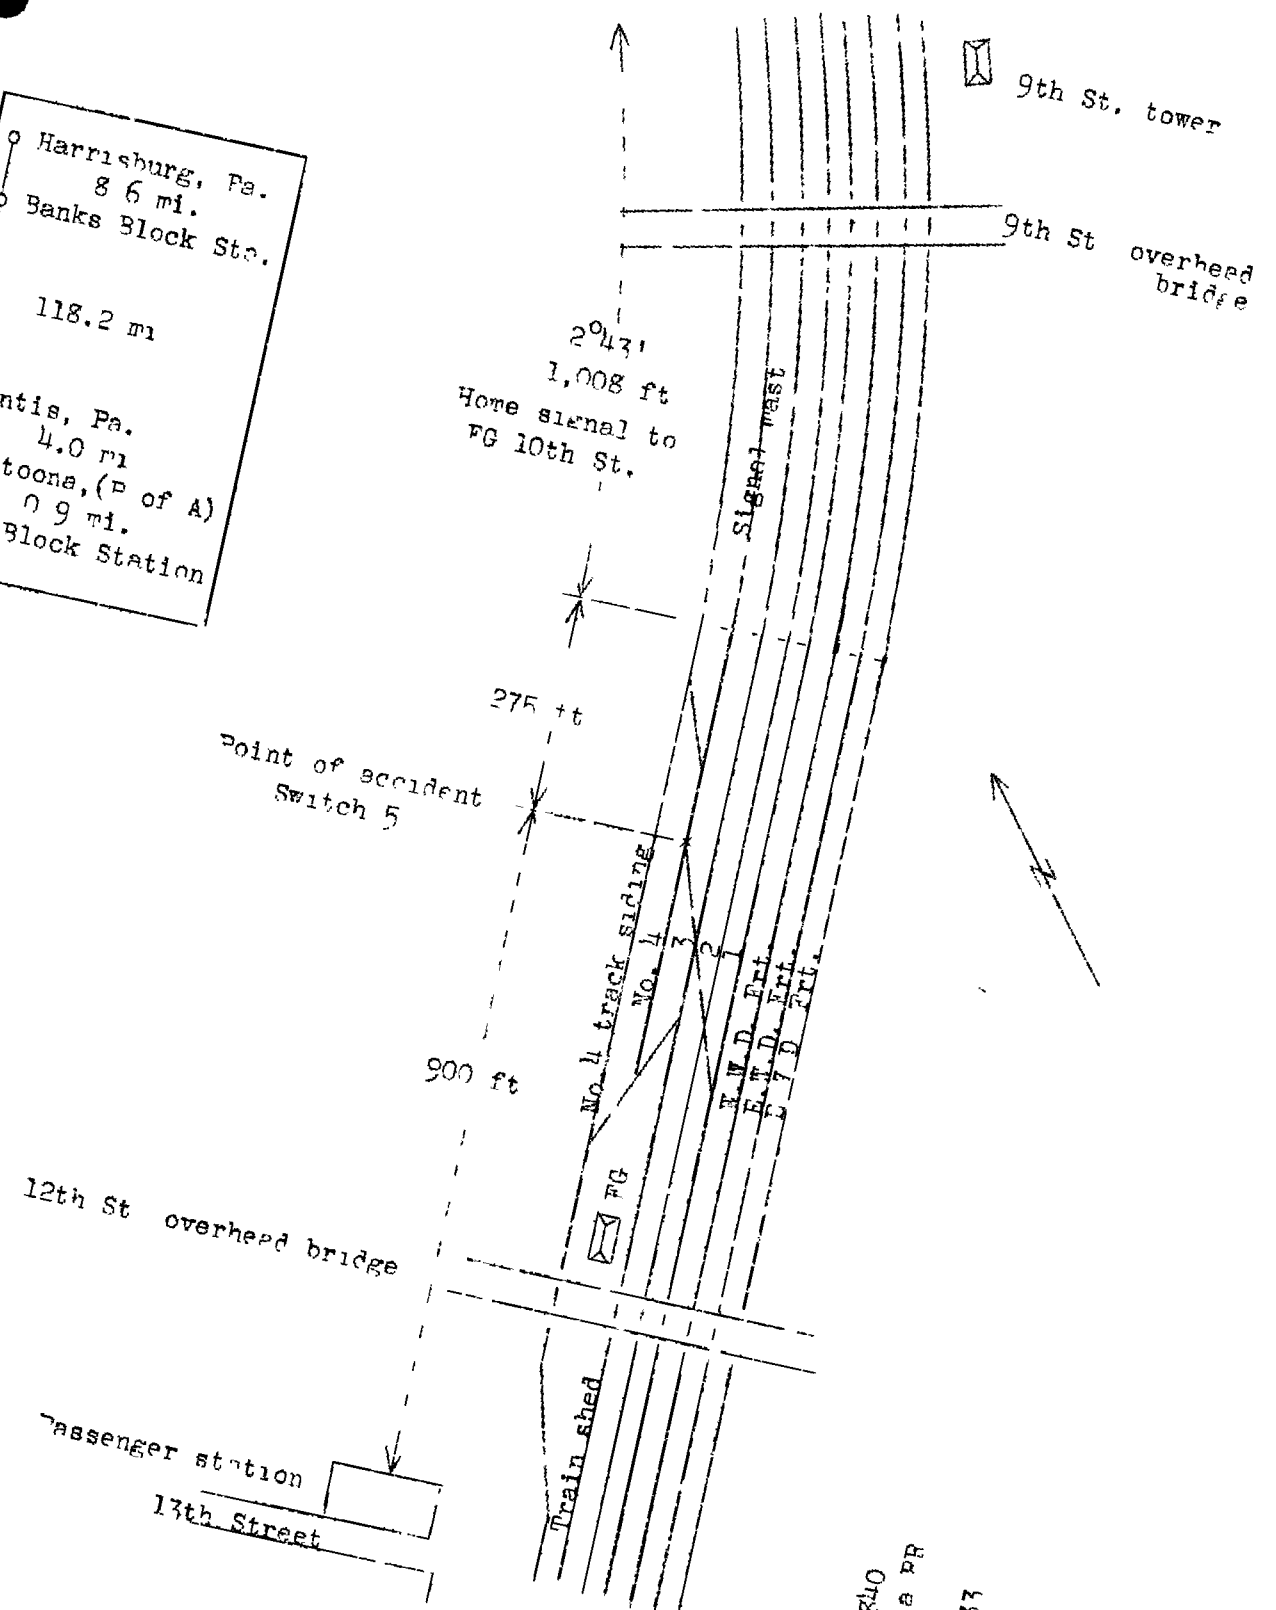
Inv. No. 1840  
 Pennsylvania RR  
 Altoona, Pa  
 July 10, 1933

FG Tower is located between tracks 4 and 3, just east of the 12th Street bridge. The home signal governing the movement of west-bound trains through FG interlocking is located on a signal mast on the north side of track 4, at 10th Street, about 850 feet east of FG tower; it is a position-light signal giving three indications, stop, stop and proceed expecting to find the block occupied, and proceed; the indications of this signal do not give an approaching train information as to which of the station tracks it is to occupy. The switches in this vicinity are controlled and operated electro-pneumatically from FG Tower, and train movements are required to be made under control and at a speed not exceeding 12 miles per hour. At the time of the accident the route was lined for a movement from track 4 through cross-over switch 5 and then through two double-slip switches across tracks 3 and 2 to track 1 and thence
