INVESTIGATION NO. 2489
THE PENNSYLVANIA RAILROAD COMPANY
REPORT IN RE ACCIDENT
NEAR BADEN, PA., ON
MARCH 16, 1941

Railroad:	Pennsylvania
Date:	March 16, 1941
Location:	Baden, Pa.
Kind of accident:	Derailment
Train involved:	Passenger
Train number:	316
Engine number:	3773
Consist:	5 cars
Speed:	60-70 m. p. h.
Operation:	Automatic block-signal system
Track:	Four; tangent; level
Weather:	Snow and strong wind
Time:	9:03 p. m.
Casualties:	5 killed; 121 injured
Cause:	Accident caused by malicious tampering with track.

Accident near Baden, Pa., on March 16, 1941, caused by malicious tampering with track.

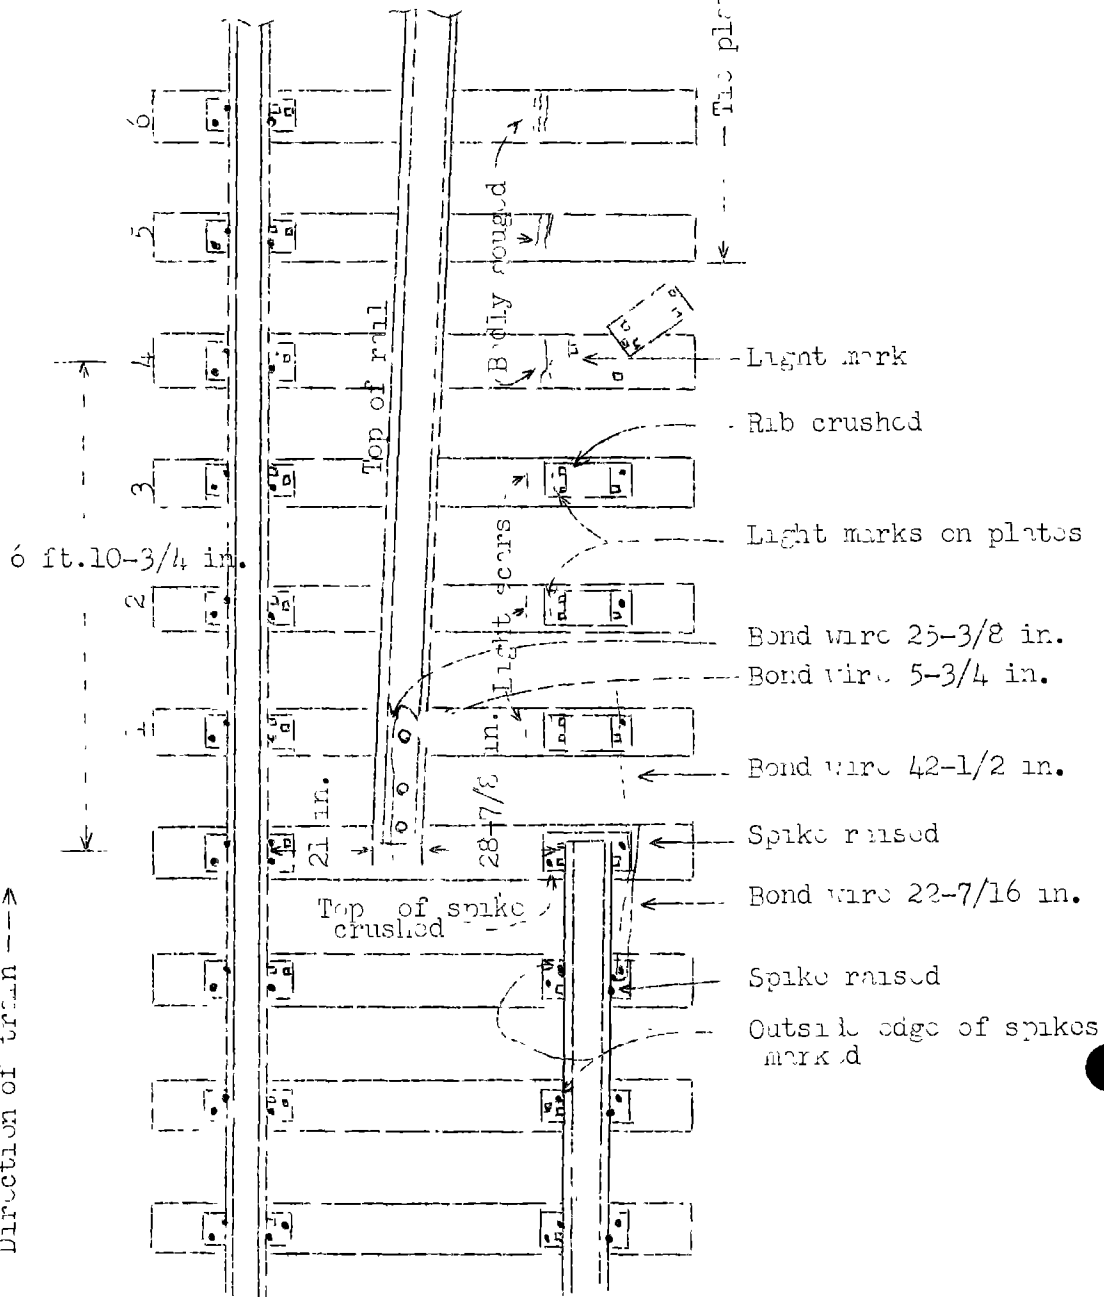
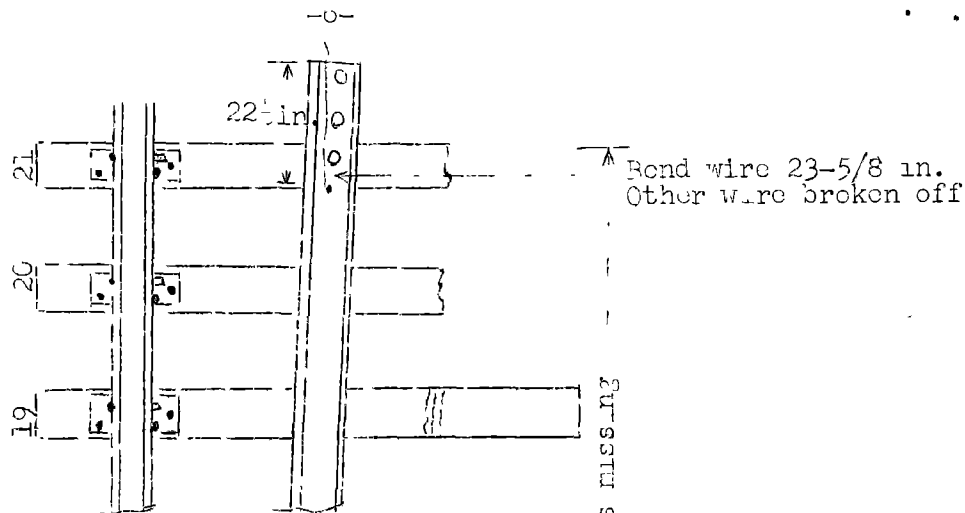
Sketch of track as found after accident occurred.

disclosed that the west and east ends of the rail were, respectively, 28-7/8 inches and 23 inches inward from the gage side at their original locations. Starting on tie No. 4, there were deep flange marks on the top of the south ends of the remaining ties of the panel from which the rail had been removed. These marks progressively increased toward the east until the more easterly ties were badly splintered. The south ends of the ninth, twelfth, thirteenth, twentieth, and twenty-first ties were broken off. The two rails immediately east of the rail involved, remaining connected, were found in the second car. The receiving end of the rail adjacent to the east end of the misplaced rail was formed into a blunt wedge-shaped, because of having been struck heavy blows by wheels. There were light marks on the heads of the rail-holding spikes on the gage side of the leaving end of the rail west of the misplaced rail. The inside plate-holding spike at the joint was crushed. There also were light marks on the tieplates that remained on the ties and that were spiked on the outside; the rib on the third tieplate was crushed. The north rail just west of the point of derailment remained secure on its ties but was shifted to the north slightly as a result of wedging action as various units of equipment became derailed. East of the misplaced rail the engine apparently straddled the south rail, which acted as a guard rail, and the engine proceeded on the roadbed to the point where it overturned. Later, 26 track spikes, 3 six-hole angle bars, 3 tieplates, 3 bolts, 1 nut, 2 lock-nut washers, 2 wrenches and 1 claw bar were found scattered down the bank opposite the misplaced rail within an area of 47.5 feet along track No. 1 and 55 feet to the edge of the river. One wrench, which was provided with a pipe-extension handle, was found opposite the west end of the rail at the edge of the water, but the jaws were too small to fit the nuts of the angle-bar bolts in use. The other wrench was found in the water opposite the east end of the rail, and was of the proper size to fit a 1-7/8-inch nut; it was a standard P. R. R. tool bearing the inspection mark of the P. R. R. A nut, a bolt and a spike also were found in the water. The claw bar, which had a distinctive Pennsylvania Railroad feature, a crinkle in the handle, was found opposite the east end of the rail at the edge of the water; however, it did not have the Pennsylvania Railroad inspection mark and the chisel end was not of standard dimensions. The claw end had been reformed some time after it was manufactured but a die had not been used in accordance with the company's requirement, as the jaws were irregularly spaced. Examination of two angle bars found opposite the west end of the rail disclosed that the bolts had been removed by means of a wrench. There were gouges on the sides of the bars cut by lock-nut washers when they were forced backward as the nuts were being removed. No broken or sheared nuts and bolts were found. It was his opinion that the bolts had been unscrewed by one inexperienced in track work. The spikes indicated that

Soon after the accident occurred, several railroad officials and employees and some officers of the State of Pennsylvania found one of the south rails lying near the center of the track. The first mark of derailment, a flange mark on a rib of the third tieplate east of the west end of the misplaced rail, indicated that this rail had been removed before No. 316 was derailed. All rail-holding spikes, the two pairs of angle bars, the angle-bar bolts and the nuts were missing, but later most of these were found scattered on the embankment between track No. 1 and the river. The angle bars were undamaged; however, they bore marks which were apparently made by the lock-nut washers turning when the nuts were being removed from the bolts. The condition of the bolts indicated that the nuts had been removed by a wrench. The spikes were practically straight. The spike-holes and marks on the lower surfaces of the heads of the spikes indicated that the spikes had been removed by means of a claw bar. Two track wrenches and a claw bar were found near the edge of the river. One of the wrenches would fit the nuts of the bolts, and the claw bar bore indications of recent use. This evidence is conclusive that some time before No. 316 was derailed the rail involved was loosened and shifted inward from its normal position. The exact time the rail was shifted is not known. When the track was last patrolled, about 30 hours prior to the time of the derailment, no abnormal condition was observed. The last train prior to No. 316 passed the point involved about 18 minutes before the accident occurred and the crew did not observe any abnormal condition; however, a fireman on this train saw two men standing nearby and a batter mark on the receiving end of the misplaced rail indicated that part of the

The evidence indicates that the conductor cables at the ends of the displaced rail were not broken when the rail was moved toward the center of the track. The investigation disclosed that the conductor cables used as rail bonds on this line permit a rail to be moved laterally as much as 18 inches without interference with the electrical connections. Rail-bond connections can be arranged so as to restrict to a considerable extent the possible lateral displacement of a rail without interference with the normal operation of the signal system, and such an arrangement would render it somewhat more difficult to set up a defective condition in the track without causing the display of restrictive signal indications.
