REPORT OF THE DIRECTOR OF THE BUREAU OF SAFETY CONCERNING AN
ACCIDENT ON THE PENNSYLVANIA RAILROAD AT BALTIMORE, MD.,
ON JULY 25, 1933.

November 29, 1933.

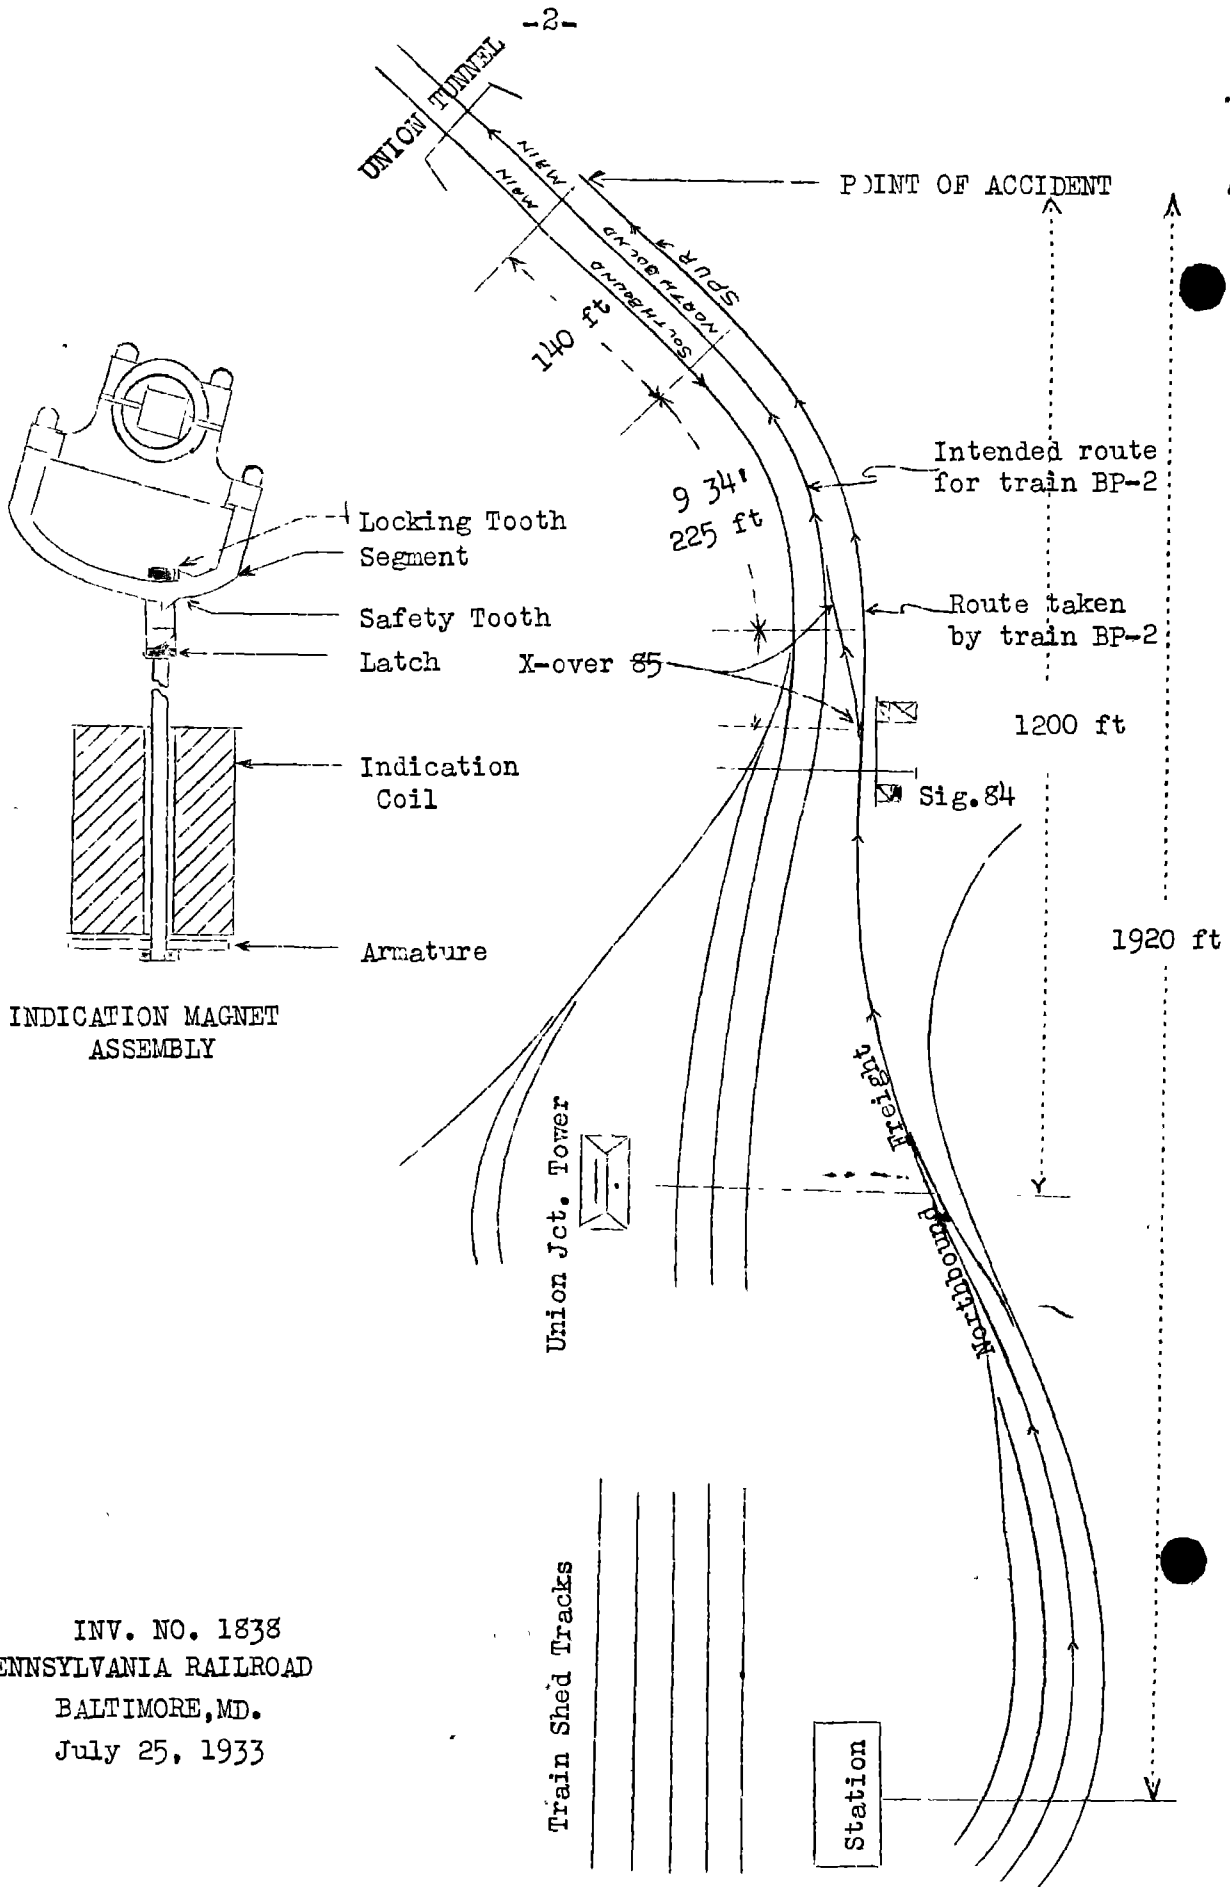
INV. NO. 1838
 PENNSYLVANIA RAILROAD
 BALTIMORE, MD.
 July 25, 1933

This accident occurred in the Baltimore Terminal at a point about 1,920 feet north of the passenger station, within the limits of Union Junction interlocking plant and about 1,200 feet north of the tower. Approaching Baltimore Terminal from the south on the Baltimore Division there are two main tracks through B. & P. tunnel which merge with two main tracks from the west at the north portal of the tunnel and from that point northward there are numerous tracks through the terminal. The passenger tracks pass directly through the train shed and the freight tracks take diverging routes around both sides of the passenger station, while north of the station all tracks again converge into two main tracks leading to Union Tunnel. Baltimore Terminal territory from the north portal of B. & P. Tunnel to the south portal of Union Tunnel is protected by two electro-pneumatic interlocking plants and train movements are governed by electro-pneumatic semi-automatic signals operated from interlocking machines at B. & P. Junction on the south end, and Union Junction on the north end, with a form of traffic locking between the two interlocking plants on all through tracks. All tracks between the two interlockings are signalled for traffic in both directions and the cooperation of the signal-men-operators in both towers is required in order to change the direction of movement. The north-bound freight track branches off from the main track to the right near B. & P. tower; the track then consists of a series of short tangents and curves varying from $9^{\circ} 30'$ to $13^{\circ} 40'$, followed by tangent track 110 feet in length to a no. 15 crossover where the track again merges with the north-bound main track. A spur track, 480 feet in length, leads off to the right at the south end of this crossover, parallels the main track and ends at a point about 80 feet from the embankment at the south portal of Union Tunnel. The spur track is tangent for a distance of 115 feet, followed by a $9^{\circ} 34'$ curve to the left 225 feet in length, and 140 feet of tangent track. The accident occurred at the north end of this spur track, the grade for north-bound trains being slightly descending.
