## INTERSTATE COMMERCE COMMISSION

REPORT OF THE DIRECTOR OF THE BUREAU OF SAFETY CONCERNING  
AN ACCIDENT ON THE PENNSYLVANIA RAILROAD NEAR BLAIRSVILLE,  
PA., ON JANUARY 18, 1933.

March 14, 1933.

Inv. No. 1806  
 Pennsylvania Railroad  
 Blairsville, Pa.  
 January 18, 1933

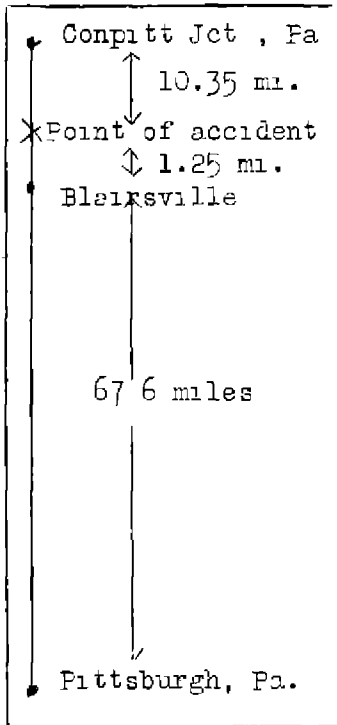
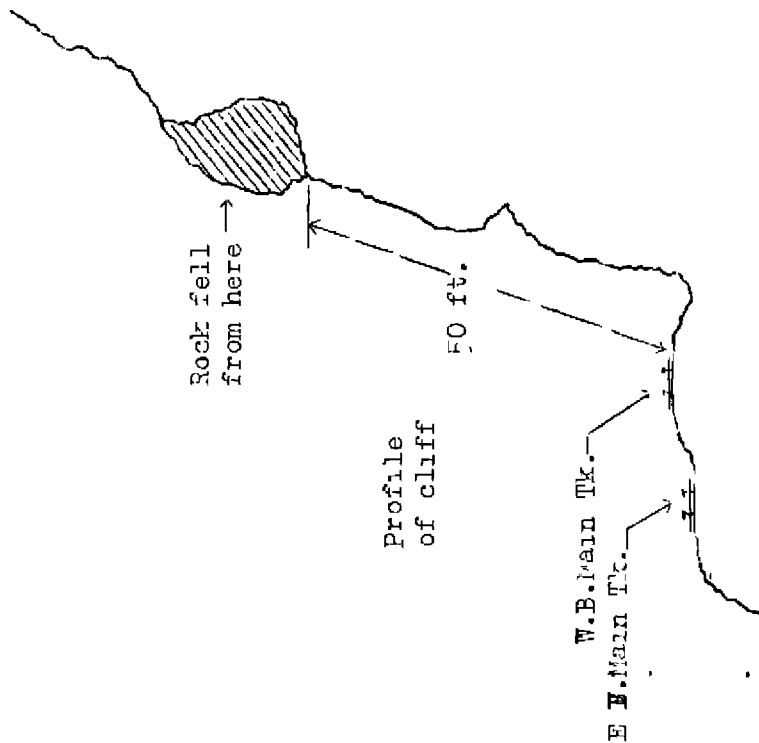
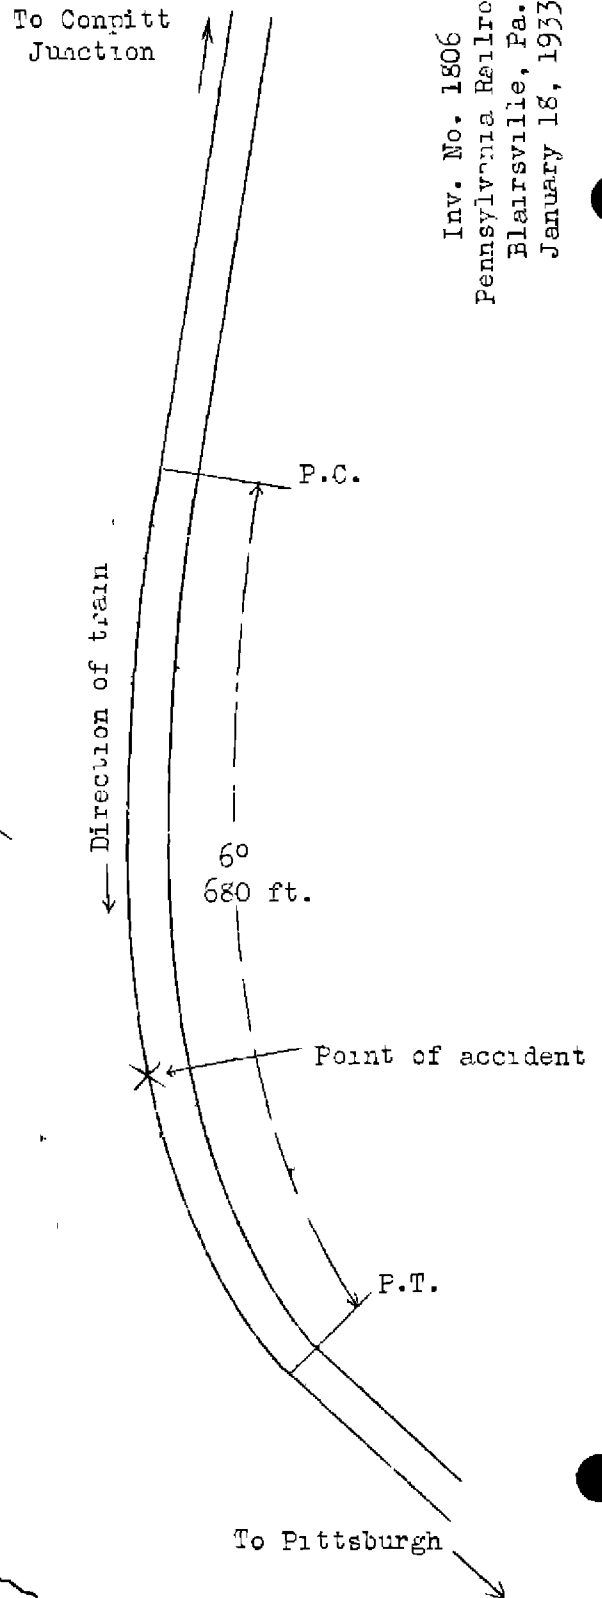
When examined after the accident by the Commission's inspectors, the rock which had fallen from the cliff was in two pieces, one measured roughly 14 by 12 by 4 feet and weighed about 30 tons, and the other measured about 12 by 9 by 4 feet and weighed about 28 tons. It appeared as though the rock had been separated from the rest of the stratum for some time, as the parts which were imbedded in the bank showed a general condition of erosion, indicating that water and dirt had been passing through the crevices. Disintegration of the supporting layer of shale under the limestone upon which the rock rested, as a result of erosion, apparently caused the rock to become dislodged.

This accident was caused by a large rock having fallen from the side of a cliff, fouling the track.

The rock became dislodged from the cliff at a point about 50 feet above the track and fouled the westbound track, where it was struck by the train involved. Subsequent investigation indicated that gradual erosion, probably extending over a considerable period of time, finally resulted in so weakening its support as to permit it to break loose from its resting place in the side of the cliff.
