ACCIDENT ON THE  
PENNSYLVANIA RAILROAD

BLAIRSVILLE, PA.

MARCH 6, 1937

INVESTIGATION NO. 2156

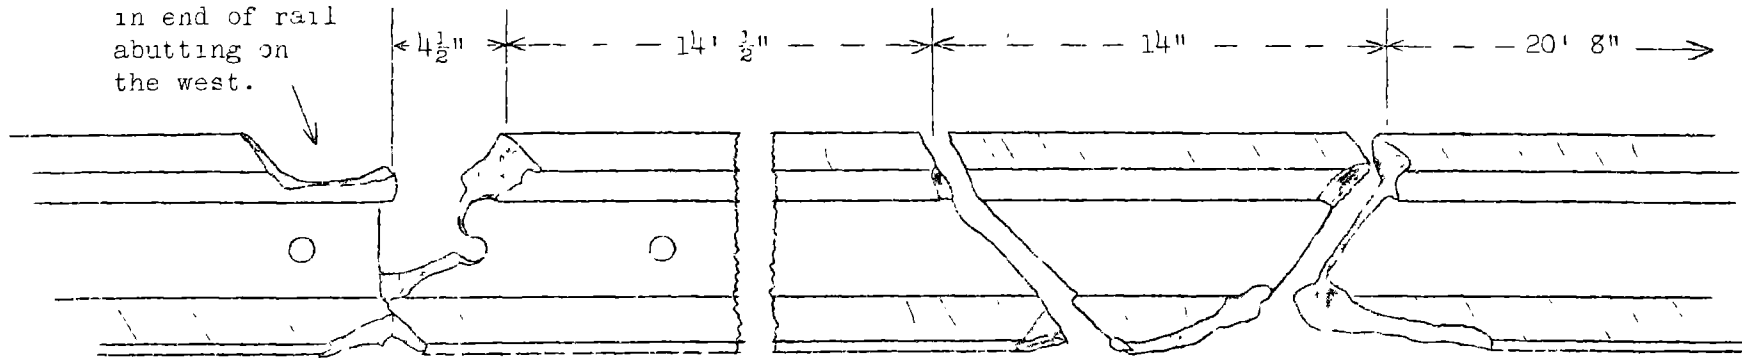
Showing break  
in end of rail  
abutting on  
the west.

of the accident, one of these rails had a triangular shaped piece broken out of the end and extending through the bolt hole. The similarity between this fracture and those found in other rails a short distance to the east within recent months strongly indicates the possibility of a broken rail being the cause of the accident. The statement of Head Brakeman Muirhead, who was in the shelter cabin on the tender of the leading engine, was to the effect that he heard a very pronounced snap beneath the engine, and almost immediately the tender became derailed toward the right and ran for a distance of 5 or 6 car lengths before the engine stopped. The estimated distance the engine traveled after the derailment occurred was corroborated by Engineman Stauffer. The broken rail was later placed in its approximate former location which was at a point 241 feet east of the forward end of the leading engine and close to, if not at, the actual point of derailment. A close inspection was made for flange marks, or other distinctive markings on the ball of this rail, but none was found. This would indicate that after the wheels of the leading engine had passed over the initial point of derailment the eastern section of the rail, which may or may not have been previously broken, overturned or was pushed outward sufficiently to allow the wheels to pass through the opening to the outside of the rail. Whether or not the rail overturned, separated, or broke, is a matter of conjecture. As this rail was turned and re-laid on this curve in 1930 or 1931 and had  $1 \frac{5}{8}$  inches flange wear, this left the rail greatly weakened, and it appears probable that the lateral thrust of two heavy locomotives moving on the  $7^{\circ} 10'$  curve at a speed of 30 or 35 miles per hour, resulted in the failure of this rail.

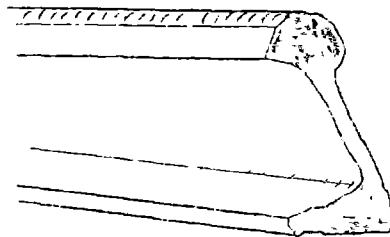
Showing worn  
condition of  
rail head;  
flange wear,  $1\frac{5}{8}''$ .
