INTERSTATE COMMERCE COMMISSION

REPORT OF THE DIRECTOR OF THE BUREAU OF SAFETY IN RE
INVESTIGATION OF AN ACCIDENT WHICH OCCURRED ON
THE PENNSYLVANIA RAILROAD AT BRISTOL, PA., ON
MARCH 13, 1931

April 17, 1931.

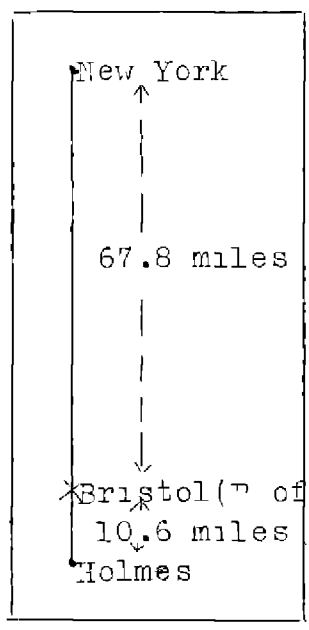
Inv. No. 1696
Pennsylvania R.R.
Bristol, Pa.
March 10, 1931.

* Final point of
derailment

* Initial point of
derailment

The first mark of derailment was a flange mark on a bolt in the first rail joint east of the broken rail, on the gauge side or the low rail, this being on the opposite side of the track from the broken rail and 19 feet east thereof. From this point eastward, the marks on the ties on the left side varied between the north rail and the center of the track, apparently caused by the wheel flanges of a derailed truck, and the guard rails at the railroad bridges over the various streets in Bristol pulled the track back towards the north rail.
