INTERSTATE COMMERCE COMMISSION

REPORT OF THE DIRECTOR OF THE BUREAU OF SAFETY CONCERNING AN
ACCIDENT ON THE PENNSYLVANIA RAILROAD AT CLY, PA., ON
SEPTEMBER 29, 1934.

November 21, 1934.

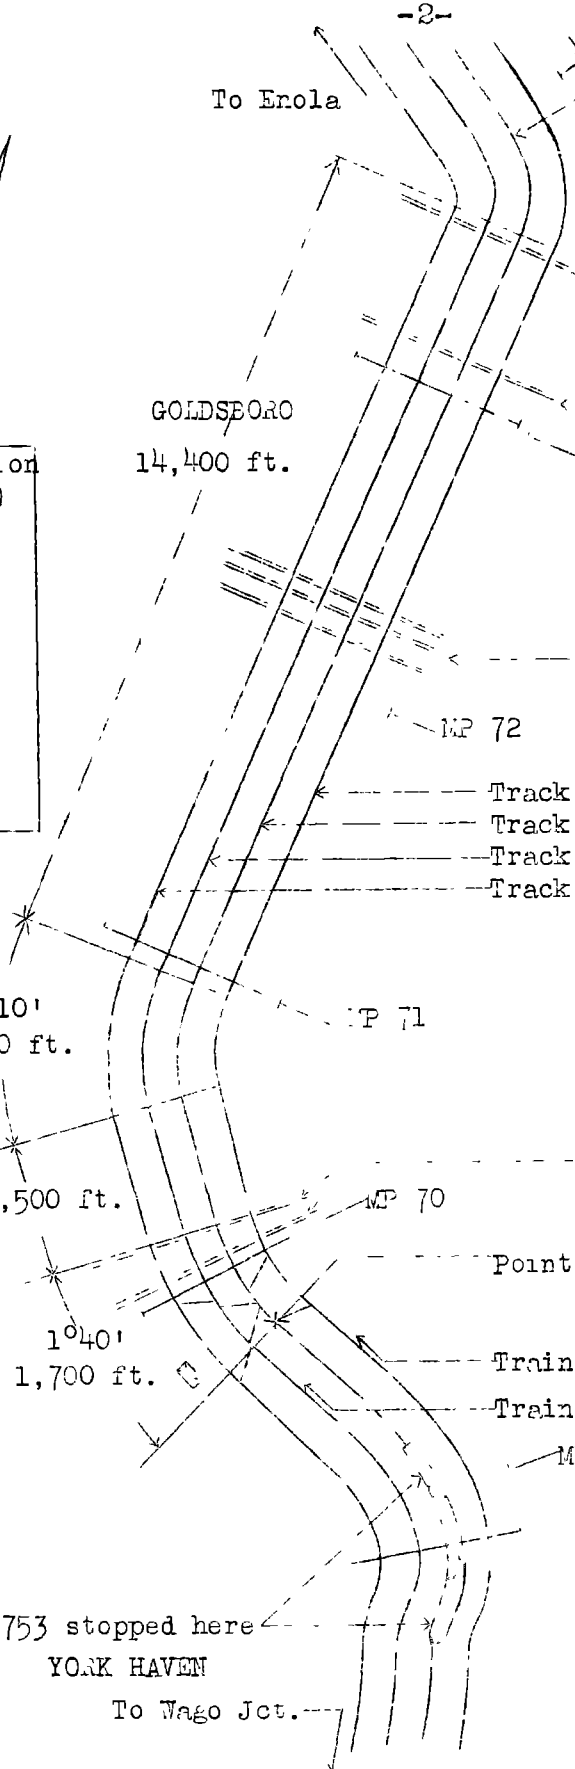
Inv. No. 1935
Pennsylvania Railroad
Cly, Pa.
Sept. 29, 1934

460 ft.- Portion of journal box bolt with nut and nut lock.

Point of derailment, Extra 6753

Extra 6753 stopped here
YORK HAVEN
To Wago Jct.
