INTERSTATE COMMERCE COMMISSION  
WASHINGTON

-----  
ACCIDENT ON THE  
PENNSYLVANIA RAILROAD

-----  
CLEVELAND, OHIO

-----  
INVESTIGATION NO. 2280

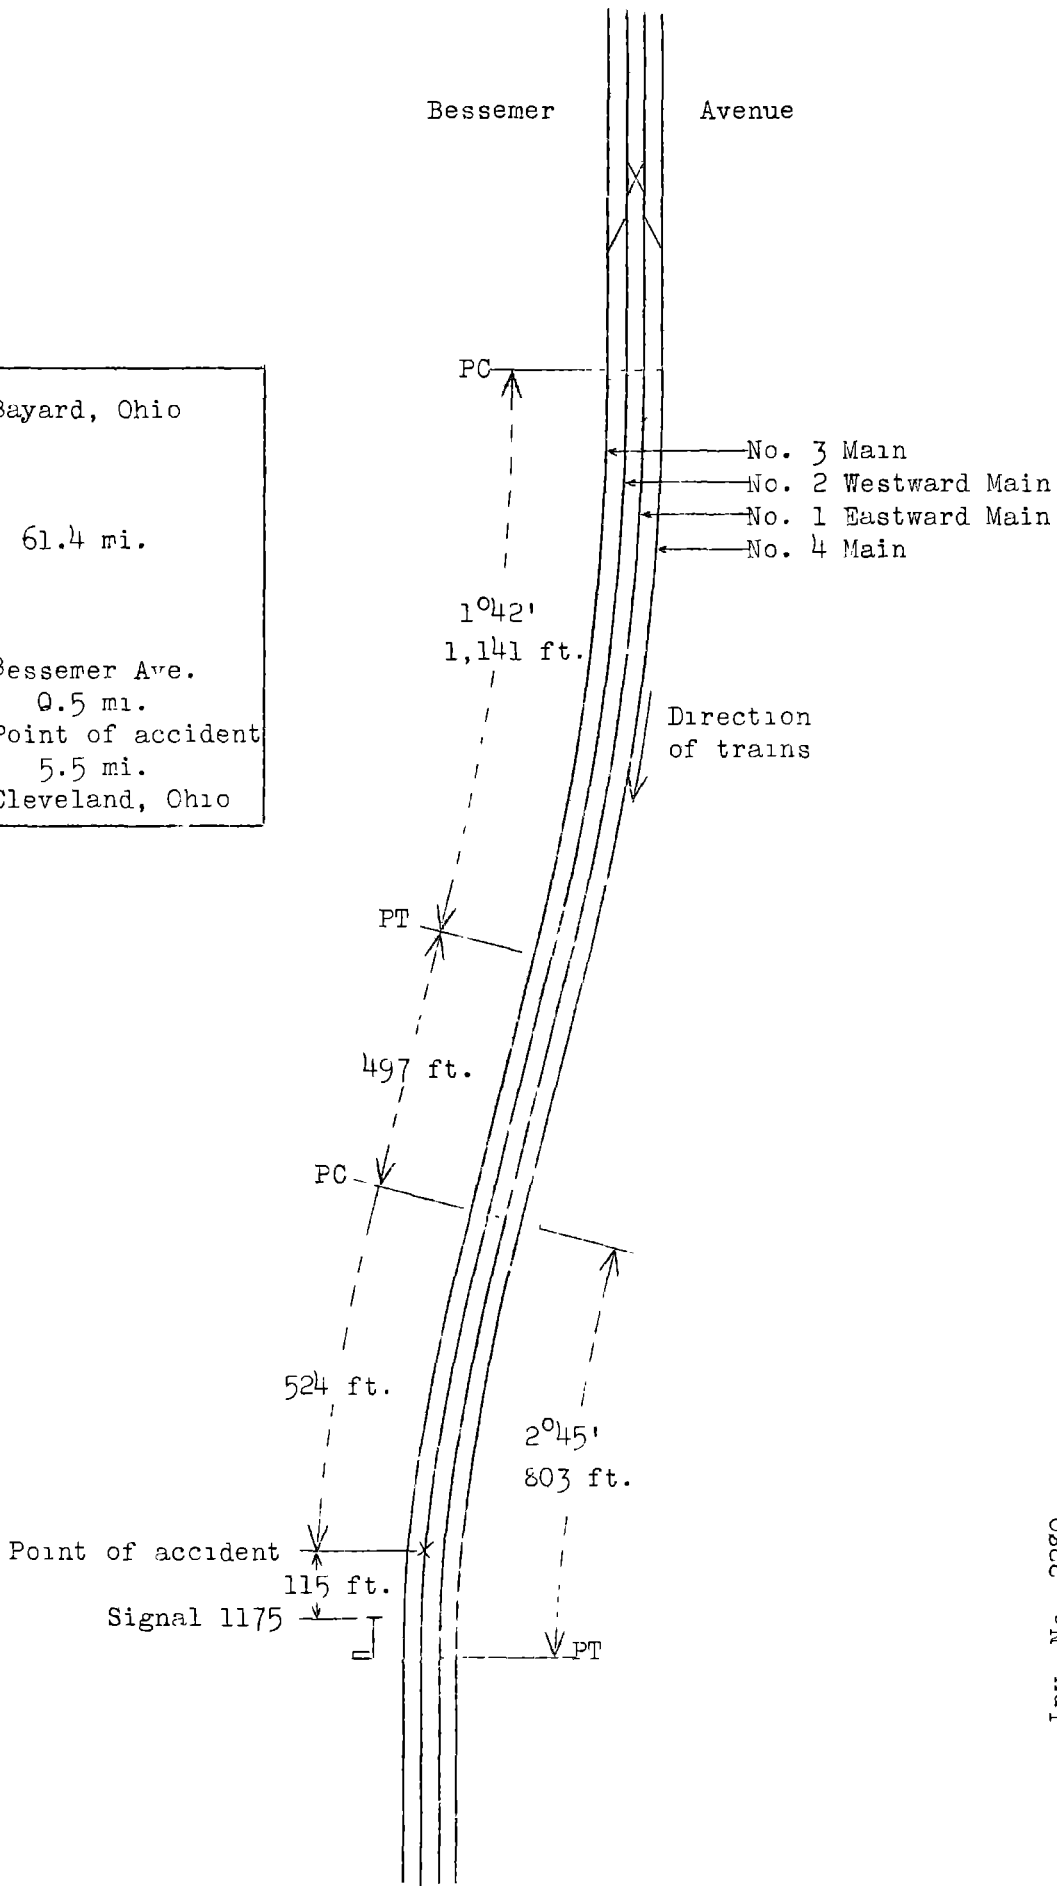
Inv. No. 2280  
 Pennsylvania Railroad  
 Cleveland, Ohio  
 June 25, 1938

At the time of the accident the eastward main track, the running track immediately north of track 2, and the running track immediately south of track 1 were clear. Under those conditions the view of the point of collision from the engine-man's side of an engine backing up was restricted to 1,073 feet, while from the fireman's side the point of accident was visible only while the engine was between points 1,348 and 1,148 feet east thereof.
