INVESTIGATION NO. 2796

THE PENNSYLVANIA RAILROAD COMPANY

REPORT IN RE ACCIDENT

MAY 3, 1944

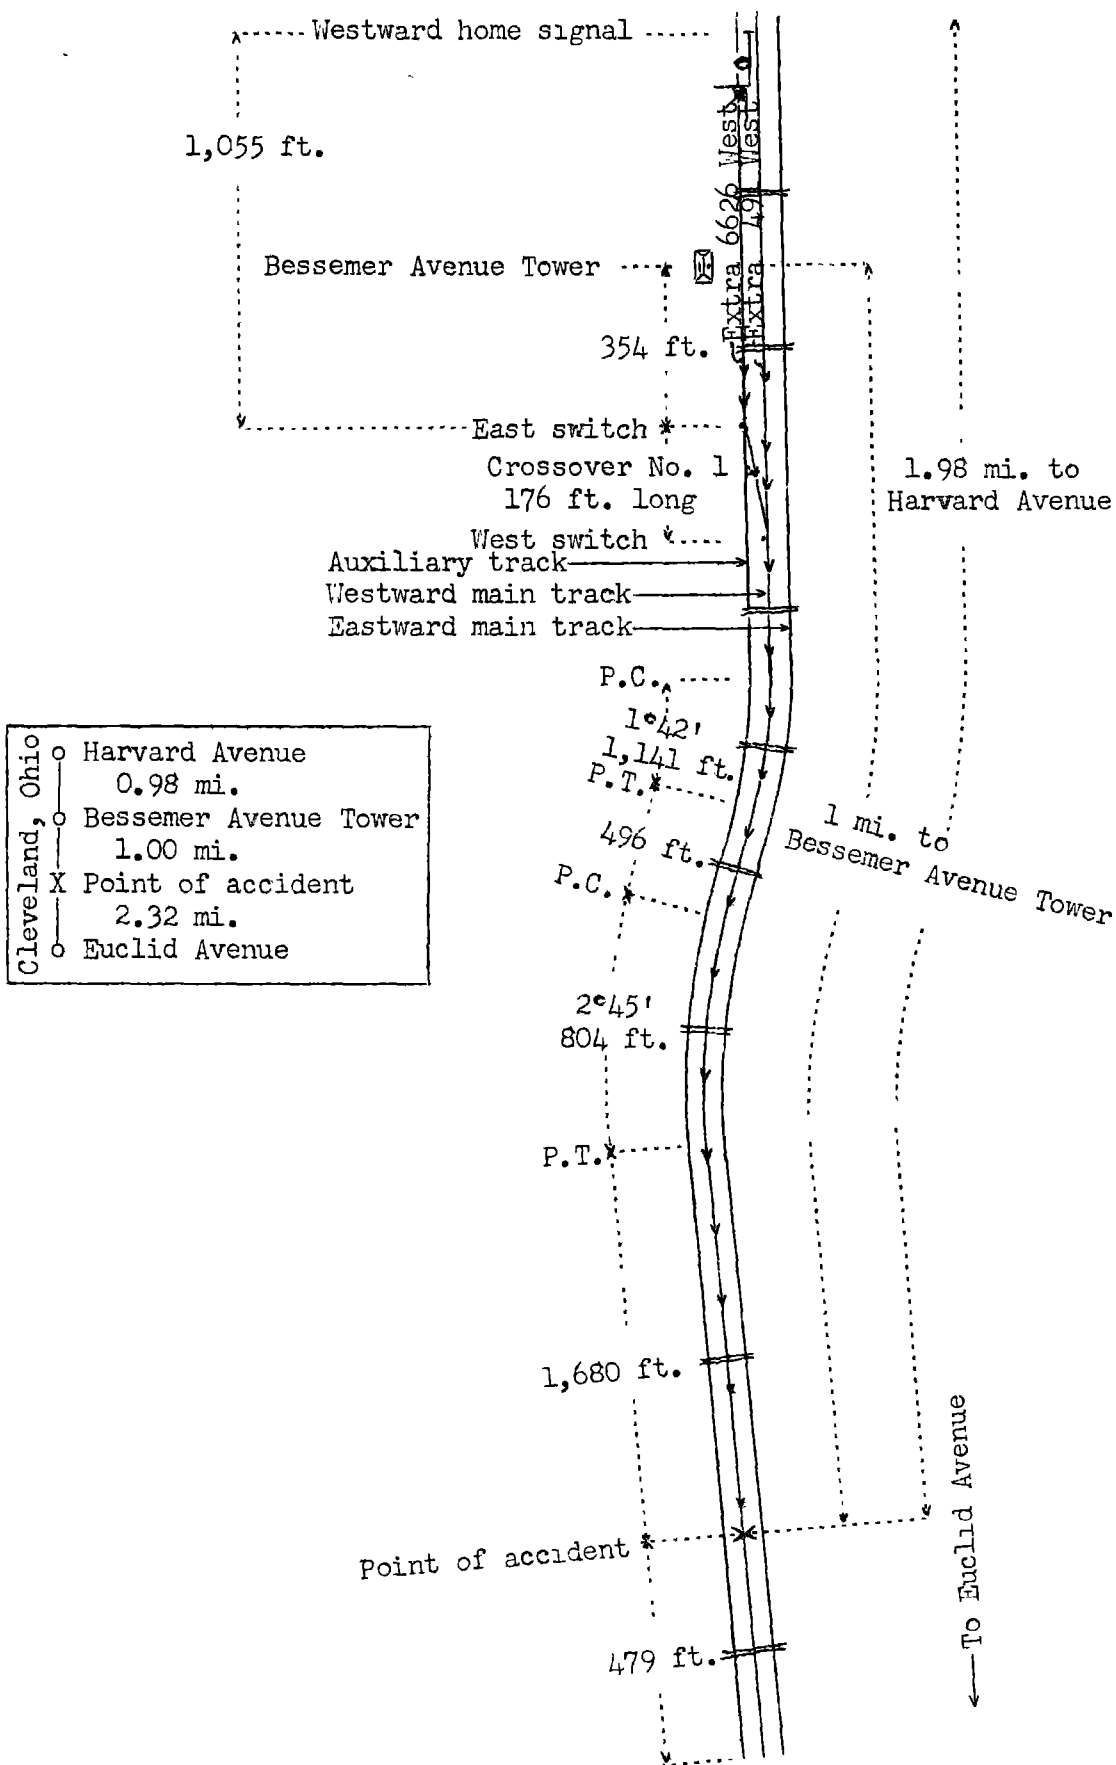
Inv-2796
 Pennsylvania Railroad
 Cleveland, Ohio
 May 3, 1944

This accident occurred on that part of the Cleveland Division extending westward from Harvard Avenue to Euclid Avenue, Cleveland, 4.3 miles. This was a double-track line over which trains moving with the current of traffic were operated by an automatic block-signal system, the indications of which superseded time-table superiority. The New York, Chicago & St. Louis Railroad train involved was being operated over a portion of this line. The accident occurred on the westward main track 1.98 miles west of Harvard Avenue, at a point 1 mile west of the tower at Bessemer Avenue. From the east there were, in succession, a $1^{\circ}42'$ curve to the right 1,141 feet long, a tangent 496 feet, a $2^{\circ}45'$ curve to the left 804 feet and a tangent 1,680 feet to the point of accident and 479 feet beyond. The grade for west-bound trains varied between 0.233 percent and 1.275 percent descending 4,467 feet to the point of accident, and was 0.5975 percent descending at this point.

In this vicinity an auxiliary track paralleled the westward main track on the north. The east switch of a crossover 176 feet long, hereinafter referred to as crossover No. 1, which connected the auxiliary track and the westward main track, was 354 feet west of the tower at Bessemer Avenue, and was facing-point for movements from the auxiliary track to the westward main track. The switches of crossover No. 1 were hand operated, and were in the charge of a switch tender.
