INVESTIGATION NO. 2910  
THE PENNSYLVANIA RAILROAD COMPANY -  
REPORT IN RE ACCIDENT  
AT COLUMBUS, OHIO, ON  
JULY 2, 1945

INVESTIGATION NO: 2910

August 31, 1945.

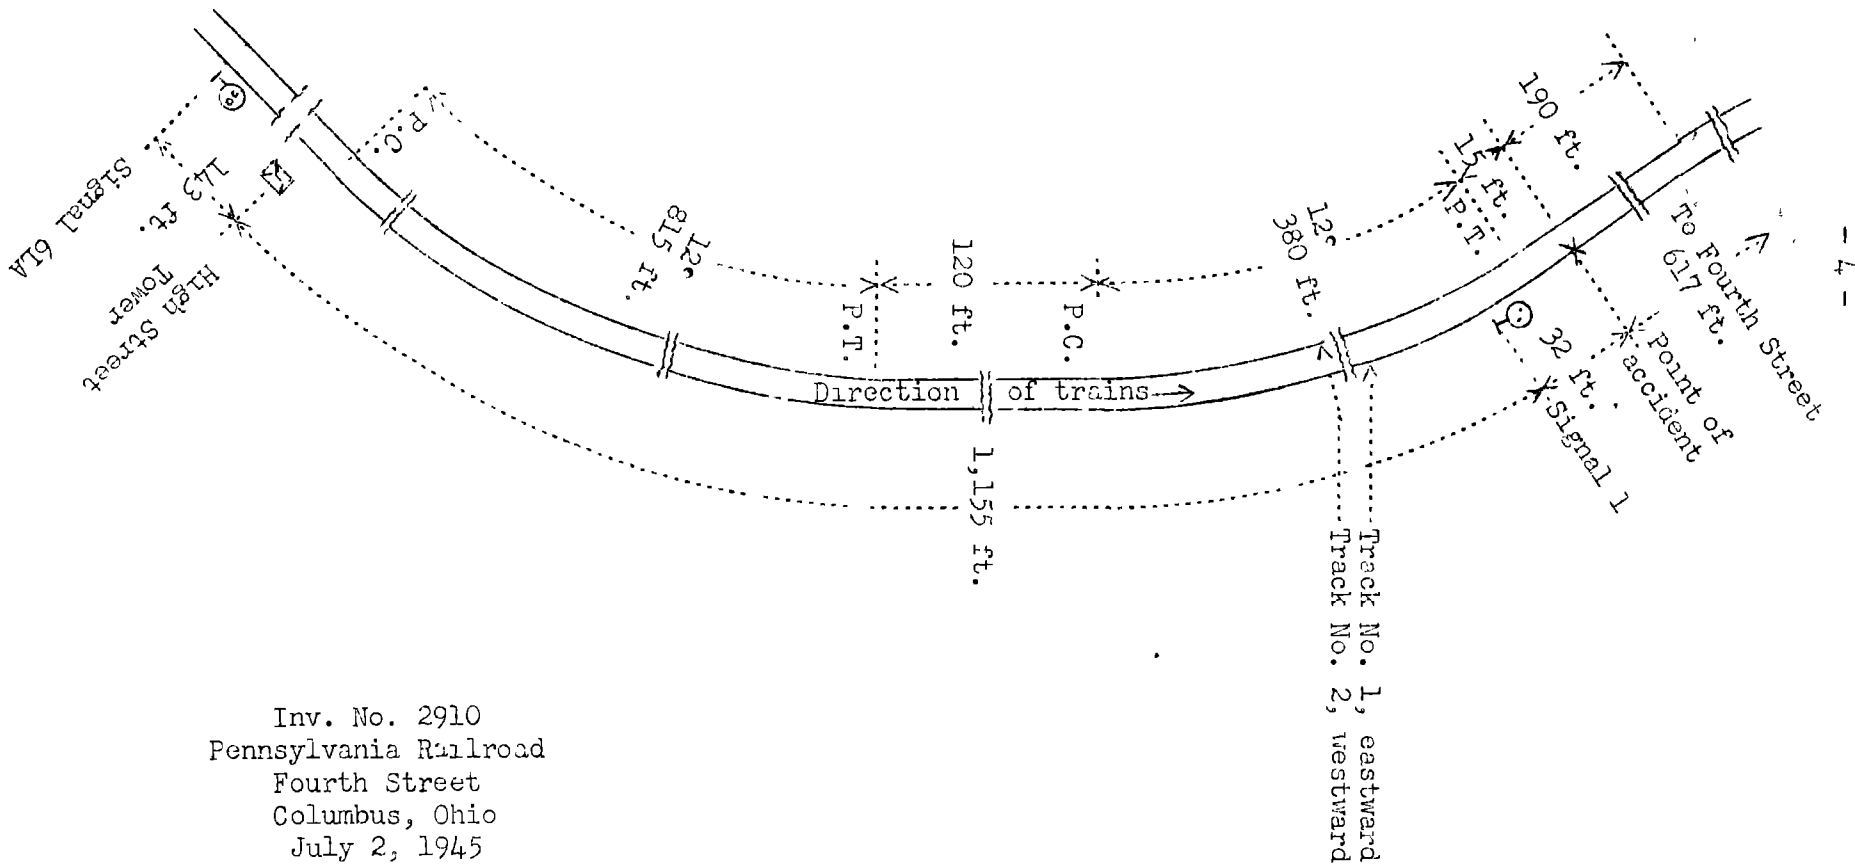
Inv. No. 2910  
 Pennsylvania Railroad  
 Fourth Street  
 Columbus, Ohio  
 July 2, 1945

Track No. 1, eastward  
 Track No. 2, westward

About 8 minutes after Extra 8255 East stopped, with the rear end standing on track No. 1, it was struck by Extra 373 East at a point 32 feet east of signal 1, which displayed proceed-at-restricted-speed.
