RAILROAD ACCIDENT INVESTIGATION

Report No 3860

THE PENNSYLVANIA RAILROAD COMPANY

AUGUST 13, 1959

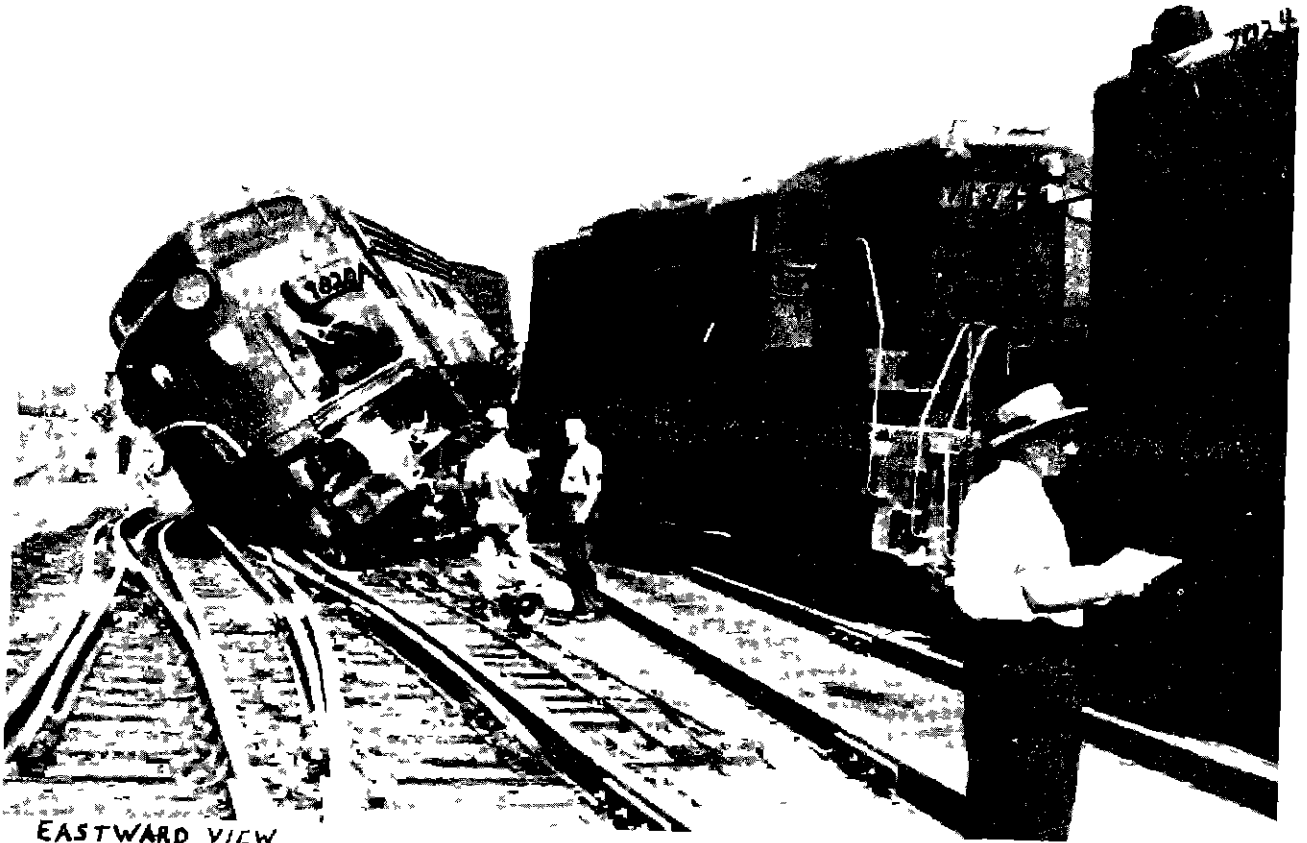
PLATE 1

EASTWARD VIEW

The 1st and 2nd diesel-electric units and the 30th car of Extra 7157 East were derailed. The 1st and 2nd units were somewhat damaged and the 3rd unit was slightly damaged. The 30th, 31st, and 32nd cars were somewhat damaged.

The derailed diesel-electric units of both trains stopped in positions as shown in PLATES 1 and 2. The engineer, the fireman, and the front brakeman of Extra 7157 East were injured. The engineer of the leading locomotive, the firemen of both locomotives, and the front brakeman of Extra 9820 West were also injured.

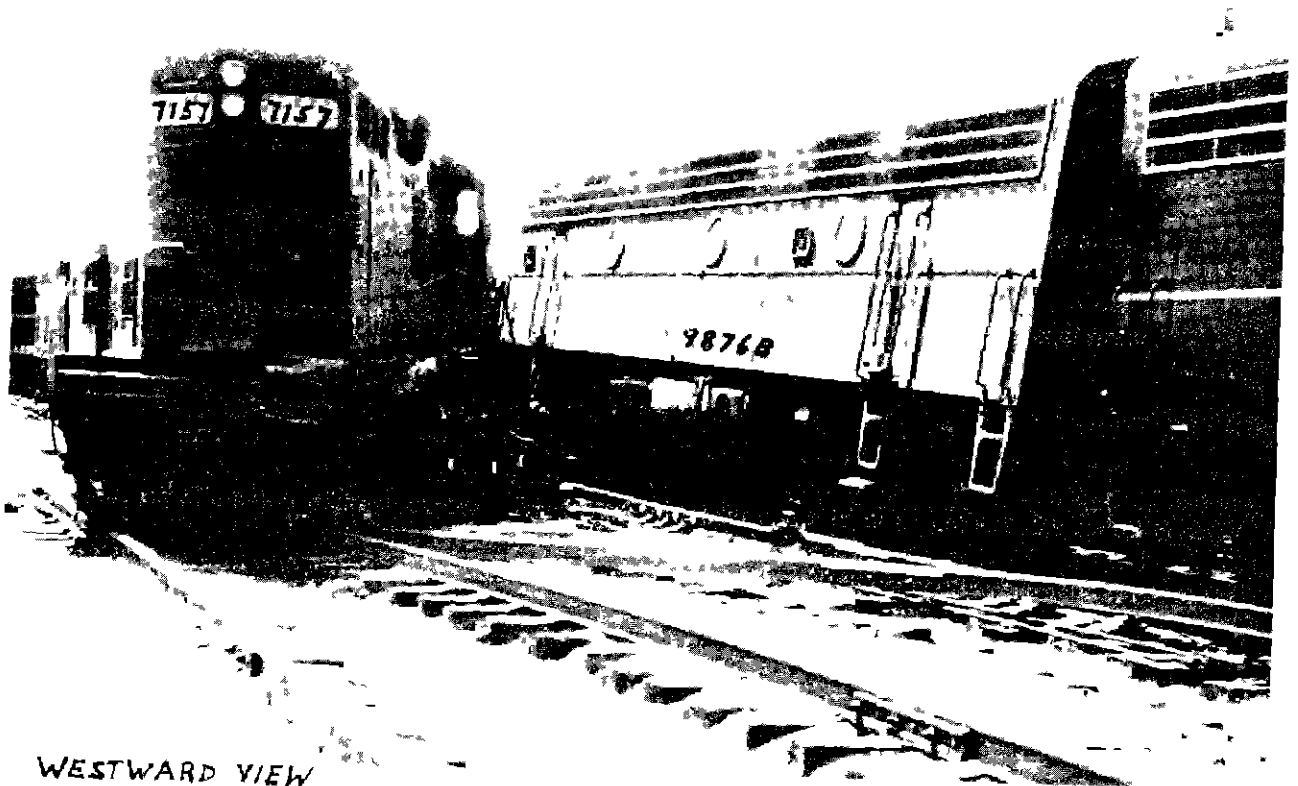
PLATE 2

WESTWARD VIEW

The 1st and 2nd diesel-electric units of Extra 9820 West were derailed. The 1st unit of the first locomotive was somewhat damaged, and the 2nd unit of this locomotive and all units of the second locomotive were slightly damaged.
