## INTERSTATE COMMERCE COMMISSION

REPORT OF THE DIRECTOR OF THE BUREAU OF SAFETY CONCERNING AN  
ACCIDENT ON THE PENNSYLVANIA RAILROAD NEAR COLUMBIA  
CITY, IND., ON MARCH 8, 1934.

May 15, 1934.

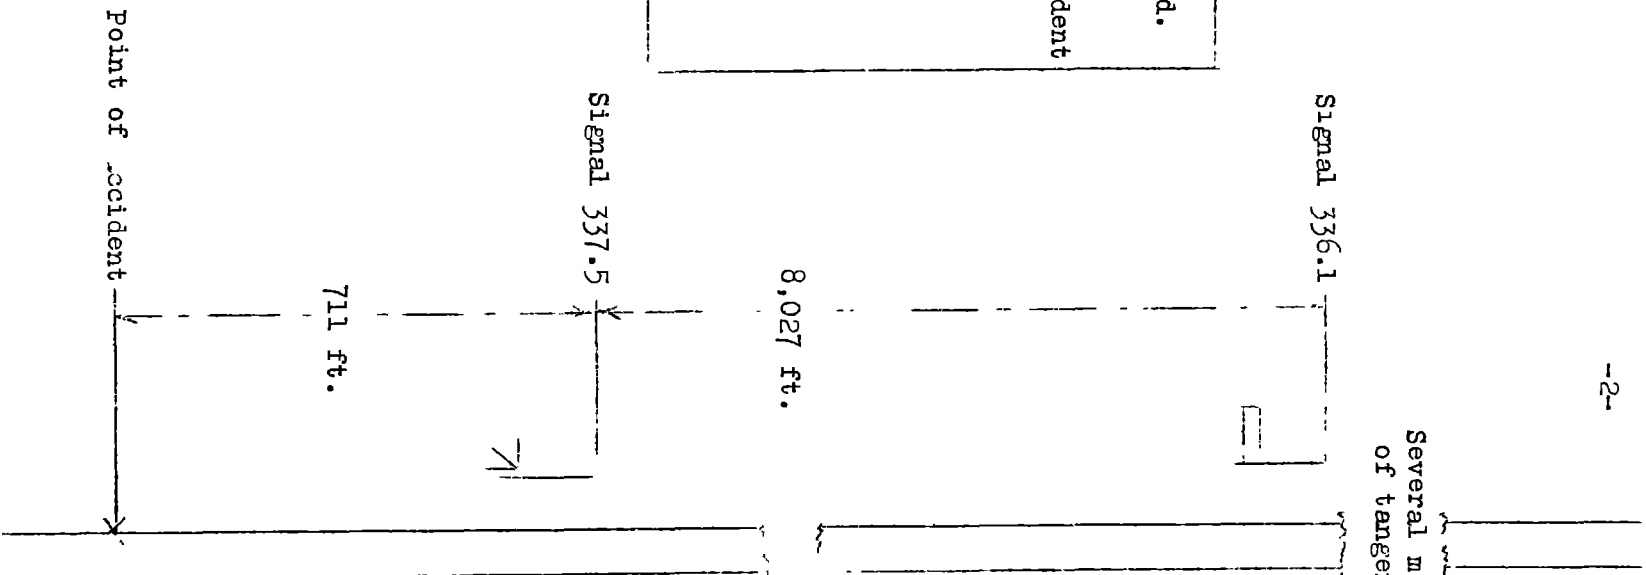
Inv. No. 1901  
Pennsylvania R.R.,  
Columbia City, Ind.  
March 8, 1934

The automatic signals involved in this accident are signals 337.5 and 336.1, located 711 and 8,738 feet, respectively, east of the point of accident. Signal 337.5, a grade signal, is an automatic signal of the position-light type, while signal 336.1 is an automatic signal of the three-position, upper-quadrant semaphore type, approach-lighted; night indications of semaphore signals are red for stop, yellow for approach next signal prepared to stop, a train exceeding one half its maximum authorized speed at point involved being required to reduce at once to not exceeding that speed, and green for proceed. The view is unobstructed.

charge of Conductor Bennett and Engineman Elliott. This train left Fort Wayne, 18.9 miles east of Columbia City, at 10:30 p.m., according to the train sheet, and stopped at Columbia City about 11:09 p.m., with the caboose 711 feet west of signal 337.5. The rear portion of the train had been standing at this point a few minutes when it was struck by Extra 5364.
