INTERSTATE COMMERCE COMMISSION

REPORT OF THE DIRECTOR OF THE BUREAU OF SAFETY CONCERNING AN
ACCIDENT ON THE PENNSYLVANIA RAILROAD AT CONVOY, OHIO,
ON SEPTEMBER 29, 1934.

November 15, 1934.

Inv. No. 1934
Pennsylvania Railroad
Convoy, Ohio
September 29, 1934

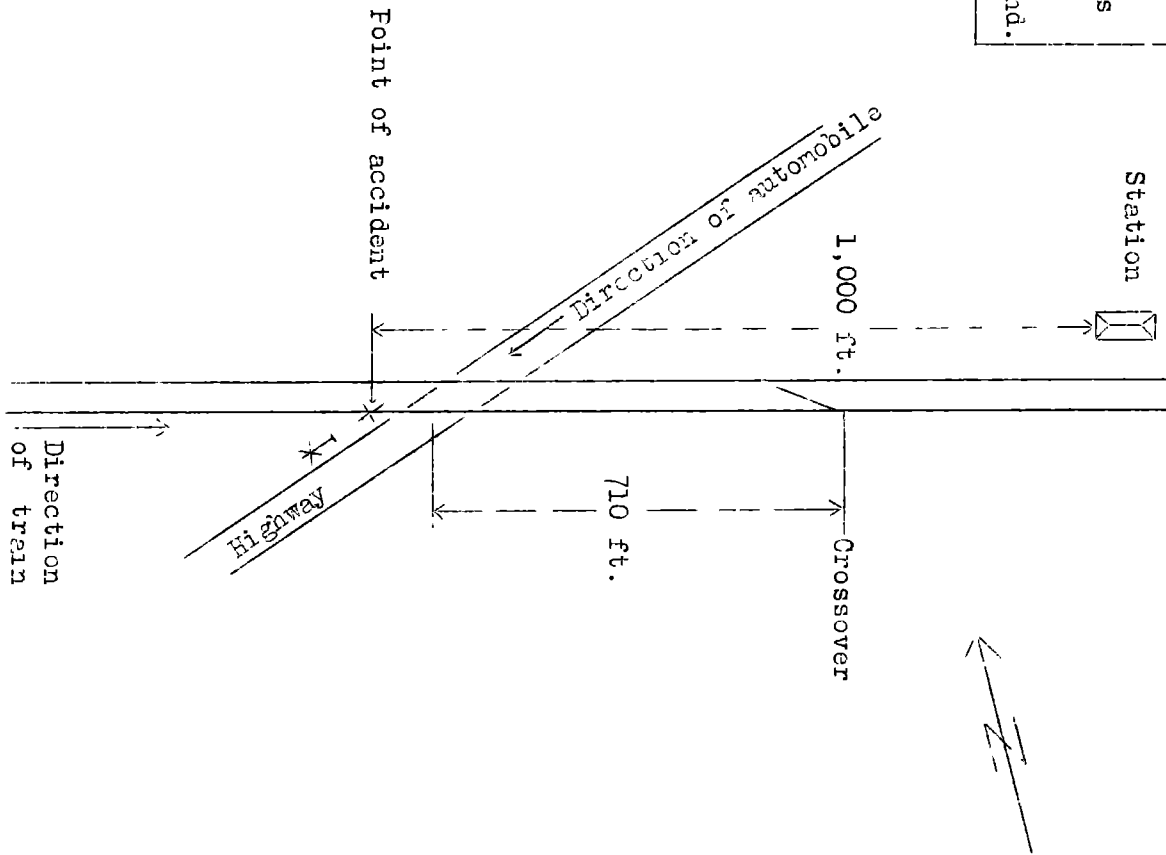
Tully Street is an improved highway which extends southwest and northeast and crosses the tracks at an angle of about 30 degrees; it is tangent for a considerable distance on each side of the tracks and is practically level except at the approaches to the crossing, where it ascends about $4\frac{1}{2}$ feet to the approximate level of the rails. The crossing itself is 17 feet in width and is surfaced with emulsified asphalt and stone. This crossing is protected by gates between 6:15 a.m. and 10:15 p.m., by warning bells for the full 24-hour period, and also by a crossing sign of the cross-bar type with an additional panel underneath the cross bars bearing the word "Danger", located on the south side of the tracks and the west side of the highway.

The surface of the crossing was in poor condition and at some points was more than 3 inches below the tops of the rails and there was evidence that during the past year several vehicles had been off the roadway at this crossing. A highway grade crossing at its best is a potential source of danger at all times, and yet on many highways the worst condition from the standpoint of maintenance is to be found at such points. There is no excuse for the existence of such conditions and they should be corrected as quickly as possible, not only at this crossing but at all other crossings where similar conditions may be found to exist.
