## INTERSTATE COMMERCE COMMISSION

REPORT OF THE DIRECTOR OF THE BUREAU OF SAFETY CONCERNING  
AN ACCIDENT WHICH OCCURRED ON THE PENNSYLVANIA RAILROAD  
NEAR DEANS, N. J., ON JUNE 7, 1932.

July 26, 1932.

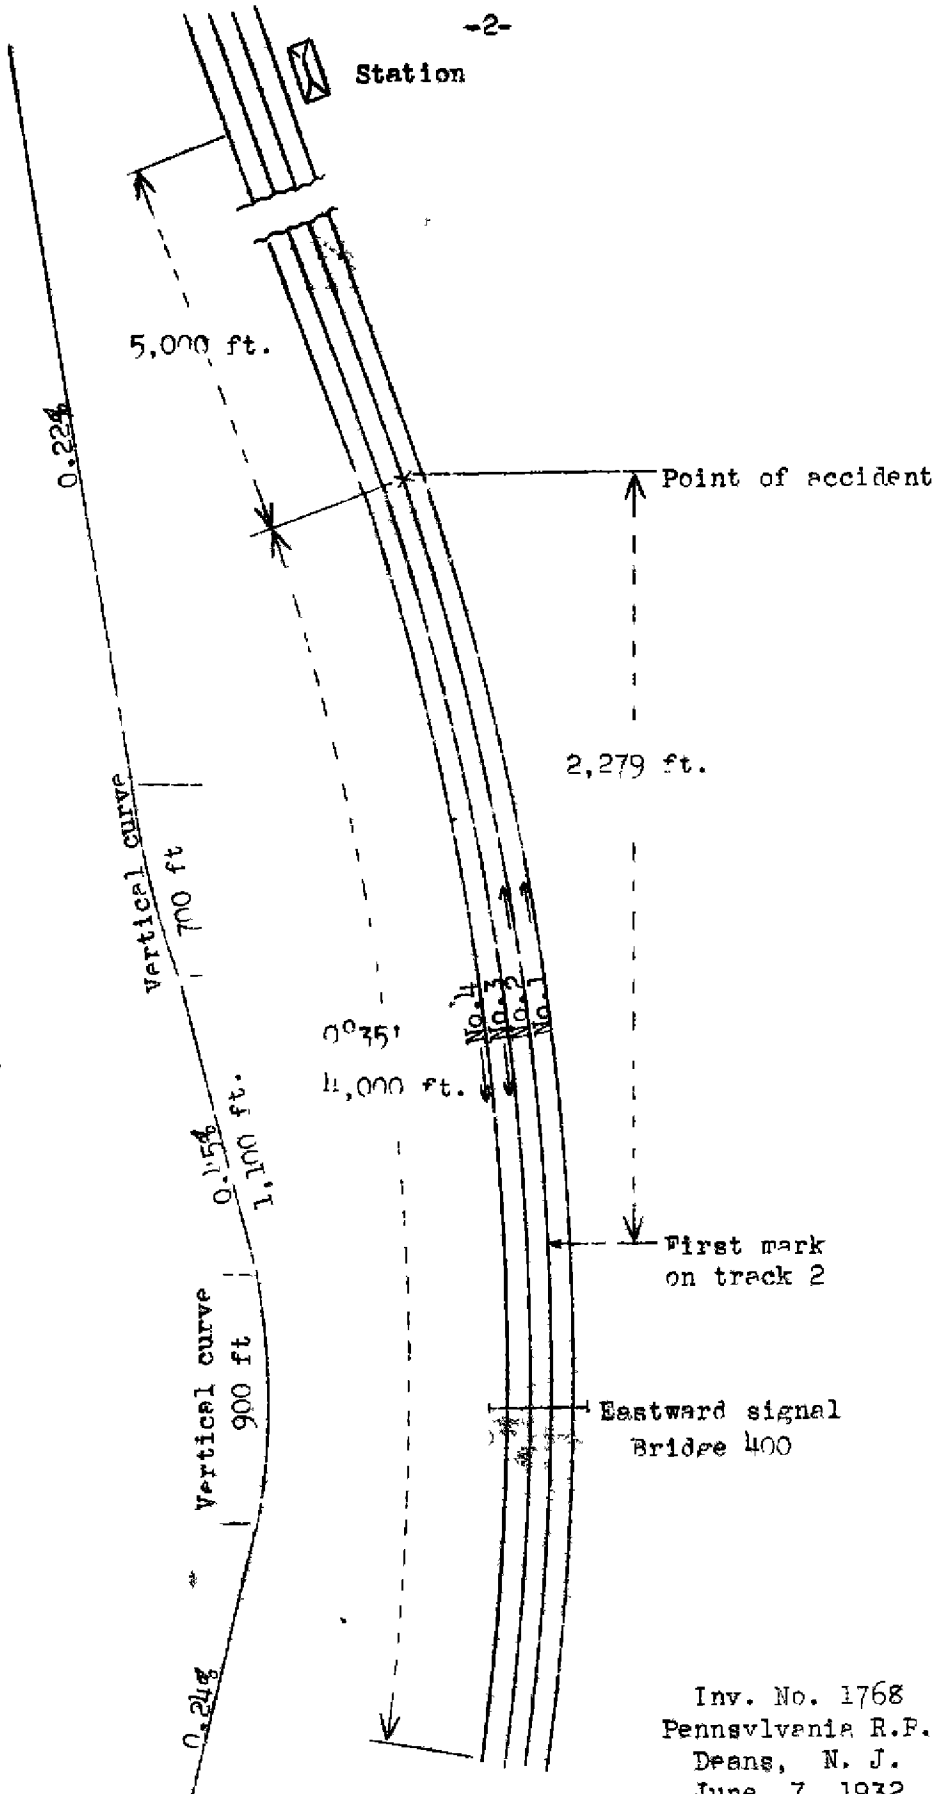
Inv. No. 1768  
 Pennsylvania R.F.  
 Deans, N. J.  
 June 7, 1932

This accident occurred on that part of the New York Division which extends between New York, N. Y., and Holmesburg Junction, Pa., a distance of 78.2 miles. This is a four-track line over which trains are operated by time-table, train orders, and an automatic block-signal system. Installations have been made for the operation of engines equipped either with cab signal and automatic train-stop apparatus, or with cab signals only. The engine of the passenger train involved was equipped with cab signal, whistle and acknowledgment, but not with automatic train-stop apparatus. The tracks numbered from south to north are 1, eastbound passenger; 2, eastbound freight; 3, westbound freight; and 4, westbound passenger. The accident occurred on track 2 at a point approximately 5,000 feet west of the station at Deans; approaching this point from the west, there is a  $0^{\circ} 35'$  curve to the left approximately 4,000 feet in length, followed by approximately 650 feet of tangent track, the derailment occurring at the beginning or western end of the tangent track, while the passenger train struck the derailed freight cars about 400 feet beyond that point. Beginning at the western end of the  $0^{\circ} 35'$  curve, the grade is 0.24 per cent descending, followed by a vertical curve approximately 900 feet in length, and then 0.45 per cent ascending grade for 1,100 feet, a vertical curve for a distance of 700 feet, and 0.22 per cent ascending grade for some distance beyond, the accident occurring on this latter ascending grade. The last automatic signals passed by the two trains involved were located on eastbound signal bridge 400, about 2,870 feet west of the point of accident.

The first mark found on track 2 was at a point 2,279 feet west of the point of derailment; it was about  $\frac{3}{4}$  inch in width and about 2 inches in length on top of a tie, 34 inches south of the gauge of the north rail. Between this mark and a point 922 feet west of the point of derailment there were marks consisting of two V-shaped grooves across the ties,  $1\frac{1}{4}$  inches apart, the north groove being 25 inches south of the gauge of the north rail, and grooves across the ties  $\frac{1}{2}$  to 4 inches in width and 34 inches south of the gauge of the north rail. At a point 922 feet west of the point of derailment the west side of two ties were gouged out on top just inside the north rail, to a depth of from 3 to 5 inches; the succeeding tie was broken and the ballast gouged out 2 inches below the tie, and between that point and the first wheel mark on the ties, a point of derailment, there were nine different points at which the ties were broken and gouged out on their west sides; one tie plate was broken, another bent, a bolt was broken, one tie was moved eastward about 8 inches, and at one point there was a hole in the ballast about 3 inches below the bottom of the west side of the tie. At some points these gougings were near the south rail and at others, near the north rail. At the point of derailment the wheel marks were on the ties on the north side

of each rail and the bolts of an angle bar on the inside of the south rail were broken off. At a point 92 feet east of the point of derailment were found the first wheel marks on the south side of each rail.
