## INTERSTATE COMMERCE COMMISSION

REPORT OF THE DIRECTOR OF THE BUREAU OF SAFETY CONCERNING AN  
ACCIDENT ON THE PENNSYLVANIA RAILROAD AT DELPHOS, OHIO,  
ON FEBRUARY 26, 1934.

May 3, 1934.

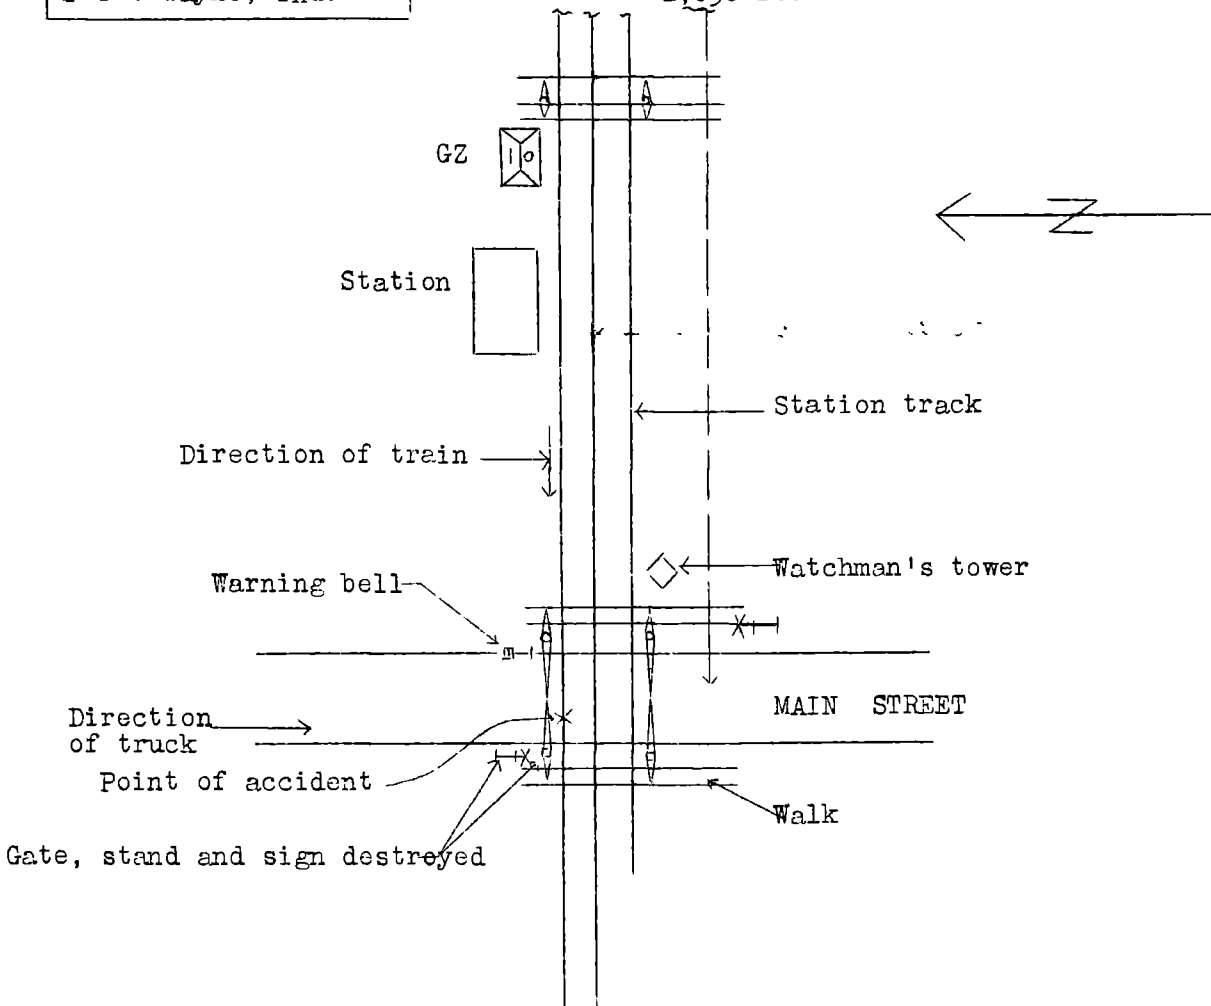
Inv. No. 1896  
Pennsylvania Railroad  
Delphos, Ohio  
Feb. 26, 1934

On the north side of the tracks there is a vacant lot which extends 41 feet east from the highway; between this lot and the station there is a hotel which very materially restricts the view to be had from a south-bound vehicle of a train approaching from the east. In addition to the hotel building, the view is interfered with by a pole line and occasionally by baggage trucks on the station platform. Due to these obstructions it is necessary to approach close to the track before a west-bound train can be seen, and at a point 30 feet from the track the train can be seen when it is 3,000 feet distant. The pole line then practically cuts off the view until a driver is only 15 feet from the tracks, and then he has a good view of the tracks.

There is no restriction on the speed of trains in this vicinity other than the general speed restriction of 70 miles per hour, while the view to be had of approaching west-bound trains by drivers of south-bound vehicles on the highway is very poor. There is a point 30 feet from the track from which a train can be seen when 3,000 feet distant but unless a driver is acquainted with this fact and is able to stop his vehicle at this particular point, he would not have any appreciable view of an approaching train until within 15 feet of the west-bound track. Any crossing where the view is so restricted and trains are operated at high speed may be classed as one of unusual danger. A check of motor traffic passing over the tracks at this crossing during the hours when the gates are not in use, 10:30 p.m. to 4:30 a.m., showed that only one-third of the trucks and one-third of the passenger automobiles stopped before crossing the tracks. A standard railroad crossing sign and crossing bells do not provide sufficient protection during these hours and the railroad company should give immediate attention to the necessity for providing such additional protection as will afford adequate warning of danger, either by installing flashing light signals or by such other means as may appear desirable.
