INVESTIGATION NO. 2540
THE PENNSYLVANIA RAILROAD COMPANY
REPORT IN RE ACCIDENT
AT DUNKIRK, OHIO, ON
NOVEMBER 9, 1941

Accident at Dunkirk, Ohio, on November 9, 1941, caused by
a passenger train striking a cylinder head which had
been thrown from an engine on an adjacent track.

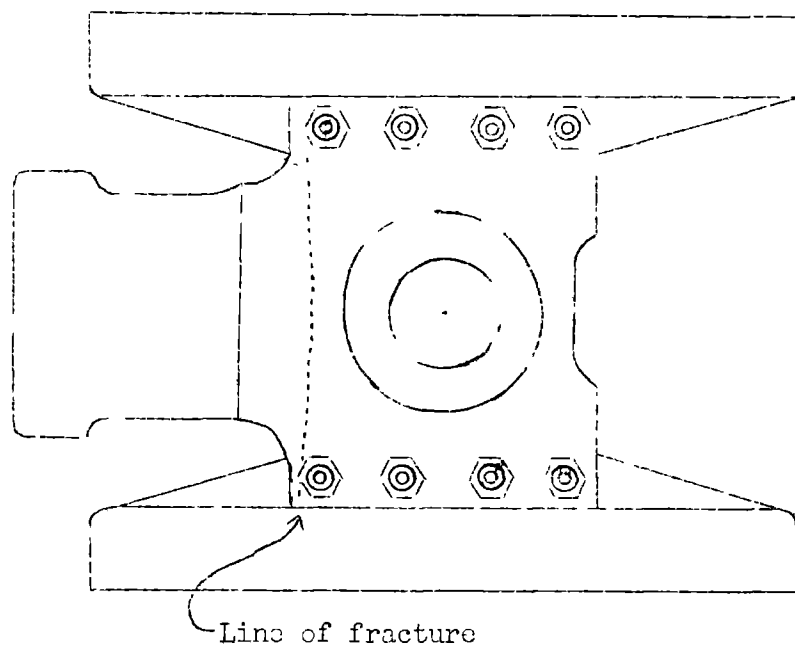
Crosshead of engine 8196

Side view showing fracture
through outside web of body

Examination after the accident disclosed that the left crosshead of engine 8196 was broken and the left cylinder head was missing. The crosshead involved was of the 3-piece, alligator type and had a cast-steel body and cast-iron shoes. Each shoe is secured to the body by four 1-inch bolts spaced 3 inches from center to center. At the crosshead pin location, the inside web of the body is 1-3/8 inches thick and the outside web is 1-7/8 inches thick. Both webs are 1-1/4 inches thick at the shoes. The inside web was fractured in an irregular line, which extended between the top and the bottom shoes at a distance of 1/2 inch to 2-1/2 inches back of the boss; this fracture was entirely new. The outside web was fractured from the top shoe to the bottom shoe in practically a vertical line, which extended between the front bolts of both shoes, and was about 2-1/2 inches ahead of the crosshead pin hole; this was a progressive detail fracture.

The crosshead involved failed as a result of a progressive fracture in the outer web of the body. This fracture progressed from the inner surface of the web outward through the web and apparently broke through the outer surface at the time of the failure. This fracture was concealed from detection during ordinary inspection, as there was no crack in the outer surface at the time of the last inspection prior to the time of the accident; however, work reports filed after the completion of the last four trips prior to the one involved indicated that the left crosshead pin was working loose. The condition of the main-rod brasses indicated but little pounding; therefore, it is reasonable to assume that flexing of the

metal surrounding the fracture was a factor to be considered concerning the loosening of the crosshead pin. Since the crosshead pin was found loose on successive trips, it appears that the pin should have been removed for examination. Had such action been taken, it is possible the defective condition of the crosshead might have been detected.

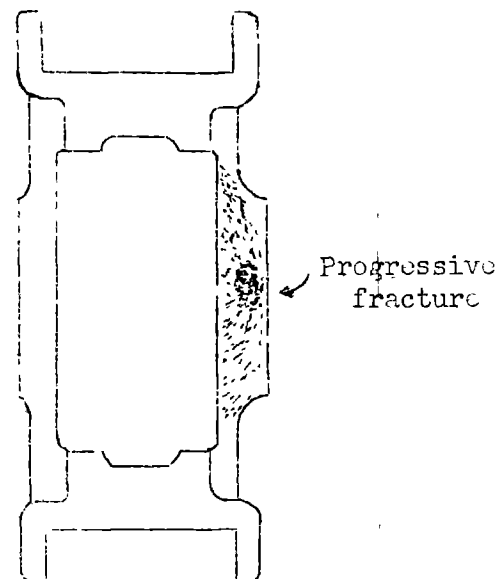
Cross-section showing progressive
fracture from inside surface outward

The center of the arc of the fracture was parallel to the longitudinal center-line of the crosshead pin, and the fracture had progressed from the inner surface of the web until it broke through the outer surface at the time of the failure. The metal indicated a faulty condition near the center-line of the web. The boss remained attached to the back end of the piston rod.
