RAILROAD ACCIDENT REPORT.

PENNSYLVANIA RAILROAD  
TRAIN PR-11A, EXTRA 2210 WEST AND TRAIN SW-6, EXTRA 2217 EAST  
DERAILMENT AND COLLISION  
DUNREITH, INDIANA  
JANUARY 1, 1968.

ADOPTED: DECEMBER 18, 1968

NATIONAL TRANSPORTATION SAFETY BOARD.  
DEPARTMENT OF TRANSPORTATION  
WASHINGTON, D. C.  
20591

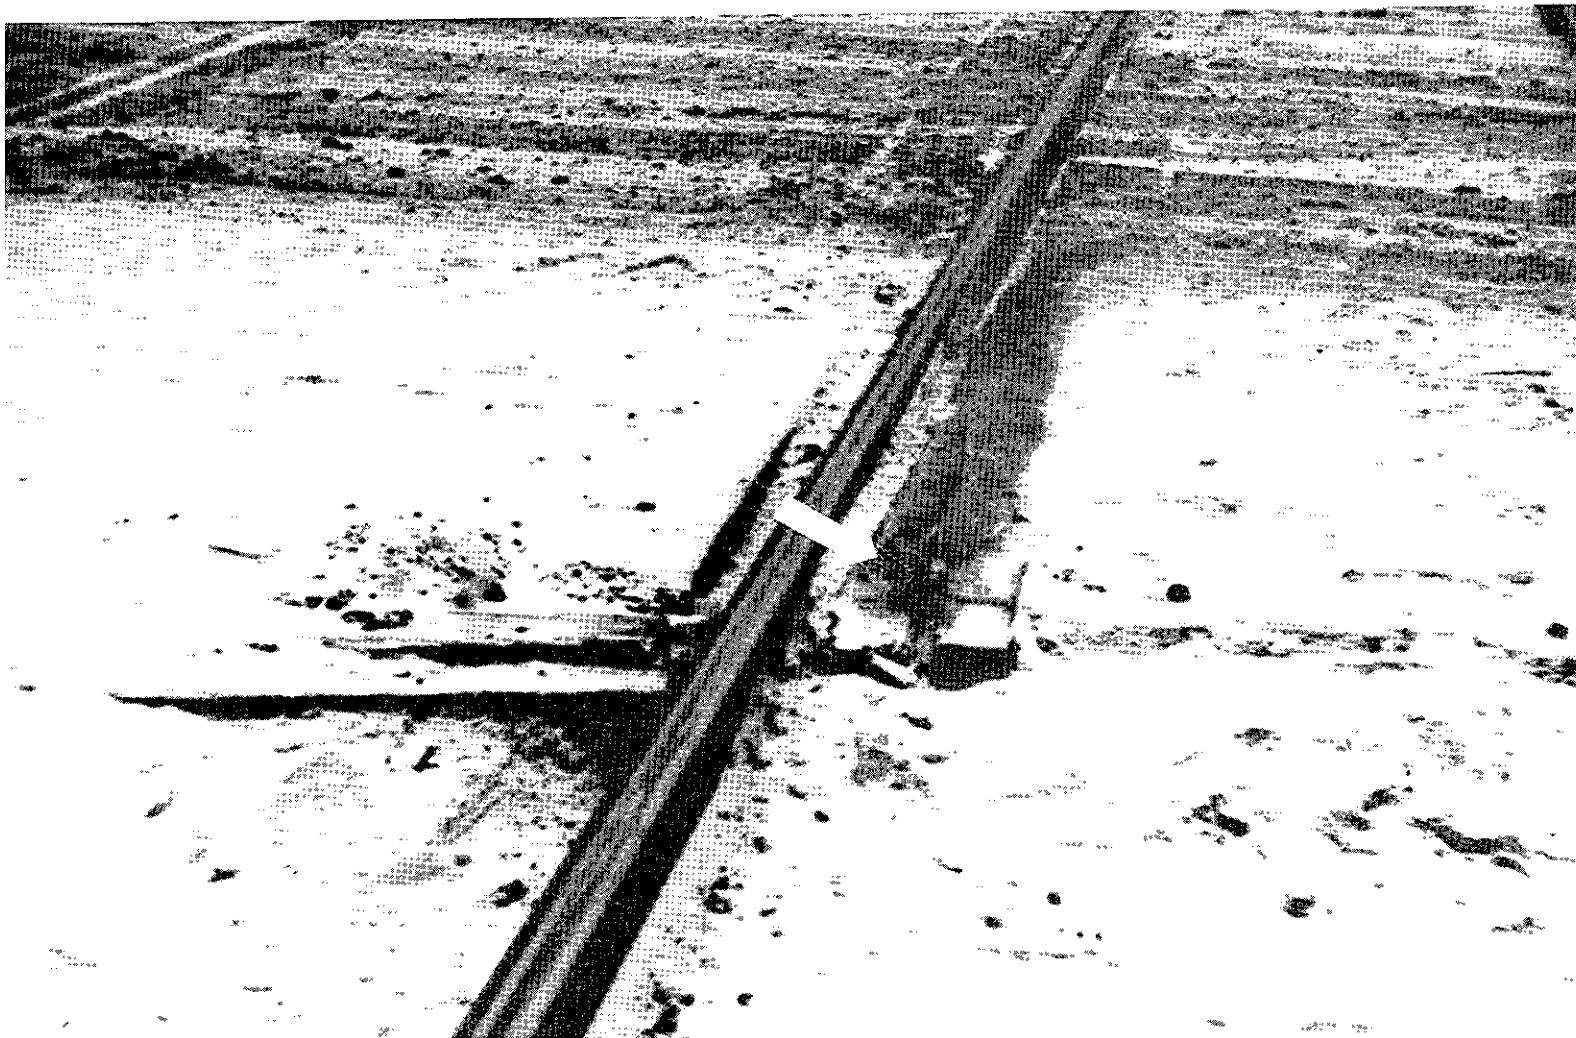
WATER STREET GRADE CROSSING  
SOUTH RAIL IN TRACK NO 2  
ARROW POINTS TO SPLIT IN PLANKING WHERE  
STRUCK BY DERAILED WHEEL OF AESX CAR 556

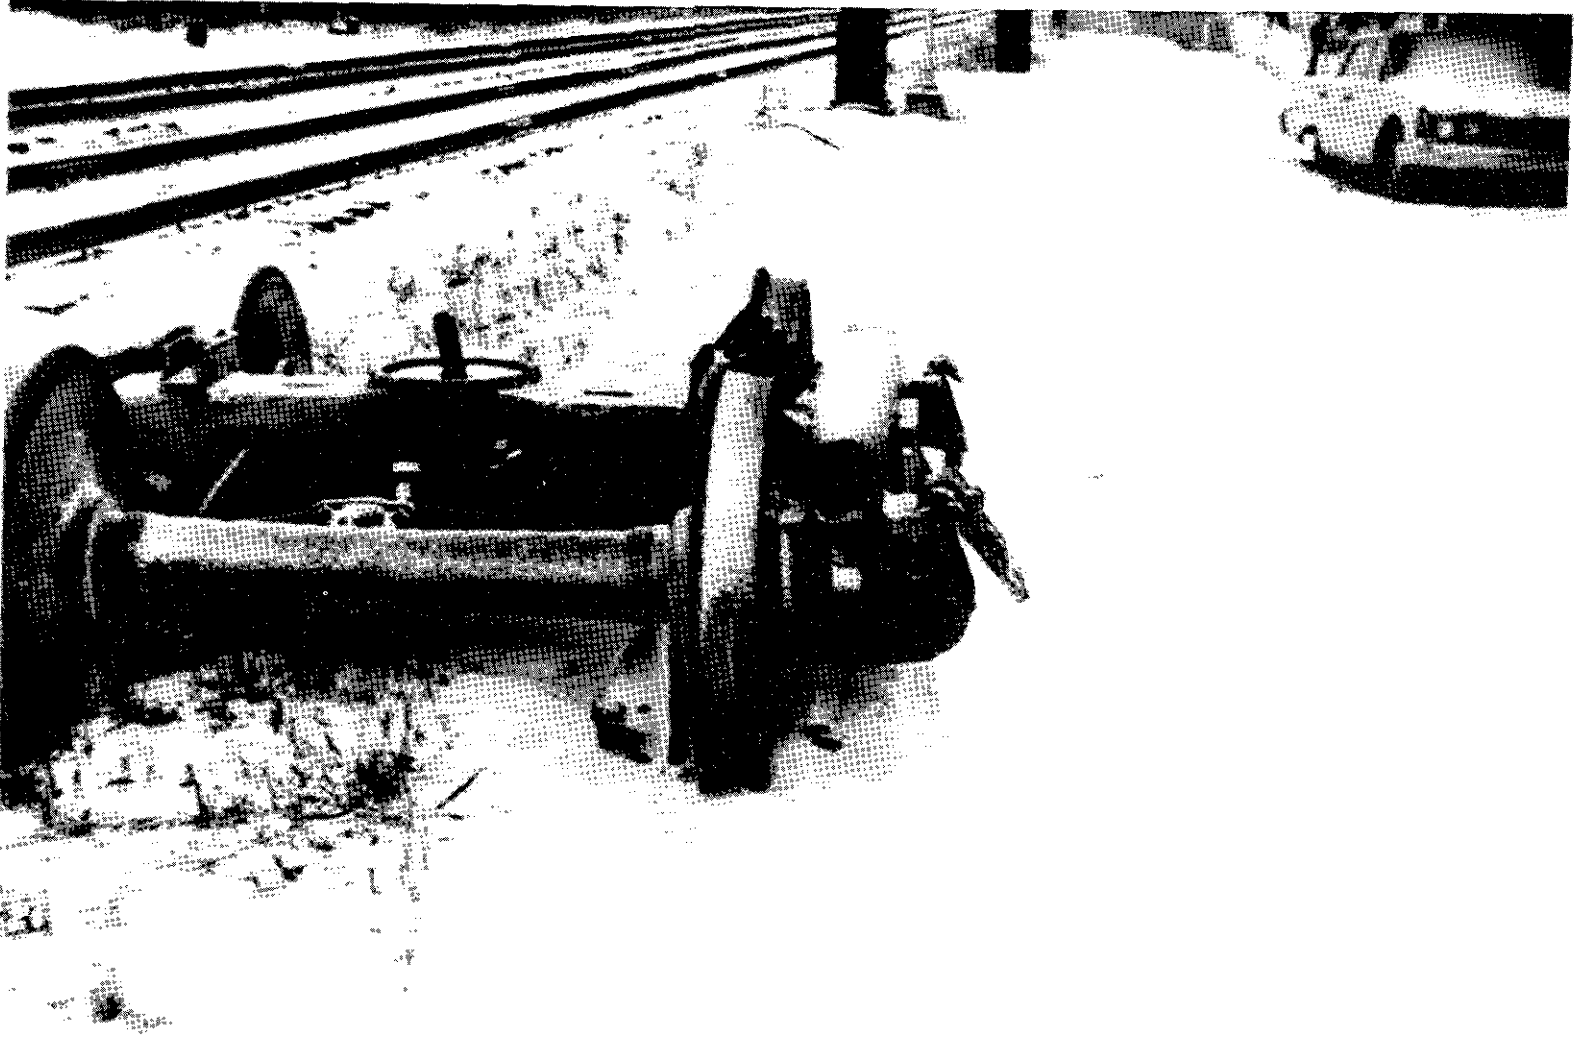
FRONT END TRUCK OF NISSAN CAR 850

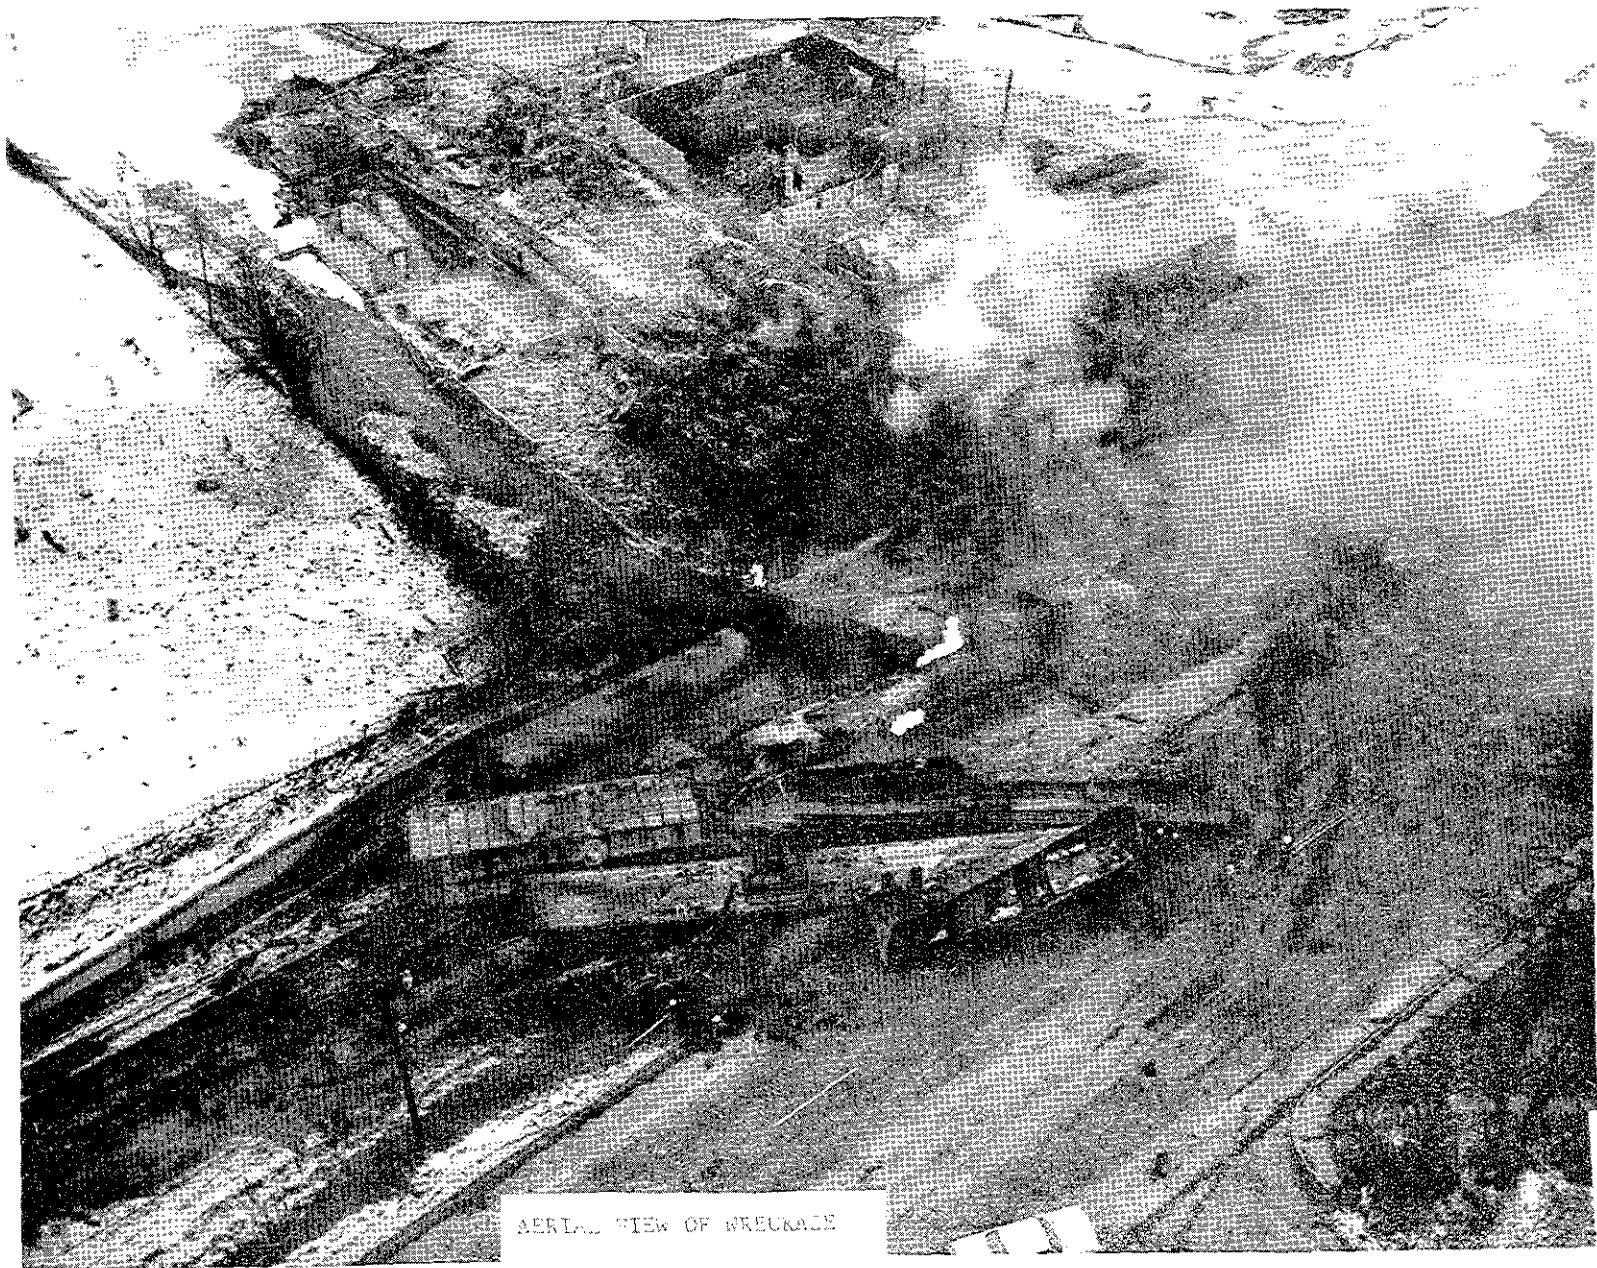
AERIAL VIEW OF WRECKAGE
