## INTERSTATE COMMERCE COMMISSION

REPORT OF THE DIRECTOR OF THE BUREAU OF SAFETY CONCERNING AN  
ACCIDENT ON THE PENNSYLVANIA RAILROAD AT EARNEST, PA.,  
ON MARCH 23, 1934.

May 28, 1934.

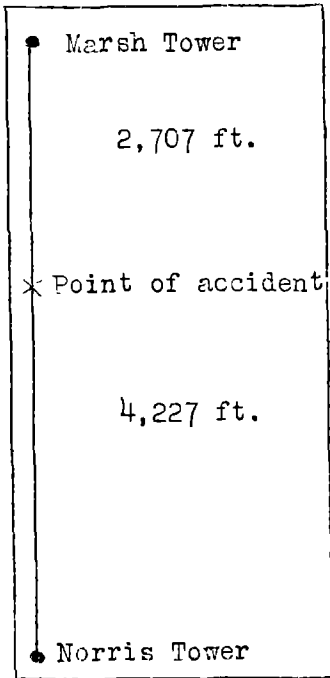
Inv. No. 1903  
Pennsylvania R.R.,  
Earnest, Pa.  
Mar. 22, 1934

Point of accident
