ACCIDENT ON THE
PENNSYLVANIA RAILROAD

ELWOOD, IND.

JULY 11, 1938

INVESTIGATION NO. 2281

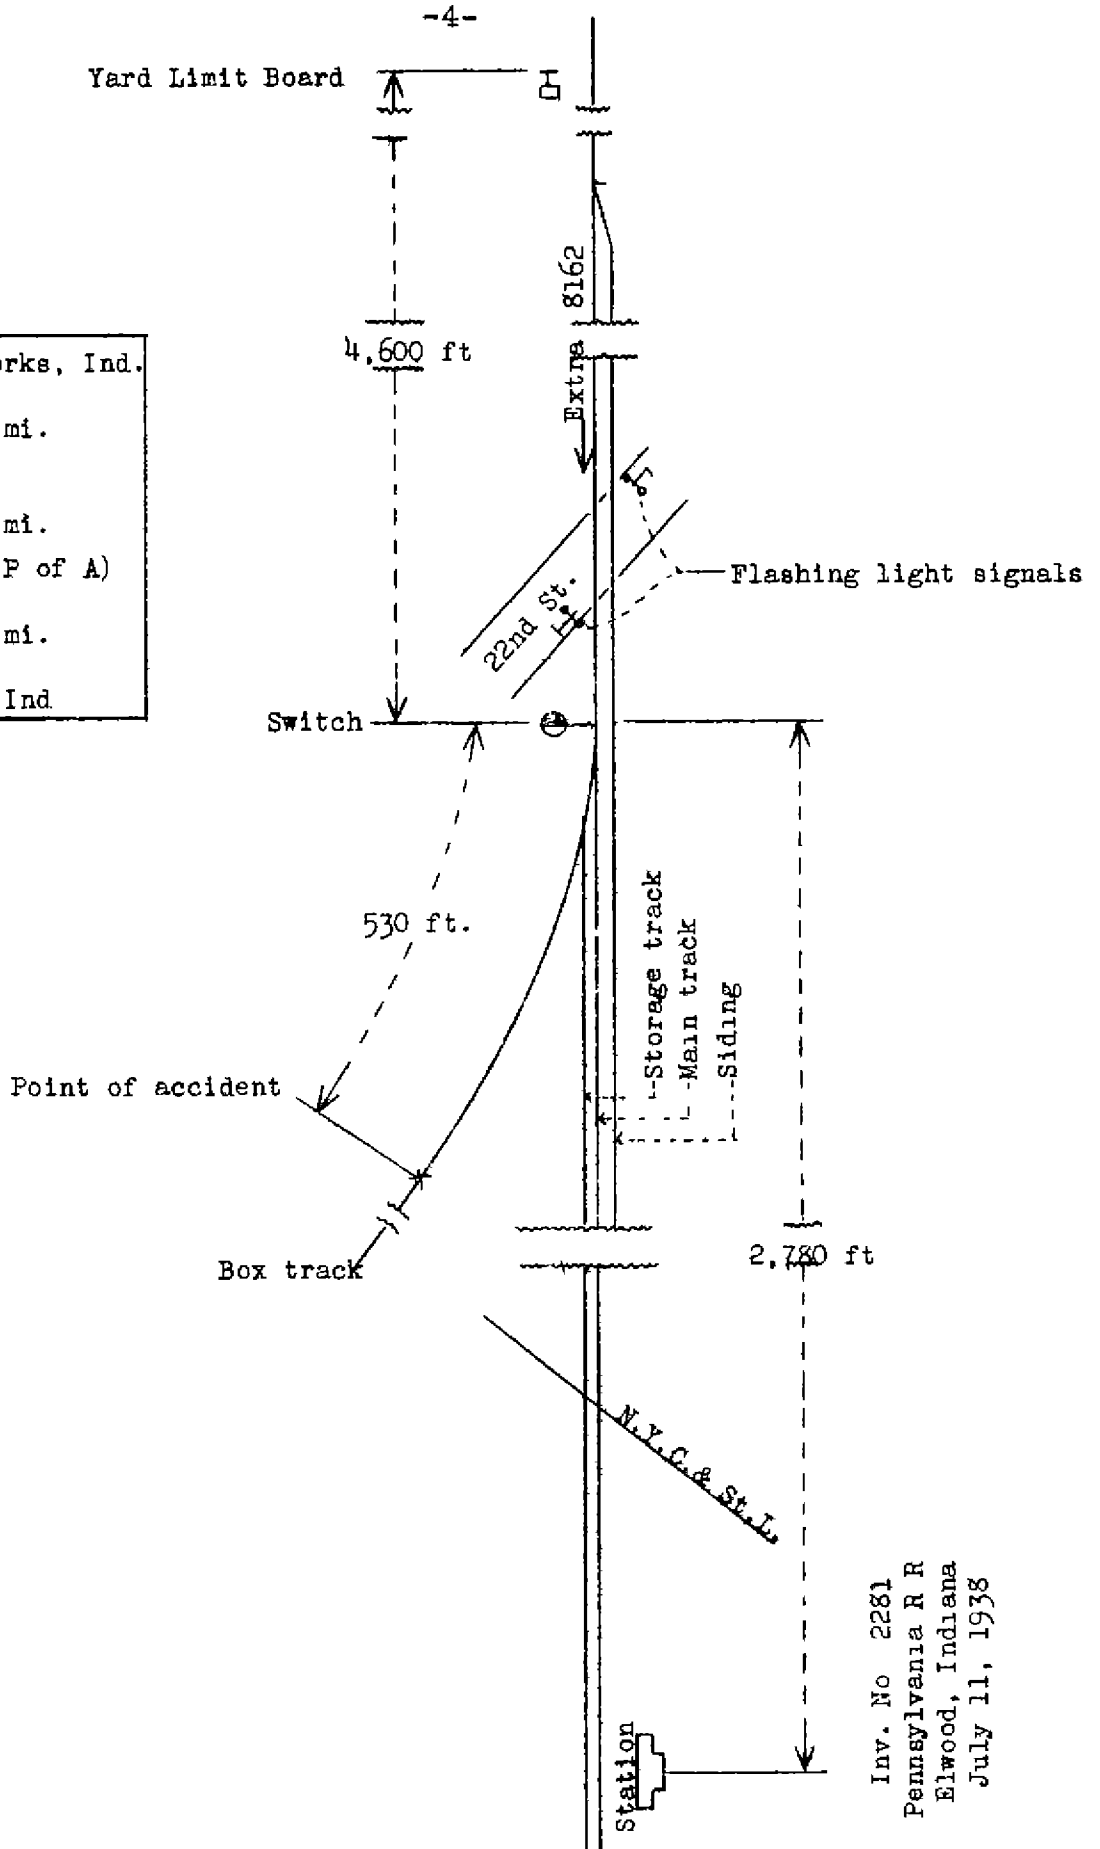
Inv. No 2281
 Pennsylvania R R
 Elwood, Indiana
 July 11, 1938

This accident occurred on that part of the Richmond Branch, Cincinnati Division, extending between Greens Fork and Walton, Ind., a distance of 88.6 miles. In the vicinity of the point of accident this is a single-track line over which trains are operated by timetable, train orders and a manual block-signal system. The collision occurred within yard limits, on an industrial track known as the box track, at a point 530 feet from the main-track switch of a track designated as the storage track. Approaching from the east the main track is tangent for several miles to the storage-track switch and for a considerable distance beyond. The east switch of the storage-track, located 4,600 feet west of the east yard-limit board, is a facing-point switch for westward movements. The storage track leads off the main track to the north through a No. 10 turnout and parallels the main track. The switch is hand operated and is provided with a New Century No. 50-B intermediate switchstand which is located 7 feet 11 inches from the gage side of the north rail and is equipped with a switch lamp, a red banner and a white banner; the centers of the banners are located 7 feet 3½ inches above the ties. The red banner is displayed when the switch is lined for the storage track and the white banner when the switch is lined for the main track. The view of the switchstand for an engineman of a west-bound train was unobstructed. The box-track switch is located 93 feet west of the storage-track switch and is a facing-point switch for westward movements. The box track leads off the storage track to the north through a No. 8 turnout, followed by a 10° curve to the right 200 feet in length, 137 feet of tangent track, another 10° curve to the right 100 feet in length, and then tangent track; the accident occurred at the north end of the last-mentioned curve, at which point the grade is 0.01 percent descending northward. The box-track switch is hand operated and is provided with a New Century 50-A low stand located on the north side of the track; it is not equipped with lamp or banner.

A siding about 3,100 feet long parallels the main track on the south; the east switch is located about 1,350 feet east of the storage-track switch.
