BUREAU OF SAFETY

REPORT NO. 2007

REPORT OF THE DIRECTOR OF THE BUREAU OF SAFETY CONCERNING  
AN ACCIDENT ON THE PENNSYLVANIA RAILROAD NEAR FELTON,  
DEL., ON SEPTEMBER 6, 1935.

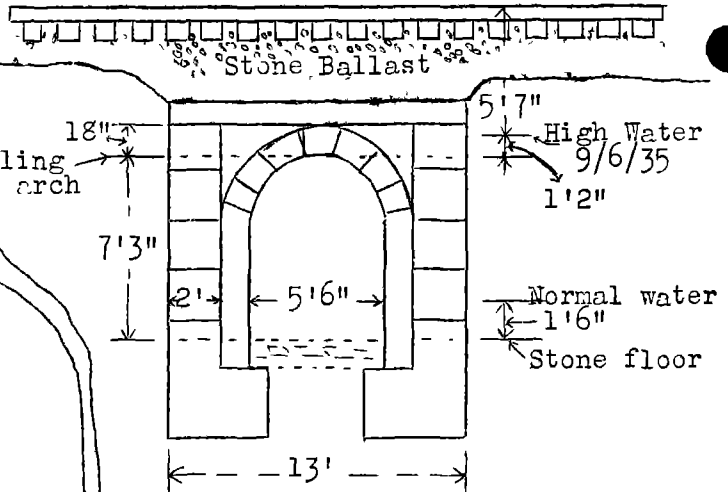
Elevation of Culvert  
West side, looking East

Culvert 59.82 made an opening for a small stream known as Fantail Branch, which in normal condition is about 2 feet deep and  $5\frac{1}{2}$  to 6 feet wide, and flows under the fill from west to east. This was an arch culvert 40 feet in length from end to end of arch, with a stone floor; the inside dimensions were 5 feet 6 inches wide, and 7 feet 3 inches from top of floor to center of ceiling. The arch was supported on the west or intake end by cut-stone stepped wing-walls 2 feet in thickness which extended 10 feet west from the face of

and parallel with the line of flow through the arch, and on the east end by a rubble stone head-wall 2 feet thick, 14 feet high, and 30 feet in length constructed flush with the face of the arch or at right angles with the line of flow. In the vicinity of the culvert the bank was not protected by rip-rap.

inches above the ceiling of the arch of the culvert and that the fill was washed out for a distance between 35 and 38 feet to the south, and between 65 and 72 feet to the north, of the center line of the culvert.

An unusually heavy rain fell during the night, the heaviest probably being some time between midnight and 5 a.m., which caused the water to rise to a point about 14 inches above the ceiling of the arch, and during this time the banks of the fill honey-combed or scoured in the vicinity of the north side of the arch on the west side of the track, undermining the roadbed and leaving the track unsupported. Two trains running in the same direction as the wrecked train had passed over this culvert within a period of about 2 hours prior to the time the accident occurred, and the crews of these trains noticed no alarming conditions at this point. High water had been reported, however, several hours earlier, and inspections had been made on three occasions during the night, but without developing any condition which appeared to require a watchman. This culvert had been built about 34 years and evidence of employees with service continuously in this territory for more than 30 years indicated there had been no previous trouble during that time due to high water or washouts at this point, the evidence that the heaviest rain came only a very few hours prior to the accident is supported
