## INTERSTATE COMMERCE COMMISSION

REPORT OF THE DIRECTOR OF THE BUREAU OF SAFETY CONCERNING AN  
ACCIDENT ON THE PENNSYLVANIA RAILROAD AT PITTSBURGH, PA.,  
ON FEBRUARY 26, 1934.

April 4, 1934.

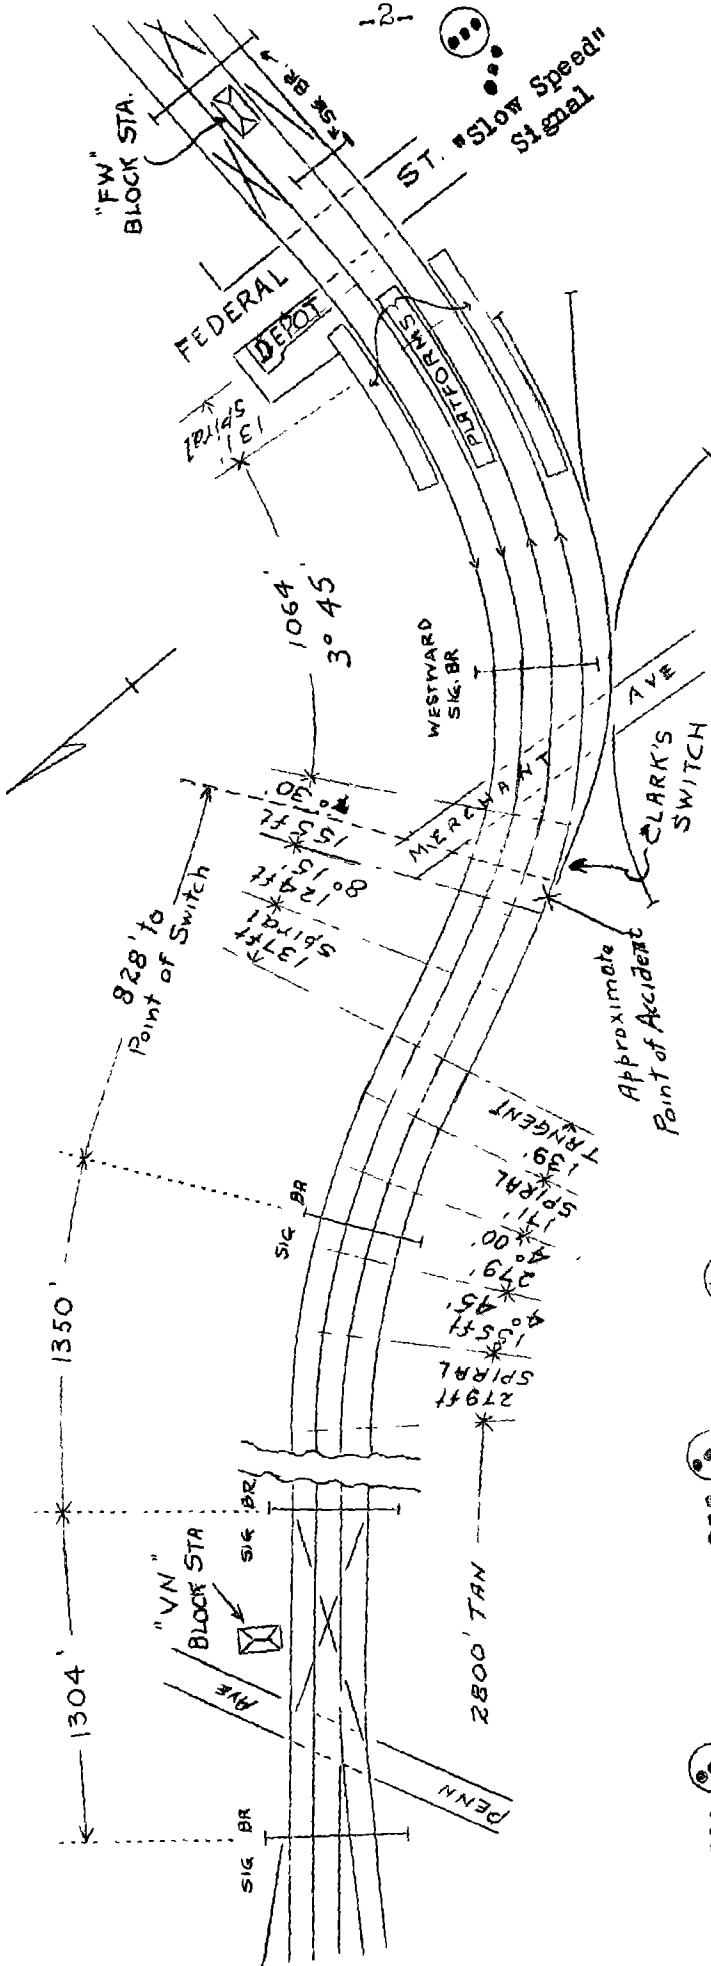
INT. NO. 1897  
 PENNSYLVANIA RAILROAD  
 PITTSBURGH PA.  
 Feb. 26, 1934

"Approach Restricting" Signal
-

"Approach" Signal

Signal Indication shown for Train No. 1638
