INVESTIGATION NO. 3249
THE PENNSYLVANIA RAILROAD COMPANY
REPORT IN RE ACCIDENT
AT FORT WAYNE, IND., ON
APRIL 28, 1949

Date: April 28, 1949
Railroad: Pennsylvania
Location: Fort Wayne, Ind.
Kind of accident: Derailment
Train involved: Passenger
Train number: 29
Engine numbers: Diesel-electric units
5852A and 5845A
Consist: 15 cars
Speed: 70 m. p. h.
Operation: Signal indications
Track: Double; tangent; level
Weather: Clear
Time: 6:23 a. m.
Casualties: 43 injured
Cause: Broken journal

Accident at Fort Wayne, Ind., on April 28, 1949, caused
by a broken journal.

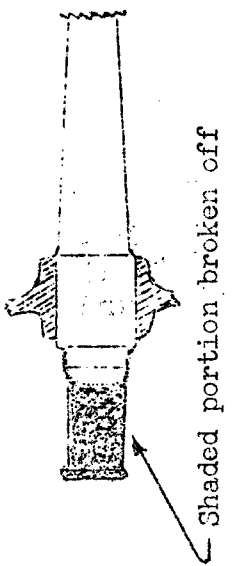
Sketch showing broken journal

Examination after the accident disclosed that the left front journal of the rear truck of the eighth car was broken, and as a result the front end of the left equalizer bar had dropped and had been in contact with the track structure. The equalizer bar and the left front pedestal tie-bar were considerably marked. Examination of the track disclosed a light scraping mark on the north side of the north rail of crossover O3 at a point 10.4 feet east of the west frog and 1.5 feet south of the south rail of track No. 2. The heel block and the point of the frog were battered. At a point 52 feet westward, scraping marks appeared on the south stock rail of the turnout at the west end of crossover O3, and the switch-point heel-block was battered. At a point 111 feet west of the first mark and 12 feet west of the west switch of crossover O3, a wheel mark appeared on the top surface of a tie at a point 5 inches inside the south rail of track No. 2. From this point westward flange marks on the tops of the ties extended diagonally northward and westward. These marks indicated that a derailed wheel had been in contact with the south rail of the east turnout of crossover O1B.

Examination of the failed journal disclosed that it had been overheated, then had become broken. The break in the journal occurred within the inner race of the inside set of the double-type roller bearing at a point 1-1/2 inches outward from the journal fillet. The portion of the journal remaining attached to the axle was ground into an oval shape stub, and it extended about 3-1/2 inches outward from the hub of the left wheel. The broken-off portion of the journal remained in the journal-box housing and was fused to the inner races. Both pieces of the journal and all parts of the bearing assembly were badly discolored by overheating. The inner assembly of the bearing was practically destroyed. The separator cages were badly broken, and the roller elements were deformed. Except for one broken separator prong, the outer assembly was intact. The rear enclosure of the journal housing was broken as a result of the breaking of the journal. All of the oil in this bearing had been burned. However, a sufficient amount of oil was found in all the other journal-bearing assemblies of this car.

the eccentricity of the right wheel was 0.005 inch, and, although proper test of the left wheel could not be made because of the broken journal, its eccentricity was computed to be 0.011 inch. The axle involved was manufactured during 1948, heat No. 54V065, serial No. 2601, and was normalized and tempered at the carrier's Juniata Shop on March 23, 1948. The journals were 6 inches by 11 inches. The records of the carrier indicated that the inner race of the failed bearing was pressed on the journal under a pressure of 20 tons, which conformed to the requirements of a range between 10 and 20 tons, inclusive. An additional requirement is that the diameter of the axle journal must be equal to the inside diameter of the inner race plus 0.002 to 0.004 inch.

According to the report of the engineer of tests of the Pennsylvania Railroad, the axle involved conformed to the requirements for a completely normalized and tempered medium-high carbon-steel axle. The carbon content was 0.575 percent, or 0.025 percent over the maximum for grade C car axles. All other requirements were as specified by the carrier. There was no record of magnetic-particle testing of the axle prior to the derailment, but such tests after the accident disclosed no fractures of the remaining portion of the axle. In conclusion, the report stated that the immediate cause of the failure was overheating as a result of the inner race of the inside roller assembly becoming free and rotating on the journal. Apparently the inner race was loosened as a result of failure of one of the separator cages, which permitted roller elements to lock the bearing. At the time of the accident the bearing assembly had an accumulation of 99,147 miles, and had last been supplied with oil on April 16, 1949. The journal-bearing assembly on the right journal of this axle was in good condition. A sampling inspection of 20 sets of double-type roller bearings which had been in service from 6 to 12 months disclosed that all were in good condition. The mileage of these journal bearings ranged between 73,232 and 132,650 miles.
