INVESTIGATION NO. 3222
THE PENNSYLVANIA RAILROAD COMPANY
REPORT IN RE ACCIDENT
AT FREEDOM, PA., ON
DECEMBER 24, 1948

Accident at Freedom, Pa., on December 24, 1948, caused
by failure to provide protection for derailed cars
which fouled adjacent main track.

Inv. No. 3222
 Pennsylvania Railroad
 Freedom, Pa.
 December 24, 1943

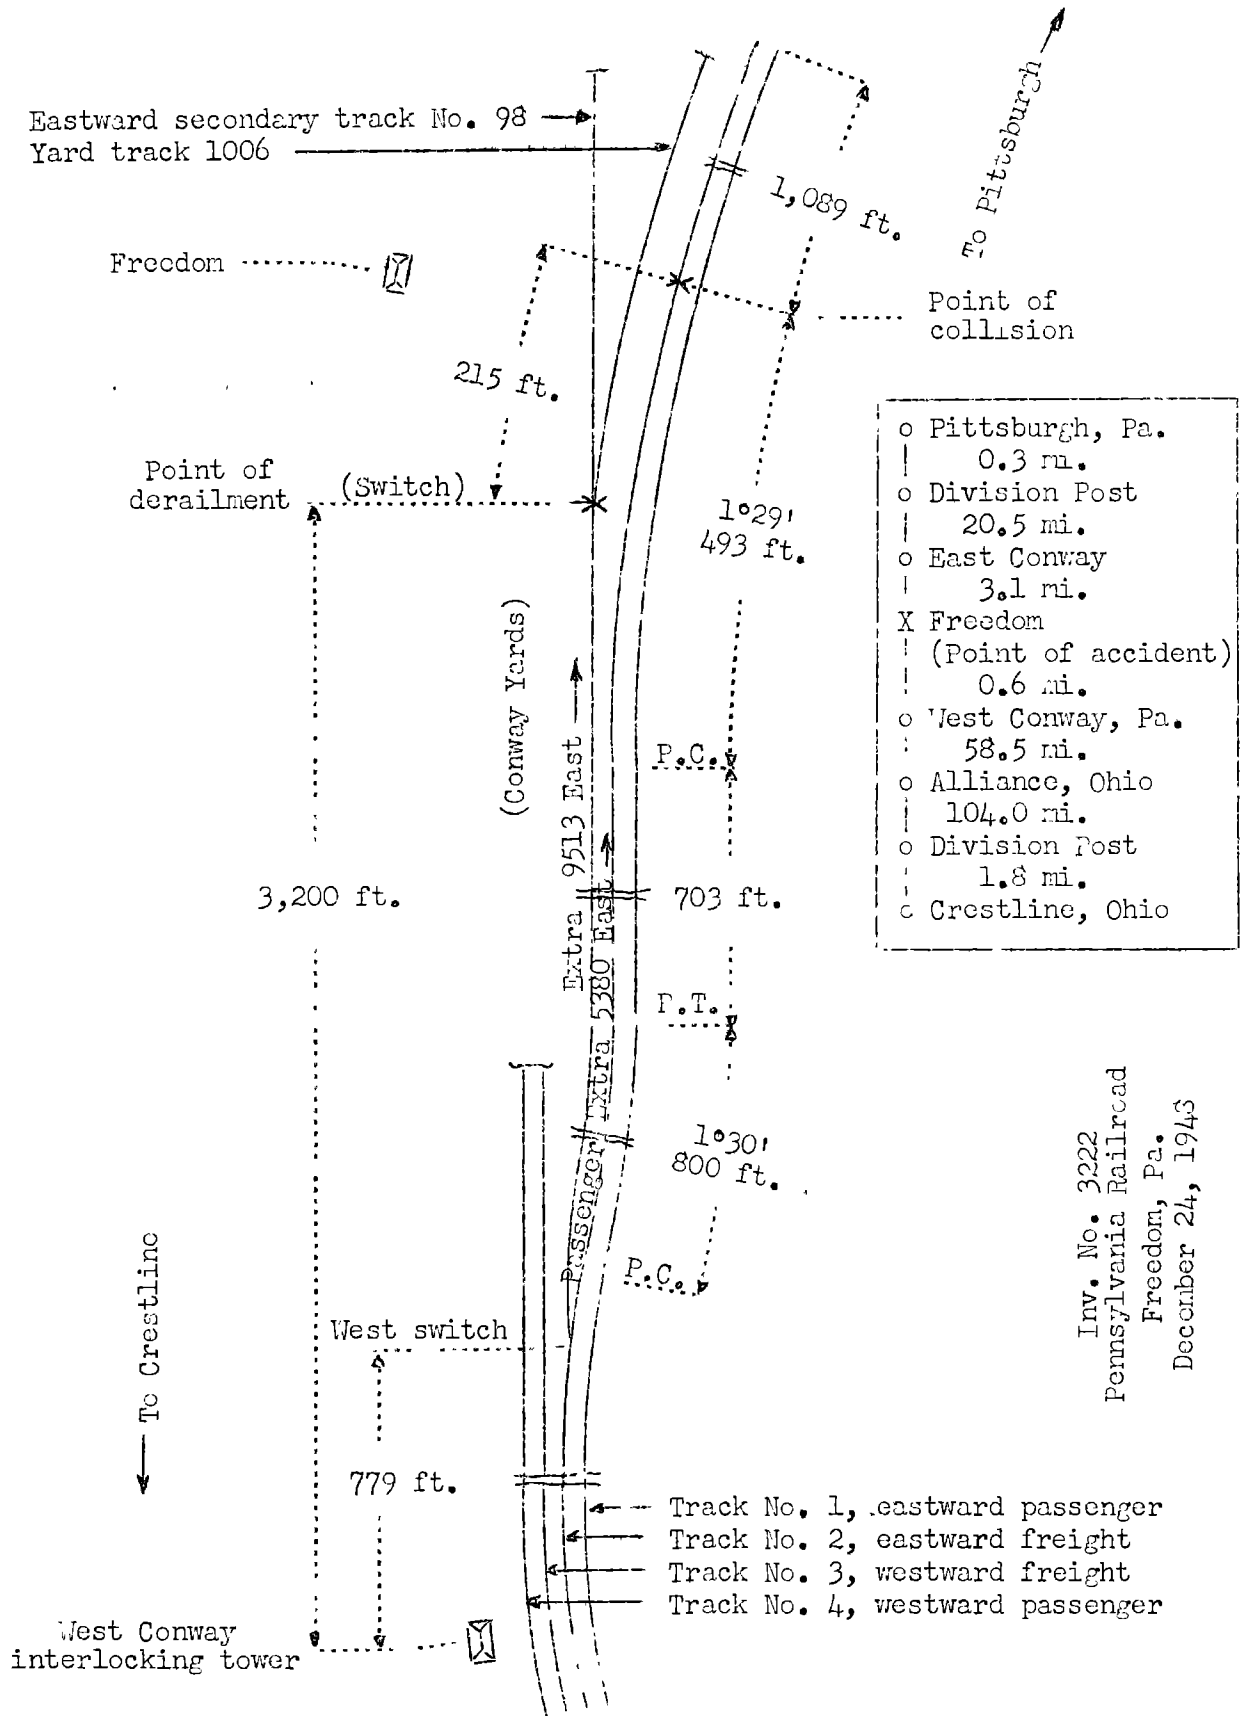
Location of Accident and Method of Operation

- Track No. 1, eastward passenger
- Track No. 2, eastward freight
- Track No. 3, westward freight
- Track No. 4, westward passenger
