INTERSTATE COMMERCE COMMISSION

REPORT OF THE DIRECTOR OF THE BUREAU OF SAFETY CONCERNING AN
ACCIDENT ON THE PENNSYLVANIA RAILROAD NEAR FRUITLAND,
MD., ON AUGUST 12, 1933.

December 15, 1933.

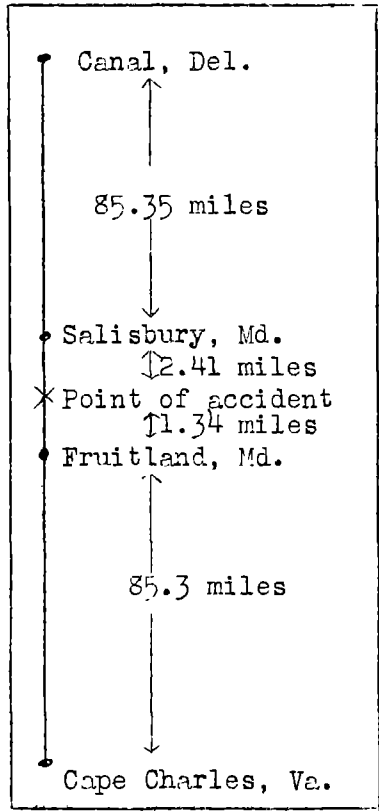
Inv. No; 1843
 Pennsylvania R.R.,
 Fruitland, Md.
 Aug. 12, 1933

Point of accident

Signal 90
