INTERSTATE COMMERCE COMMISSION

REPORT OF THE DIRECTOR OF THE BUREAU OF SAFETY CONCERNING AN
ACCIDENT WHICH OCCURRED ON THE PENNSYLVANIA RAILROAD AT
HAMLET, IND., ON JULY 19, 1932.

August 26, 1932.

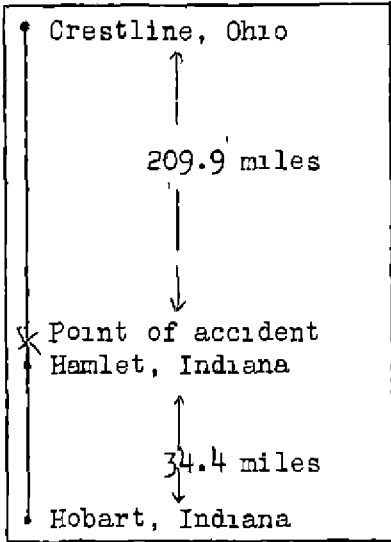
Inv. No. 1774
Pennsylvania Railroad
Hamlet, Ind.
July 19, 1932.

Point of accident
