ACCIDENT ON THE
PENNSYLVANIA RAILROAD

HARRISON, N. J.

JUNE 2, 1939

INVESTIGATION NO. 2357

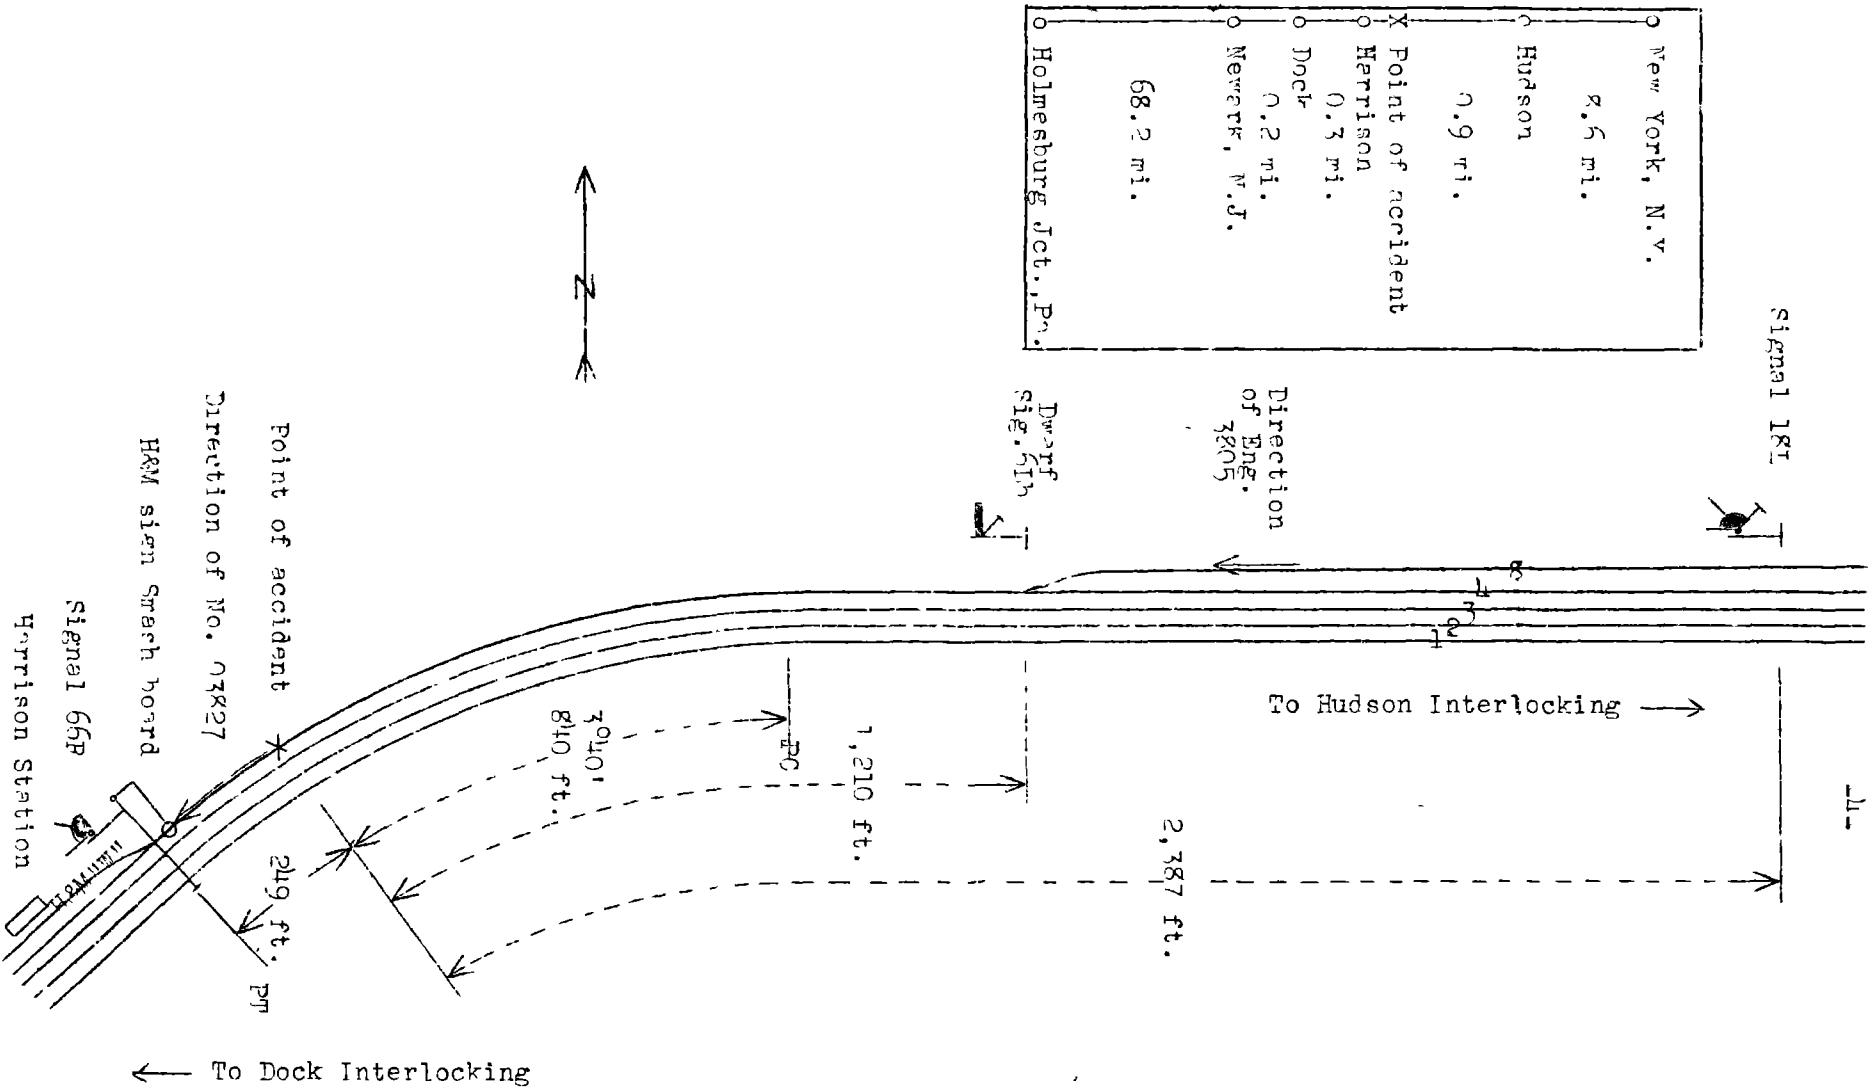
Inv. No. 2357
 Pennsylvania R.R.
 Harrison, N. J.
 June 2, 1939

Multiple unit electric trains of the Hudson and Manhattan Railroad, hereinafter referred to as the H. & M., are operated over the Pennsylvania Railroad, hereinafter referred to as the P. R.R., from Jersey City to Newark, N. J.; these movements are over the main line from Hudson interlocking to Newark, a distance of 1.4 miles. To provide a by-pass for H. & M. westbound trains through Harrison passenger station, a track designated as H. & M. track "W" diverges to the north from track 4 approximately 500 feet east of the station and parallels it through the station. Engine track 8 parallels track 4 on the north. Entry to track 4 from track 8 is made through a trailing-point switch, for westward movements, located 1,210 feet east of the point of accident. Approaching from the east there is a tangent 700 feet long followed by a 3°40' curve to the left 840 feet to the point of accident and 220 feet beyond. The grade at the point of accident is 0.68 percent ascending westward.

Signal 66R, which governs movements from track 4 to track "W", is a two-unit, position-light, interlocking home signal, located on a signal bridge immediately east of the entrance to track "W", and is operated from Dock interlocking. When this signal is displayed for a movement to track "W" there also are displayed a sign marked "H. & M." and a smash-board which drops over track 4 at a height that permits H. & M. trains to pass under it; other trains accepting this signal will contact and break the smash-board and set into operation an audible whistle at the signal. Signal 6Lb, which governs movements from track 8 to track 4, is a dwarf signal, located about 230 feet east of the switch at the entrance to track 4, and is operated from Hudson interlocking. The automatic cab-signal system is of the continuous type and displays indications conforming with the indications of the wayside signals. It is so arranged that when a train enters an occupied block a caution-slow-speed indication is displayed.
