INVESTIGATION NO. 2711
THE PENNSYLVANIA RAILROAD COMPANY
REPORT IN RE ACCIDENT
NEAR HELMETTA, N. J., ON
JULY 18, 1943

Accident near Helmetta, N. J., on July 18, 1943, caused by
failure properly to control speed of following train
in compliance with permissive-block indication.

Inv. No. 2711
 Pennsylvania Railroad
 Helmetta, N. J.
 July 18, 1943

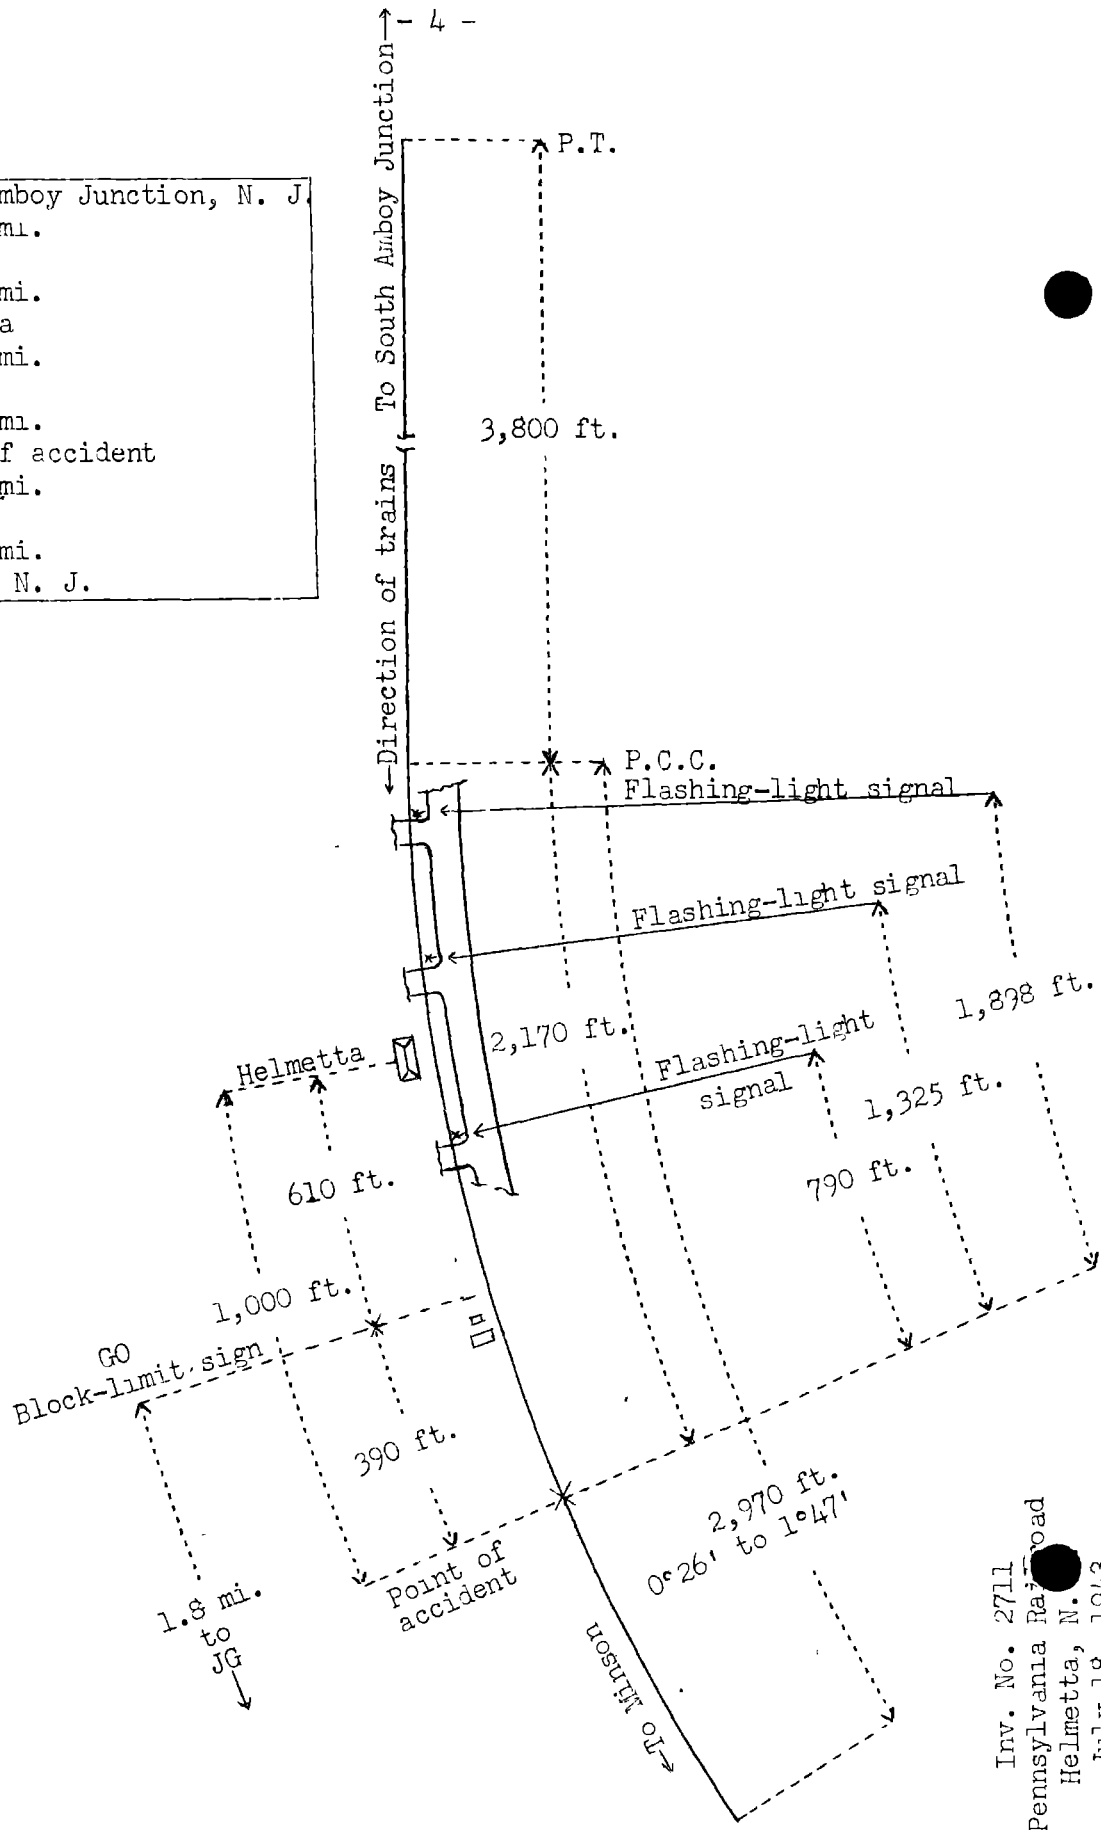
Location of Accident and Method of Operation

The block involved extended between block-limit station GO and block station JG, a distance of 1.8 miles. Block-limit station GO was in the charge of the signalman at block station JG. The eastern limit of the block was indicated by a sign located 610 feet west of the station at Helmetta. This sign consisted of the letters GO in white on a black signboard 9-1/2 inches wide and 23 inches long mounted horizontally 7 feet 2 inches above the level of the rail on a mast 7 feet 6 inches south of the south rail. For a night indication a light was provided in a box 13-1/2 inches high and 27 inches long, mounted horizontally on the mast 8 feet 8 inches above the level of the rail, with a red and a yellow lens, each of which was 5 inches in diameter. The yellow lens was next to the main track. Both the sign and the night indication were visible from either direction. A telephone booth was located on the south side of the track 19 feet west of the block-limit sign.

From the left side of a west-bound engine the view of the point where the accident occurred was restricted to about 1,000 feet, because of buildings, vegetation and poles adjacent to the track, and track curvature. Street crossings at grade were located at points, respectively, 790 feet, 1,325 feet and 1,893 feet east of the point of accident. These crossings were protected by red flashing-light signals. The masts of the signals on the south side of the track were located about 8 feet south of the south rail and the centers of the lenses were about 4 feet 6 inches above the level of the rail. Some of the lights were focused to the southeast and were visible from an approaching west-bound engine after it had passed the actuating point 3,762 feet east of the point of accident.
